An Overview of Comprehensive First Mirror Test for ITER at JET

Preprint of Paper to be submitted for publication in Proceedings of the
18th Plasma Surface Interactions in Controlled Fusion Devices, Toledo, Spain
(26th May 2008 - 30th May 2008)

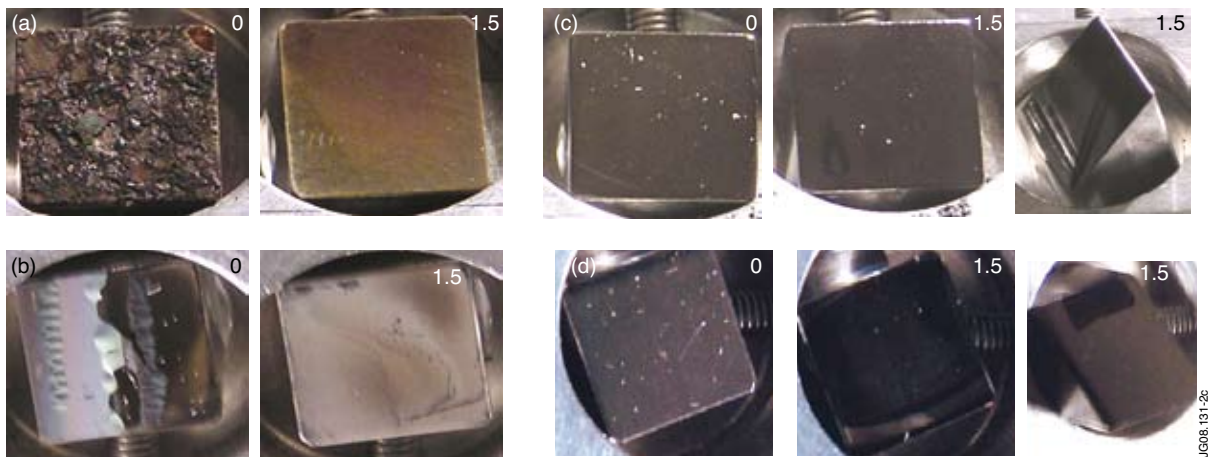
Images in Fig. 2 show the appearance of mirrors retrieved from the inner divertor leg (steel, Fig. 2a) and base (Mo, Fig. 2b), whereas samples from the main chamber wall are in Fig. 2c (Mo, shutter protected) and 2d (steel, not protected). The position of mirrors in cassettes is given, i.e. depth in channels. The quality of images is somewhat obscured by photographing through a window of the isolator. Visual inspection reveals distinct differences between mirrors from the two locations. Surfaces of all mirrors from the divertor are coated with deposits. In some cases, the layer had flaked and peeled-off. This process must occur in-situ during the exposure because discoloration is seen on the flake-free surface thus indicating the formation of a new co-deposit. It is impossible, however, to conclude whether the flaking happened only once or several times during the long-term exposure. For mirrors from the outer wall the picture is more complex. As shown in Fig. 2c, three

Mo mirrors positioned near the mouth of the channel (0 and 1.5cm protected by the shutter) are nearly free from a visible co-deposit, but some surface imperfections could be observed. Only a narrow deposition belt is noted on the chamfered surface. Mo samples from deeper locations (3 and 4.5 cm) are partly (not the whole surface) coated by thick films. Very similar deposition pattern also developed on steel samples located deep in the channel. In addition, a flat-front mirror at 1.5cm was coated, whereas on the adjacent chamfered sample (1.5cm at the center) the deposit covered only a small area, as inferred from Fig. 2d. These results suggest that deposition on all mirrors in wall units took place during tokamak discharges and it was not connected with wall conditioning. Some differences in deposition, like those observed on two adjacent steel samples at 1.5cm, are probably related to some local geometrical effects that are difficult to identify having in mind the complexity of wall structures in JET. Microscopy studies have not been accomplished yet for technical reason (Be and T contamination of mirrors), but one may suggest that lack of deposits on mirrors placed at the channel mouth in main chamber units is related to removal of deposited species by charge exchange neutrals reaching these surfaces.

Figure 2: Appearance of mirrors after exposure in JET, position of mirrors in cassettes is marked: (a) inner divertor, steel; (b) divertor base, steel; (c) main chamber wall, molybdenum, shutter-protected; (d) main chamber wall, steel, not protected by shutter.

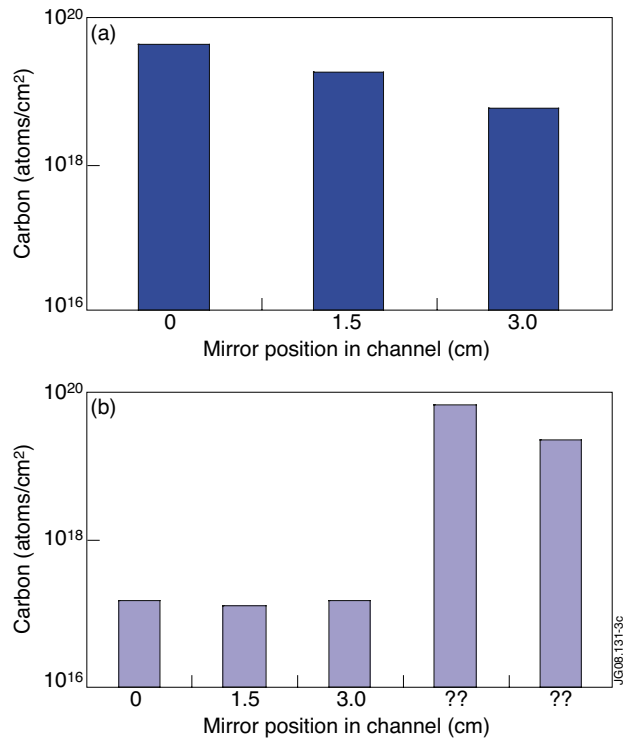
IBA results are shown in graphs on Fig. 3 a and b for Mo mirrors from the outer divertor leg and the main chamber wall, respectively. The most distinct difference is that the deposition on samples from the divertor decreases with the depth in channel for all studied samples, whereas the opposite trend is characteristic for wall samples. Thus, IBA data confirm the general observation from the visual inspection. The quantitative results for carbon deposition on steel mirrors from the outer divertor were nearly identical, within $\pm 5\%$, to those shown for Mo in Fig 3a. The recorded EPS spectra for thick carbon layers were modeled with SIMNRA [9] to obtain the concentrations and layer thickness, e.g. 10 μm for samples from the main chamber wall. However, proper assessment has not been possible for very thick layers formed on the inner divertor sample located at the channel mouth, see Fig. 2a.

All deposits, whether thin or thick, contain carbon-12 and deuterium as the main components (D/C concentration ratio ~ 0.65 for the outer and inner divertor samples) and small quantities of beryllium and carbon-13. The concentration of these minority species was in the range $5 \times 10^{16} \text{ cm}^{-2} - 1 \times 10^{18} \text{ cm}^{-2}$, but no systematic tendency regarding their deposition could be traced. The presence of C-13 in measurable quantity derives from three experiments using $^{13}\text{CH}_4$ tracer in material migration studies [8,10,11]. The last experiment of this kind was performed just on the last operation day before the shut-down.

Figure 3: Carbon deposition on Mo mirrors in: (a) outer divertor; (b) main chamber wall.

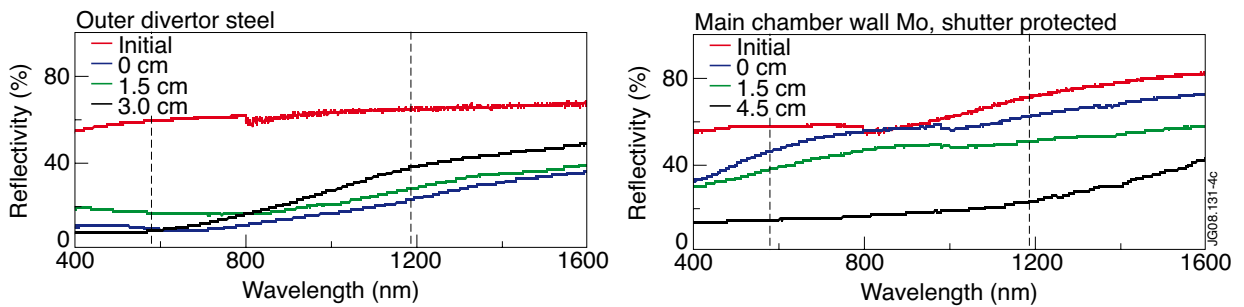
Total reflectivity was measured for all 29 mirrors retrieved from the torus and it was compared with the initial reflectivity. Plots in Fig. 4 a and b show results for mirrors located at different distances from the channel mouth in cassettes from the outer divertor and main chamber wall, respectively. These results are representative for all mirrors from the two major locations, i.e. the divertor and main wall. Though some differences within each category have been noted, the general tendency

is well reflected in Fig. 4: the increase of reflectivity with the depth in channel for mirrors in the divertor and the decrease of reflectivity with the depth for mirrors on the wall.

Figure 4: Total reflectivity of mirrors from: (a) outer divertor, steel and (b) main chamber wall, Mo.
