# Comprehensive First Mirror Test for ITER at JET with Carbon Walls

Preprint of Paper to be submitted for publication in Proceedings of the  
23rd IAEA Fusion Energy Conference, Daejeon, Republic of Korea  
(10th October 2010 - 16th October 2010)

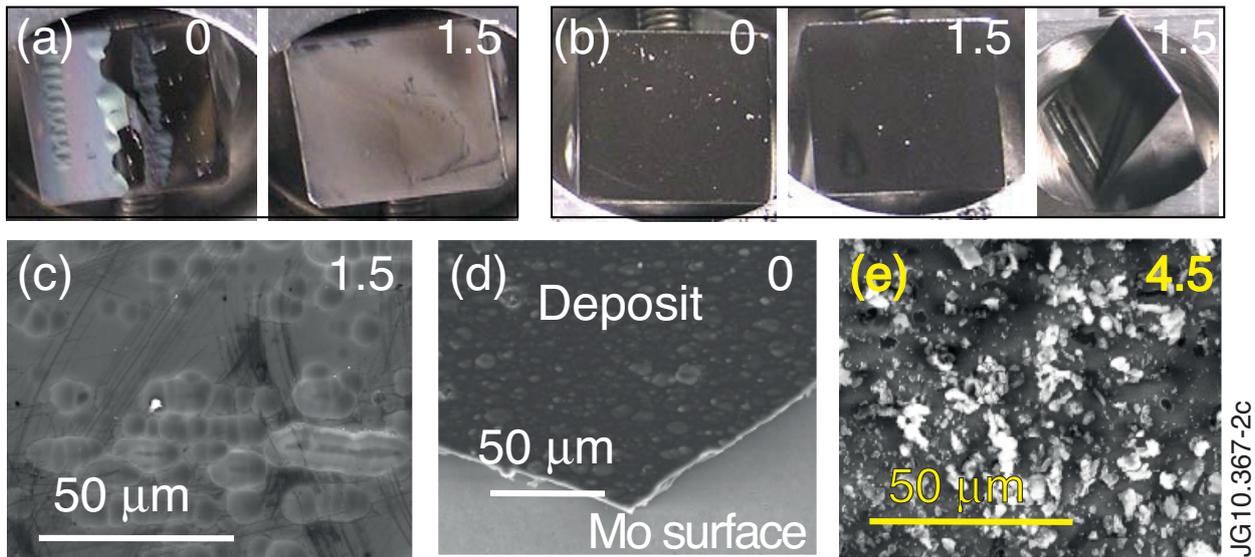
Images in Fig. 2 (a) show the appearance of Mo mirrors retrieved from the divertor base, whereas steel samples (not protected by shutter) from the main chamber wall. The position of mirrors in cassettes is given, i.e. depth in channels. The quality of images is somewhat obscured by photographing through a window of the isolator. Visual inspection reveals distinct differences between mirrors from the two locations. Surfaces of all mirrors from the divertor are coated with deposits. In some cases, the layer had flaked and peeled-off. This process must occur *in-situ* during the exposure because discoloration is seen on the flake-free surface thus indicating the formation of a new co-deposit. It is impossible, however, to conclude whether the flaking happened only once or several times during the long-term exposure. For mirrors from the outer wall the picture is more complex. As shown in Fig. 2 (b), three Mo mirrors positioned near the mouth of the channel (0 and 1.5 cm protected by the shutter) are nearly free from a visible co-deposit, but some surface imperfections could be observed. Only a narrow deposition belt is noted on the chamfered surface. Mo samples from deeper locations (3 and 4.5 cm) are partly (not the whole surface) coated by thick films. Very similar deposition pattern also developed on steel samples located deep in the channel. These results suggest that deposition on all mirrors in wall units took place during tokamak discharges and it was not connected with wall conditioning. Some differences in deposition, like those observed on two adjacent steel samples at 1.5 cm, are probably related to some local geometrical effects that are difficult to identify having in mind the complexity of wall structures in JET.

Details of surface features are shown in Fig. 2 (c-e) for mirrors from three different locations: steel sample from the outer wall (1.5 cm in channel), Mo from the divertor base (channel mouth) and

steel from the inner divertor (4.5 cm in channel), respectively. The formation of chains of bubble-like structures in Fig. 2 (c) may be considered as a precursor state for the layer detachment, disintegration and peeling-off. There are several factors that can contribute to this. There is a significant mismatch of thermo-mechanical properties between the metal surface polished to mirror quality and the carbon-based film. Possible temperature excursion during plasma operation or wall baking may introduce internal stress. Such stress in the film poorly adhered to the mirror surface causes detachment. It is difficult to conclude which factors prevail in the film disintegration. From the practical point of view the most important thing is that such processes occurring in the diagnostic channel would be a strong source of dust which can be charged and levitate thus obscuring the quality of spectroscopic measurements. Careful examination of the cracked deposit, Fig. 2 (d), reveals both granular and stratified structure of the film which has a thickness of about 3-5  $\mu\text{m}$ . The deposit formed in the inner divertor Fig. 2 (e) shows a rough, dusty-like structure which is similar to that observed several times on PFC from other tokamaks [8-11].

Figure 2. Appearance of mirrors after exposure in JET, position of mirrors in cassettes is marked: (a) divertor base, steel; (b) outer wall, molybdenum, shutter-protected. Surface topography of mirrors after exposure: (c) bubble-like structure of the peeling-off deposit on steel mirror from the outer wall; (d) flake on Mo mirror from the divertor base; (e) dusty deposit on steel mirror from the inner divertor. SIMS and

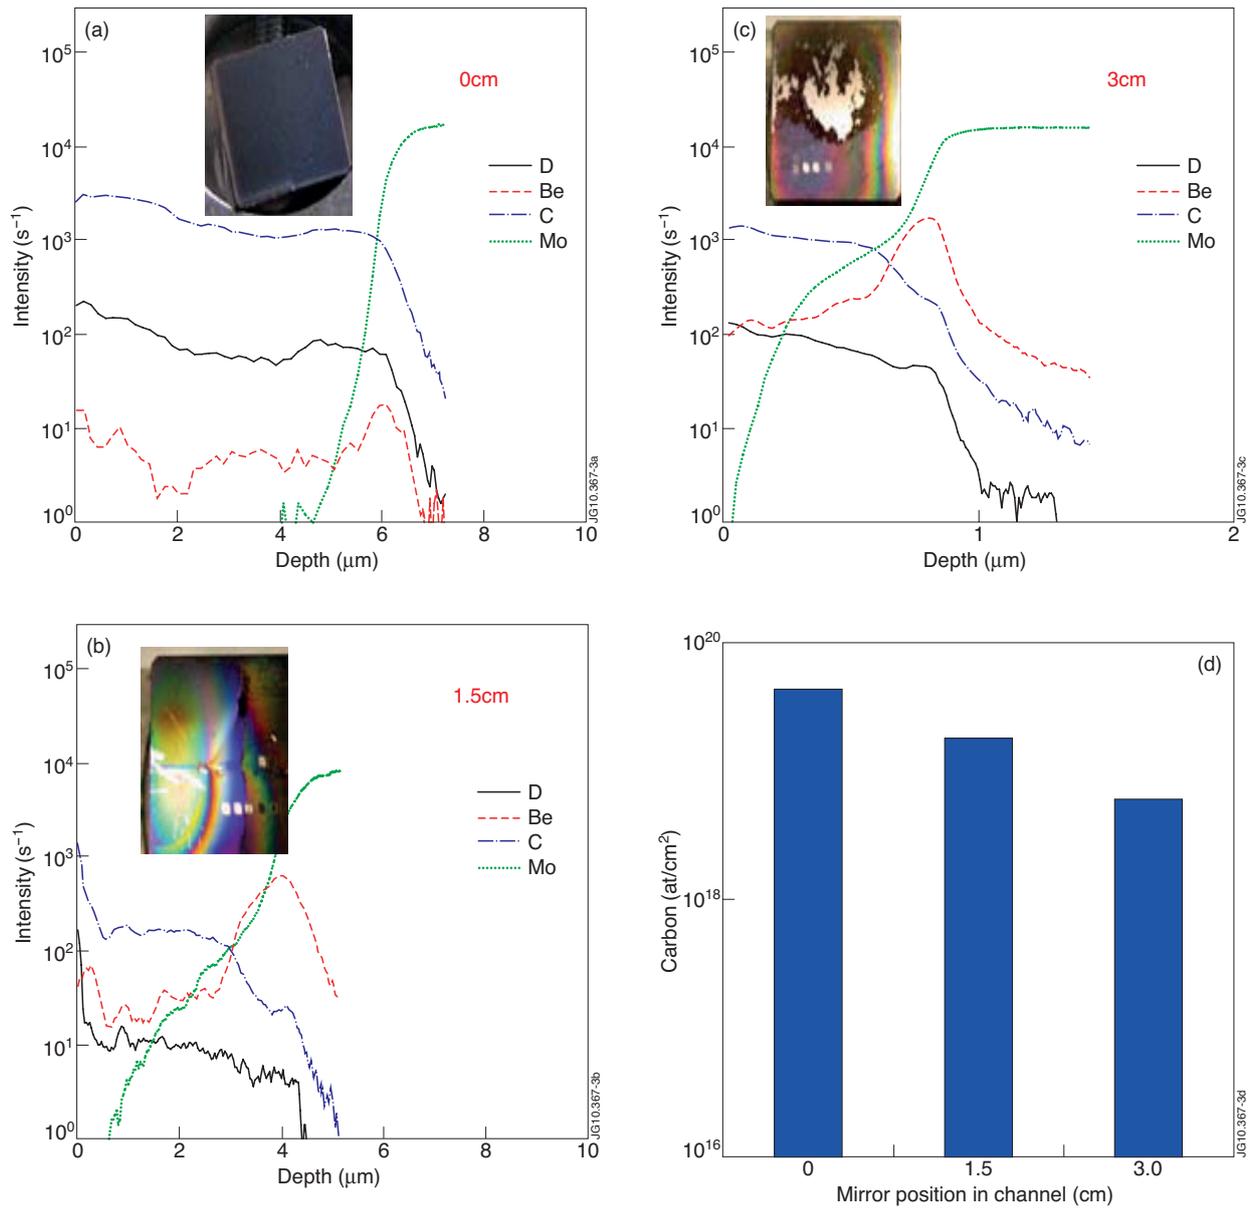
SIMS and IBA results are shown in graphs on Fig. 3 (a-c) and (d), respectively for Mo mirrors from the outer divertor leg. From the SIMS plots one infers the qualitative composition of the films (carbon, deuterium and beryllium) and the layer thickness of approximately 6.5, 4 and 0.85  $\mu\text{m}$  on mirrors located 0; 1.5 and 3 cm from the front of the channel, respectively. The interface between the Mo substrate and the layer is not perfectly sharp especially in the case of thinner films, i.e. on the mirrors located at 1.5 and 3 cm in the channels. It is an indicator of material mixing during the layer formation. One may assume that the arriving flux of neutral carbon and small quantities of beryllium atoms caused sputter erosion of the Mo surface. As a result, these erosion products and the arriving species were deposited together on the mirror surface. The formation of carbides on the interface cannot also be excluded but SIMS and IBA do not permit conclusive statements on that matter. Quantitative EPS measurements plotted in Fig. 3 (d) show that the carbon films contain  $4.3 \times 10^{19}$ ,  $1.8 \times 10^{19}$  and  $0.6 \times 10^{19}$  C at  $\text{cm}^{-2}$ , thus corresponding to 6.6, 3.0 and 1.0  $\mu\text{m}$ , respectively. Assuming the deposit density of about  $1.3 \text{ g cm}^{-3}$  equal to  $6.5 \times 10^{22}$  C at  $\text{cm}^{-3}$  [12] the agreement between SIMS and IBA results is nearly perfect; some discrepancies may be attributed to the non-uniformity of the layer thickness especially due to flaking of the deposits, as can be seen in the image inserted in Fig. 3 (c). The beryllium content in these films is in the level from  $5 \times 10^{17}$  to  $1 \times 10^{18}$   $\text{cm}^{-2}$ , i.e. a few atomic per cent.

The results in Fig. 3 are representative for all divertor samples: deposition decreases with the depth in the channel. An opposite trend is characteristic for mirrors from the main chamber wall, where very small amount of deposited species is detected on the mirrors located near the channel mouth (e.g. only  $1.3\text{-}1.5 \times 10^{17}$  C at  $\text{cm}^{-2}$  on the three front sample at 0 and 1.5 cm), but thicker deposits are found deeper in the channel at 3 and 4.5 mm. Thus, IBA and SIMS data confirm the general observation from the visual inspection. Moreover, the data obtained for the front mirrors (i.e. located at 0 cm) in the divertor agree qualitatively with the deposition pattern observed on the sensors of quartz microbalance (QMB) devices installed in the vicinity of the mirrors: most significant

Figure 3. Surface composition and thickness of deposits on Mo mirrors from the outer divertor: SIMS depth profiles and total carbon content in films measured with EPS.

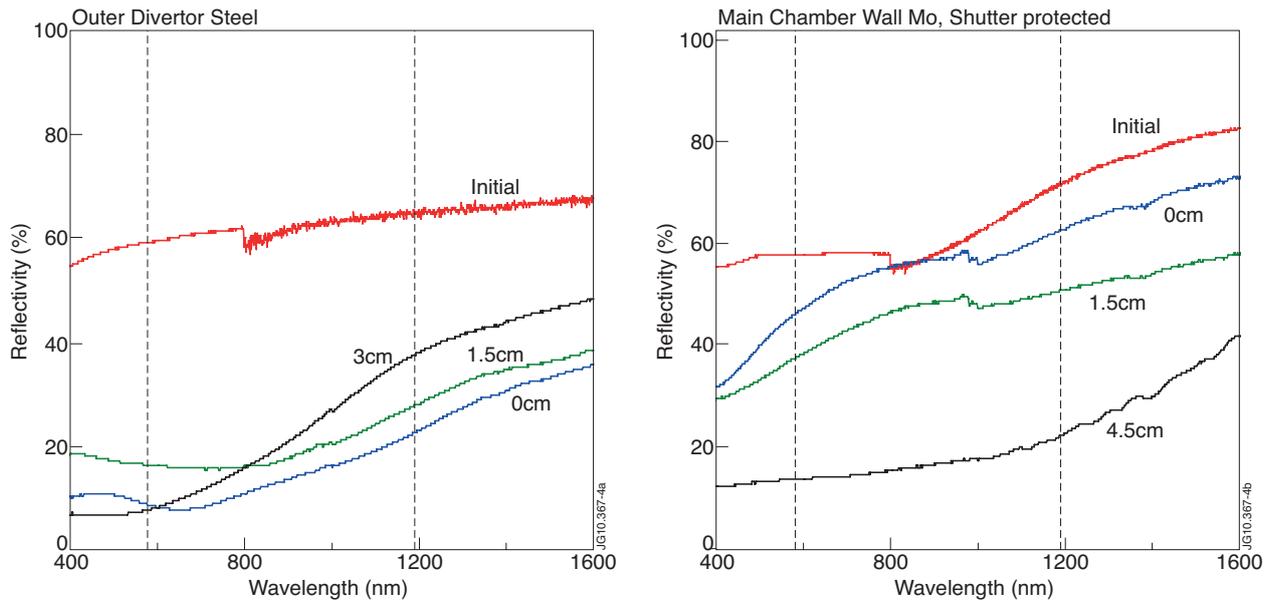
Total reflectivity was measured for all 29 mirrors retrieved from the torus and it was compared with the initial reflectivity which was determined for all the mirrors before their installation; the scatter was well below 5% [2]. Therefore, for the clarity of presentation, the initial reflectivity is represented by single plots in Fig. 4 (a) and (b) which show results for mirrors located at different distances from the channel mouth in cassettes from the outer divertor and main chamber wall, respectively. These results are representative for all mirrors from the two major locations, i.e. the divertor and main wall. Though some differences within each category have been noted, the general tendency is well reflected in Fig. 4: the increase of reflectivity with the depth in channel for mirrors in the divertor and the decrease of reflectivity with the depth for mirrors on the wall.

- (i) In the divertor base very significant loss of reflectivity is measured close to the channel mouth: in the visible range by a factor of 6-10 at 0 and 1.5 cm.

- (ii) In the outer and inner divertor reflectivity drop by a factor of 10 in visible range (400-800 nm) is recorded at all locations. At 1400 nm it reaches eventually 50% of the original value for mirrors deep in the channel (3 cm) and ~30% for mirrors located close to the channel entrance (0 and 1.5 cm).

- (iii) On the main chamber wall, close to the channels entrances high reflectivity (~90%) is maintained at infrared range by both steel and Mo surfaces. However, in the range 400-600 nm the drop by 15% (steel) and 30% (Mo) is measured. 1.5 cm from the channel entrance the reflectivity drops by 35-50% and at deeper locations (3, 4.5 cm) it is only 20-25% of the original value due to deposits. These results suggest that fair reflectivity of mirrors near the channel mouth is due to the instant removal of deposits by the flux of charge exchange (CX) neutrals. However, the deposition prevailed over erosion deeper in the channel because of the decreased CX flux to that location.

Figure 4. Reflectivity of mirrors from: (a) outer divertor, steel and (b) main chamber wall, Mo.

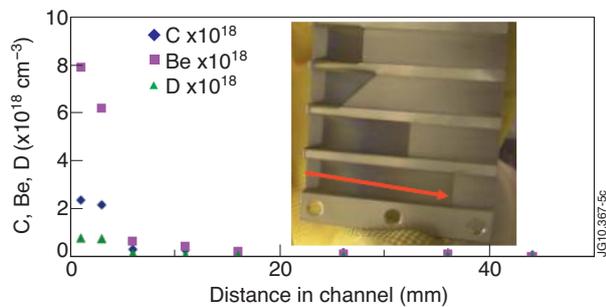
Fig. 5 shows the deposition profiles of C, Be and D in a channel of a cassette housing mirrors on the outer wall. The cassette was located in the midplane of Octant 4, toroidally about 40° from the beryllium evaporator; the channels of this cassette were not protected during the evaporations by the magnetic shutter. Two regions of the deposition can be distinguished in the profiles. There

is a greater content of all species up to 10 mm deep into the channel. The profile in that region is not decreasing exponentially but has a peak at about 2-4 mm. It can be attributed to the erosion of species deposited near the channel mouth. In the deeper part of the channel (15 - 45 mm) the co-deposit is fairly thin containing  $0.8-2 \times 10^{17} \text{ cm}^{-2}$  of C and Be atoms. Qualitatively similar in shape deposition profiles have been recorded for other cassettes housing mirrors in other locations. The major difference between the cassettes from the outer wall and the divertor was that in the latter case only very small quantities or no beryllium (especially inner divertor) have been detected. The result is in full agreement with measurements of deposition in previous campaigns in JET with a series of divertors: Mk-IIA [14,15] Mk-IIGB (Gas Box) [16] and Mk-IISRP (Septum Replacement Plate) [17]. It also agrees with the analysis of other erosion-deposition diagnostic tools used in TRS and exposed along with the mirrors in the presence of the Mk-IIHD (High Delta) divertor [18] and with general results of material migration studies in JET [19].

Figure 5. Deposition profiles and contents of beryllium, carbon and deuterium along the channel in the cassette located on the outer wall.

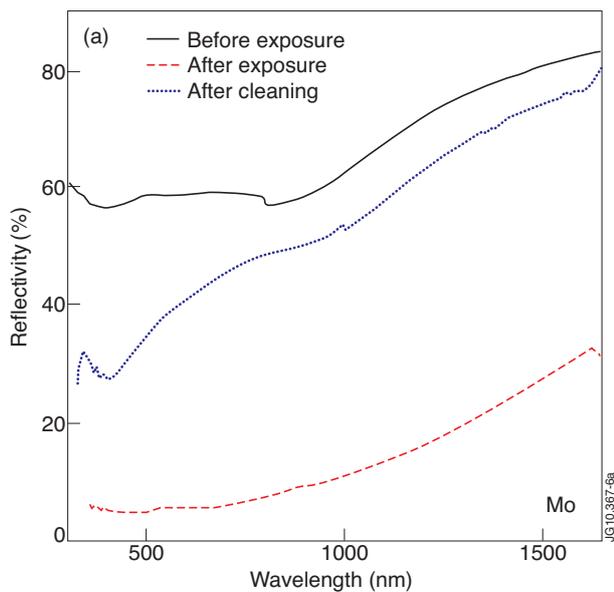
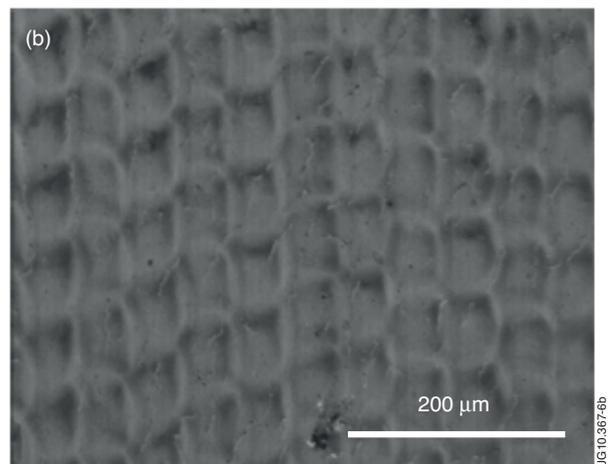
Plots in Fig. 6 (a) show the changes of reflectivity (mirror after the exposure and then after cleaning in comparison to the original values). One may infer that the regain of reflectivity after cleaning was 50% in the visible range and over 85% in infra-red. Despite pre-calibration of the laser power density the surface was damaged as seen on the micrograph in Fig. 6 (b). Similar type of damage was observed on all laser irradiated mirrors; details are in [6].

Figure 6. Reflectivity of a Mo mirror before and after exposure in JET and after laser-assisted cleaning. (b) Damage on the Mo surface cleaned by laser pulses.
