C. Ruset, H. Maier, E. Grigore, G.F. Matthews, G. De Temmerman,
A. Widdowson and JET EFDA contributors

W Coatings Under High Thermal Loads in JET and Magnum-PSI

Preprint of Paper to be submitted for publication in Proceedings of the
14th International Conference on Plasma-Facing Materials and Components for Fusion Applications,
Jülich, Germany.
13th May 2013 - 17th May 2013

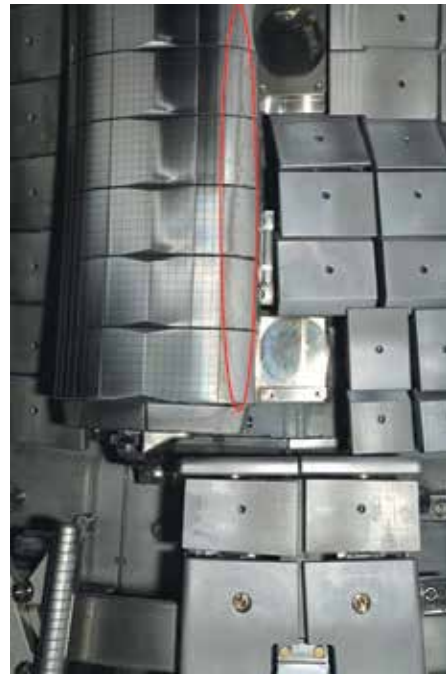
The monitoring pulses did not show a substantial increase of the C level during plasma operation in campaigns which suggested a good condition of the W coatings on CFC tiles. Then, the visual inspection confirmed that the overall picture on the W coatings from the ILW looks good. However, some local modifications occurred and the discussion in the paper will be focused on these aspects. In the main chamber W coated CFC tiles were introduced in areas with the highest thermal loading. In the Inner Wall Guard Limiter they are near to the Be tiles. The pictures of those areas show relative thick deposits of material (probably Be) on the W coated CFC tiles (“wings”). This can be seen in Fig.3 taken in Octant 7, inner wall, bottom of the limiter beam. On the limiter there is a transition from strong erosion (in the centre area) to deposition (in the side zones). The ridge of the Be tiles was eroded or even melted in some cases [10] and material was deposited on the W-coated wings tiles. The same phenomenon has been seen in Octant 3 (inner wall, bottom of the limiter beam), Octant 5 (outer wall, mid-plane), Octant 6 (top limiter beam) and Octant 8 (top limiter beam). This is clear a pattern, specific for this type of wall. The other W coated CFC tiles shown in Fig.3 appear to be in very good condition.

Figure 3: Deposits of Be on W-coated wings, inner wall, bottom of limiter beam, Octant 7.

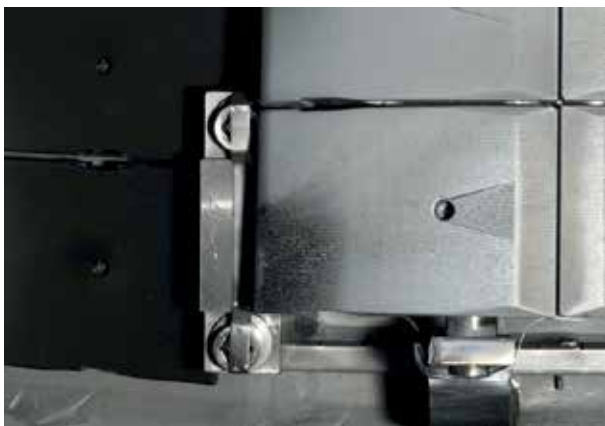
A thorough inspection of the W coated CFC tiles revealed the damage of one bottom tile, Inner Wall Guard Limiter placed in the same position in Octants 2, 5 and 7. It is shown in Fig.4. The W coating seems to be melted on the left round edge of the tile. The damage seems to be produced by the runaway electrons in the early commissioning phase of the ILW during an emergency shutdown (pulse 80263).

Figure 4: Local damage of the bottom tile, IWGL, Octant 2.

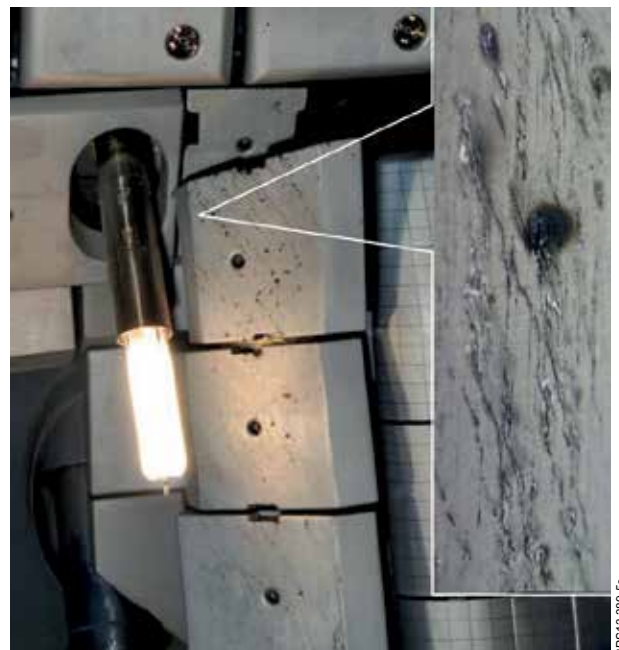
Another phenomenon which was observed after the first campaigns is arcing on some particular tiles. These are located on outer wall, shine through protection, Octants 1 and 5. An image is shown in Fig.5. The pattern of the damages is the same in both octants. Two of W-coated CFC tiles from Octant 1 were removed and inspected carefully with a high resolution camera in the BeHF. The following aspects were revealed:

- The W coating was subjected to intense arcing. This leads to delamination of the coating along the arc track and even melting of the W coating. This is evidenced in Fig.5 (inset).
- In local zones the temperature during arcing was so high that the CFC substrate was affected. Black spots surround the W melted zones indicating that carbon was eroded from the substrate and deposited onto the W coating.

A clear explanation on the arcing phenomenon on those particular tiles was not found yet. It might be associated with the presence of some small carbon particles resulted from mechanical processing of the CFC tile after W coating or related to the earthing of particular tiles to the vessel leading to local variations in potential during extreme events such as disruptions. On the other hand there were other tiles adjusted after W coating during the installation of the ILW without arc signs. More investigations are necessary in order to clarify the presence of such intense arcs on these tiles.

Figure 5: Arcing on W coated shine through protection tiles, outer wall, Octant 1.
