# The Remote Photogrammetric Survey and Engineering Analysis of the Divertor Structure during JET's Remote Tile Exchange

B Macklin, R Brade, F Hurd, J Tait.

JET Joint Undertaking, Abingdon, Oxfordshire, OX14 3EA,

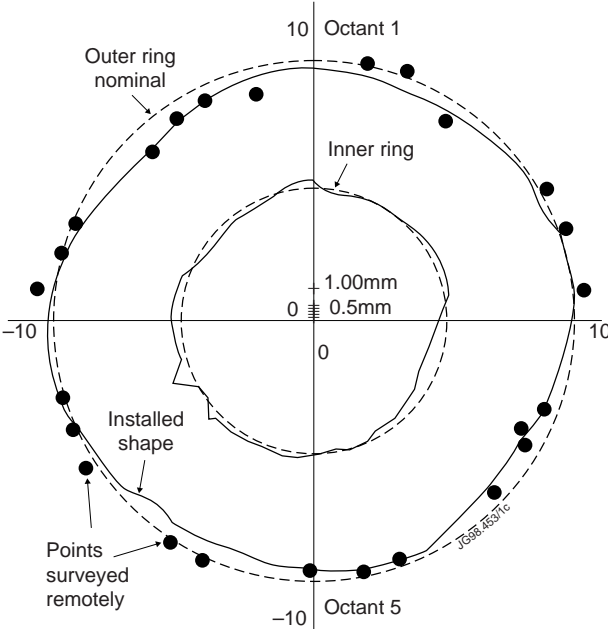
Fig. 4 Comparison of structure shape

Initial processing of the survey was carried out automatically thanks to the use of coded targets. The final result for this survey was achieved with a mathematical area of uncertainty or RMS (Root Mean Square) error of 0.03mm for targets and an RMS of 0.06mm for camera positions leading to an average RMS for the survey of 0.1mm. A summary of results is presented below (figs. 4 & 5)

Best Fit Circles	Dev. from Nominal	RMS of measurement
Outer Ring (targeted)	-0.11	0.1
Outer Ring (untargeted)	-0.22	0.29
Inner Ring (untargeted)	-0.22	0.19
Base Plate (untargeted)	-0.08	0.14
Best-Fit Plane Height	0.11	0.11

Fig. 5 Summary of structure deviations

The remote application of photogrammetry developed at JET proved that there has been no unacceptable change in shape or position of the divertor structure, therefore confirming its integrity. The flexibility of this technique was demonstrated when it was used for an unplanned, high accuracy, remotely targeted survey of the damaged KG6 outer waveguide. The ability to carry out an engineering analysis of large structures, using data captured remotely, is essential for the construction, operation and maintenance of fusion machines [3]. This ability, using commercially available survey equipment, has been successfully demonstrated at JET.
