Intervention to Repair a Tritiated JET Neutral Beam Injector

JET Joint Undertaking, Abingdon, Oxfordshire, OX14 3EA,

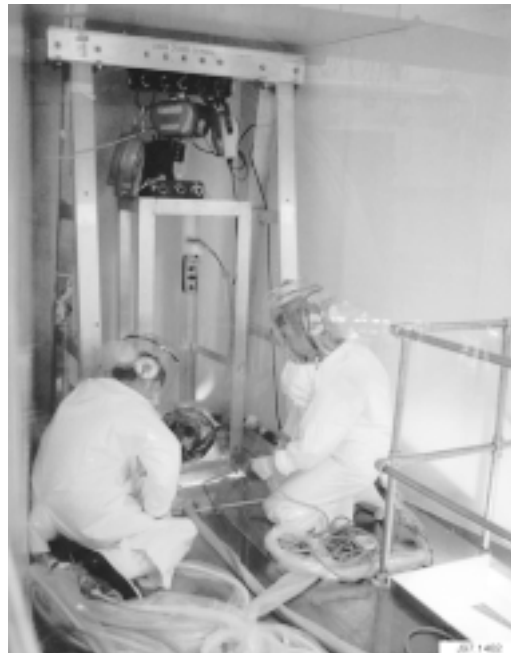
Fig 1 Suited personnel preparing the hoist in the NIB access cabin

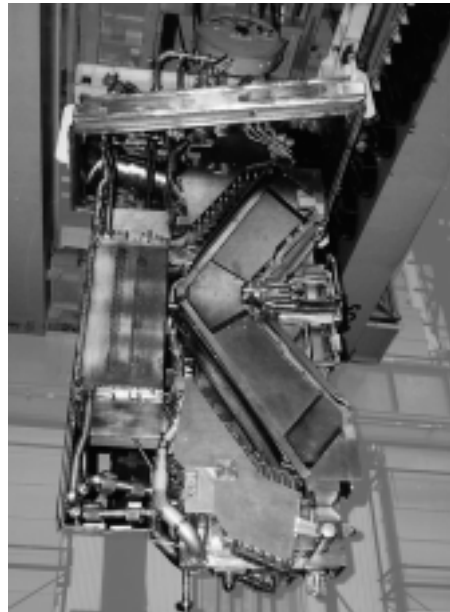
Fig 2 The CSC showing beamline components and integral NIB lid

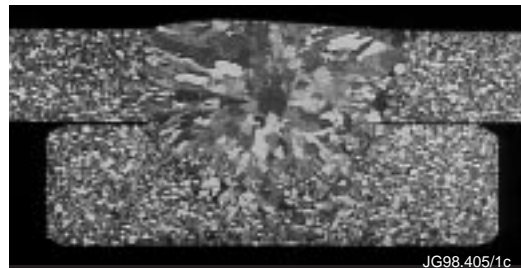
Fig 4 Macrograph section of completed orbital weld with insert ring

Production Proof Samples (PPS's) were made in the NIB prior to each in-situ welding operation (and with the same equipment) and each PPS subjected to both visual inspection and examination via sectioned micrograph (Fig 4). Procedures were developed for orbital welding of pipe diameters 17, 26 and 60mm with appropriate inserts. On completion of all welding operations the Fast shutter/Box Scraper systems were subjected to a pressure test of 9 bar and a global helium leak test to $< 1 \times 10^{-9} \text{ mbls}^{-1}$.
