Investigation on the Erosion/Deposition Processes in the ITER-Like Wall Divertor at JET Using Glow Discharge Optical Emission Spectrometry Technique

(18th May 2015 – 22nd May 2015)
Aix-en-Provence, France

Investigation on the erosion/deposition processes in the ITER-like Wall divertor at JET using Glow Discharge Optical Emission Spectrometry technique

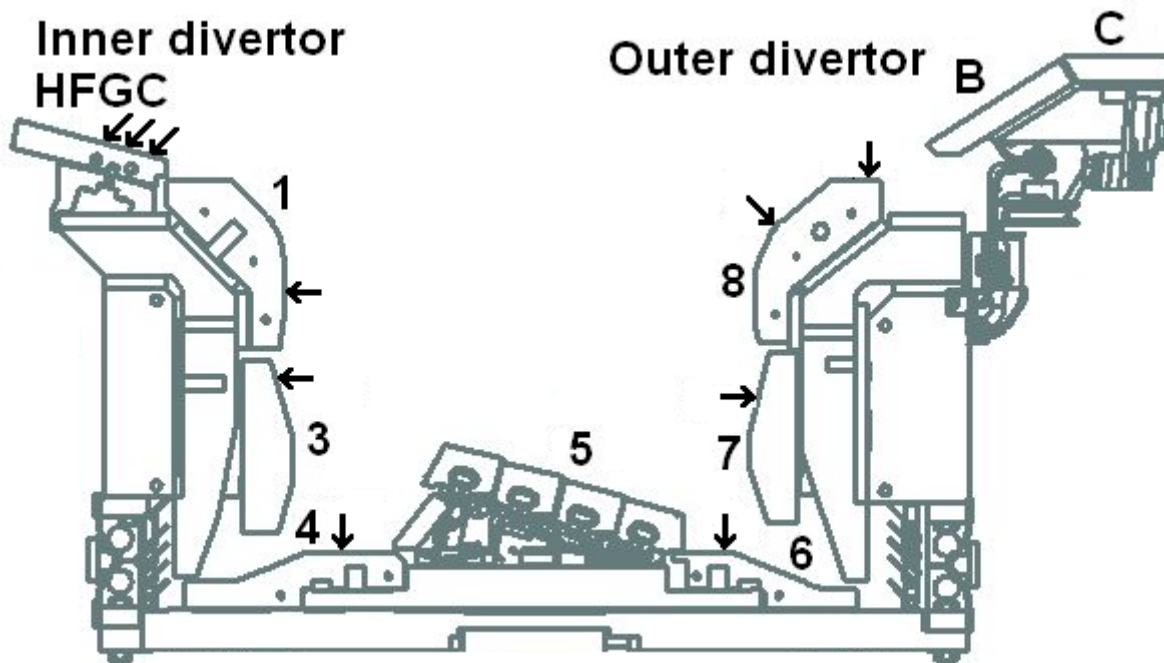
Fig. 1 JET divertor area and tiles identification; arrows show the position of the samples analyzed by GDOES

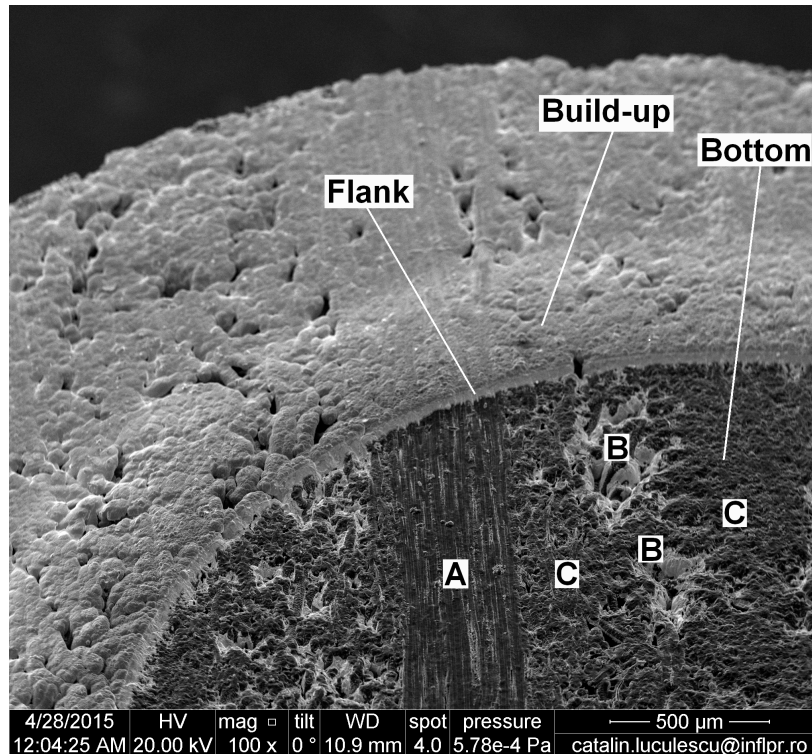
open porosity at the surface, with dimensions of pores in the range of a few ten up to a few hundred μm and depths up to 250 μm . The interior of these open pores is coated with Mo and W during the coating process and with beryllium during plasma operation (see areas B in Fig. 2). It appears that to some extent even interior areas of open pores without direct line of sight to the exterior are being coated. However, more experiments are necessary to confirm this hypothesis. On the other hand the percentage of ~ 5 at.% of W at the surface indicate a low deposition of W together with Be. At the same time the decrease of the Mo concentration at the surface from 100 at.% to about 10 at.% could be associated with the local erosion of Mo. The SEM analyses confirmed the missing of Mo top layer in some areas.

Fig. 2 GDOES crater with the depth of 40 μm on Tile 3; A-carbon fibers parallel to surface; B-carbon fibers perpendicular to surface; C-felt

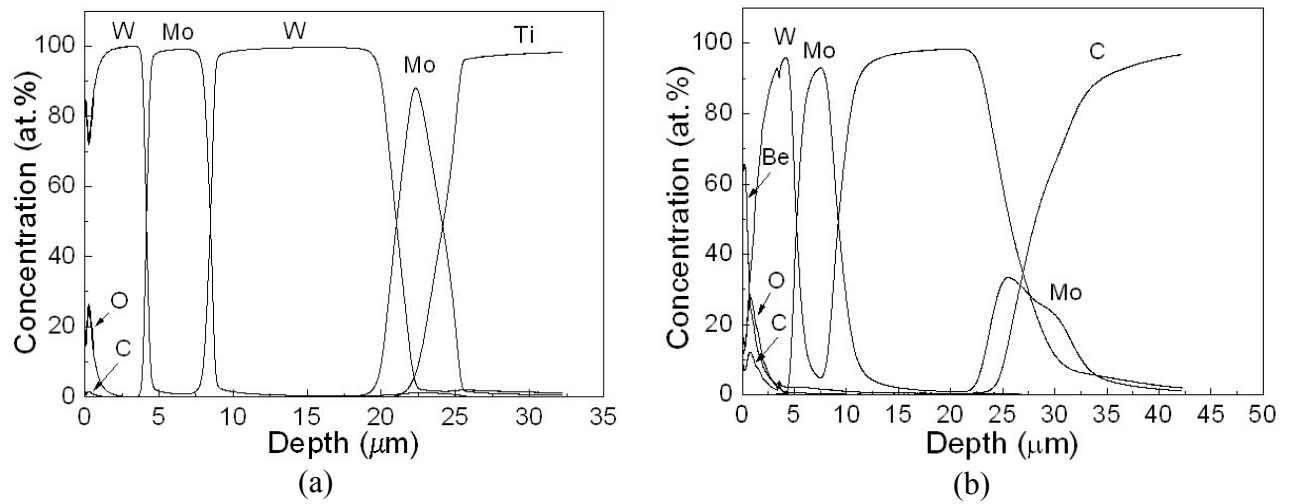
No erosion was detected on the investigated tiles in specific areas where the samples were cored from except Tile 3. A very thin layer of Be was measured on Tiles 1, 4, 7 and 8, while thicker deposits of Be were detected on Tiles 3 and 6. Typical GDOES depth profiles before and after plasma exposure are shown in Fig.3 for Tile 7. Unfortunately CFC samples coated in the same run with the real tiles installed in JET are not available so the comparison was performed between GDOES profiles obtained with Ti witness samples coated in the same run with the real JET tiles and CFC samples cored from the same tiles after their exposure in JET. As it can be seen, the profiles are quite similar except at the CFC/Mo interface where the irregularities of the CFC influence the Mo and W profiles. A sharp peak of Be appears at the surface followed by a fast drop in a few microns. Small Be “tails” like that shown in Fig. 3b were observed on Tiles 1, 4, 7 and 8. They can be explained by the roughness and porosity of the surface. Significant higher concentrations of Be (60 at.% and 75 at.%) were measured on Tiles 3 and 6. Be was detected up to a depth of 40-70 μm (Fig.4). As can be seen from Fig. 2 the CFC material shows a substantial

Fig.3 GDOES depth profiles for the W/Mo marker deposited on Ti witness sample coated in the same run with Tile 7 (before plasma exposure) (a) and on sample cored from Tile 7 after plasma exposure (b)

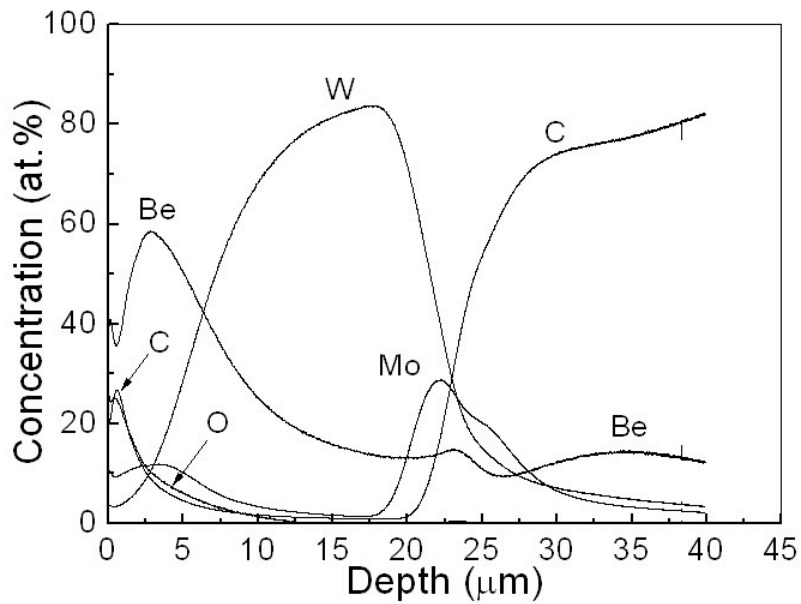
Erosion was not measured on any tile except tile 3 where the top Mo layer seems to be removed in certain areas.

Fig.4 GDOES depth profiles for the W/Mo marker deposited on Tile 3 after plasma exposure

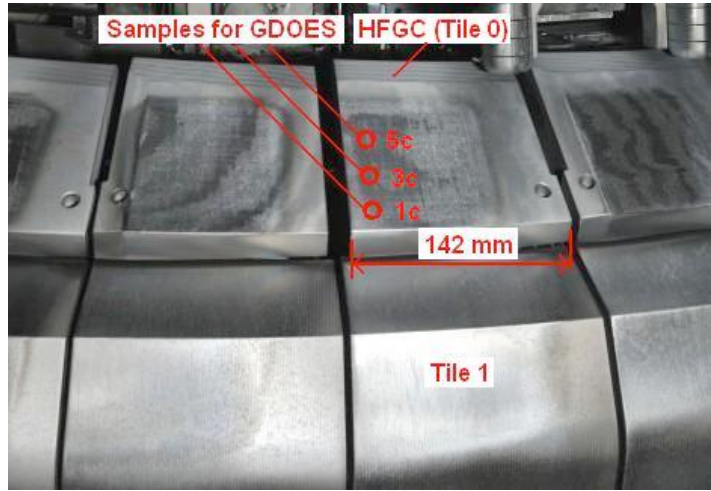
A special attention was paid to the HFGC tile where a thick layer of Be (20-25 μm) was measured on the W coating in three locations. A picture of the HFGC tile in the ILW and the positions of the samples are shown in Fig.5. A dark zone covering about 70% of the total area of the HFGC tile can be clearly seen. The samples used for GDOES analyses were cut from the dark area. Apparently the dark area on HFGC in Fig. 5 could be interpreted as a strong erosion area where the W was removed from the CFC substrate. However, in accordance with the GDOES results shown in Fig. 6 this is an area with a strong Be deposition on W coating. Be but also W and Mo was detected up to a depth of 100 μm . This large depth does not represent the coating thickness, but it is due to the porosity, roughness and imperfections of the CFC material as it is shown in Fig.7. The pores dimensions are in the range of a few tens-hundreds of microns with the depth reaching sometimes 0.25 mm. This was demonstrated by X-ray micro-tomography [6]. The GDOES results are in agreement with those obtained by RBS on the same tiles [4].

Fig.5 Tiles HFGC in JET wall

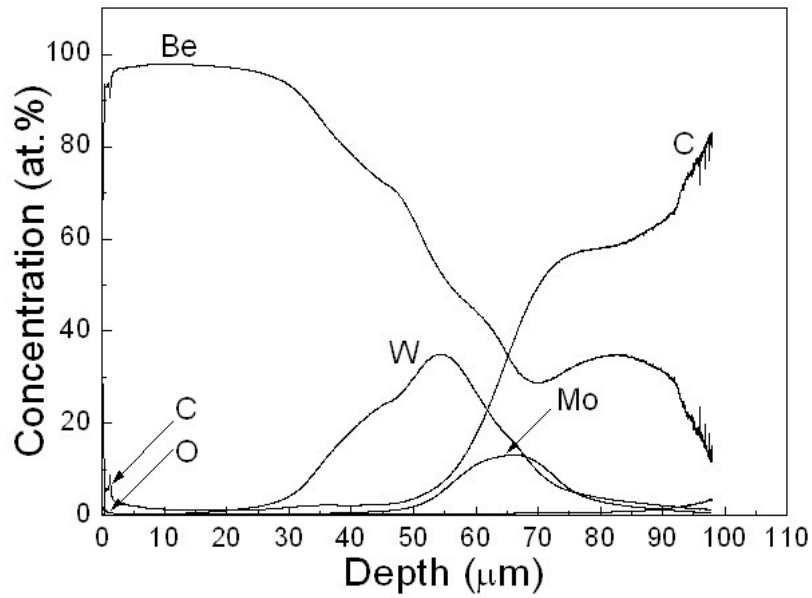
Fig. 6 GDOES depth profiles for the W-coated CFC sample (3c) cut from HFGC tile exposed in JET

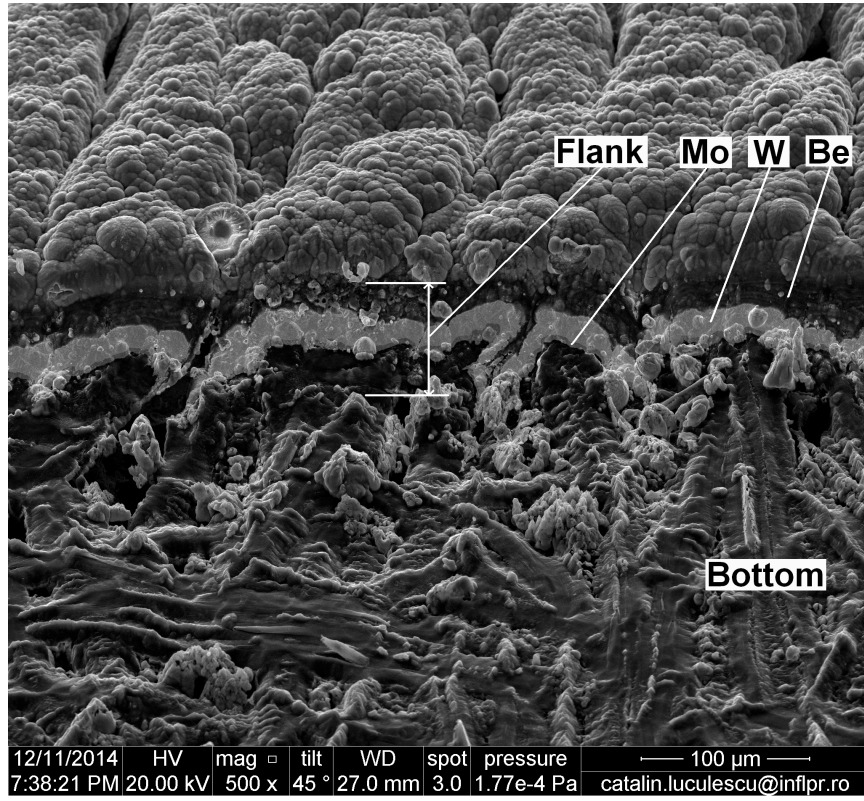
Fig.7 SEM image of the GDOES crater (flank and bottom) for a sample cored from HFGC tile
