EUROFUSION WPJET2-PR(16) 14815

## **Modification of diagnostic mirrors in current and next-step fusion devices**

# Modification of diagnostic mirrors in JET

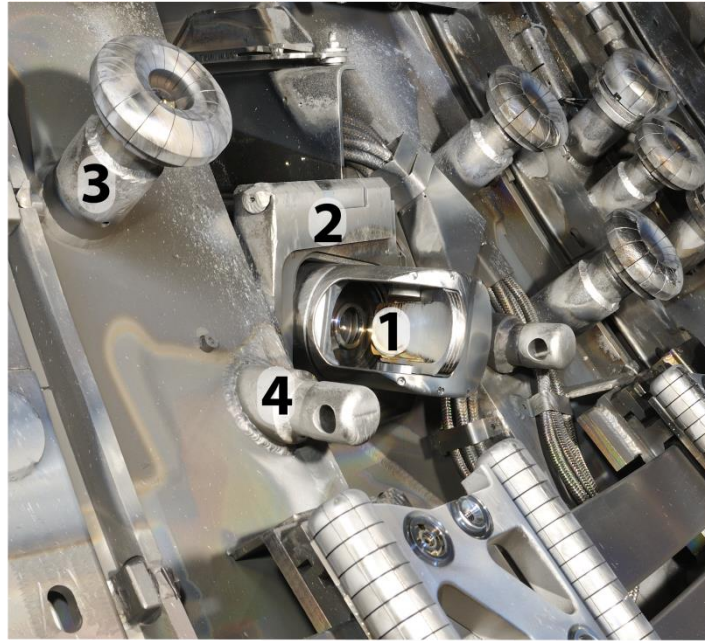
The Li-beam diagnostic mirrors were retrieved after the 2011-2012 and 2013-2014 experimental campaigns. The mirrors were 13 x 5 cm<sup>2</sup> and 1 cm thick plates made of bulk stainless steel with a gold coating. They were installed in a periscope head on top of the vessel at about 42 cm from plasma. Figure 1 shows the top of JET vessel with the Li-beam diagnostic mirror in the periscope head surrounded by various types of limiters, e.g. castellated mushroom roof limiters.

Figure 1: Top of the JET vessel: 1) mirror, 2) periscope head, 3) castellated mushroom roof limiter, 4) crane rail.

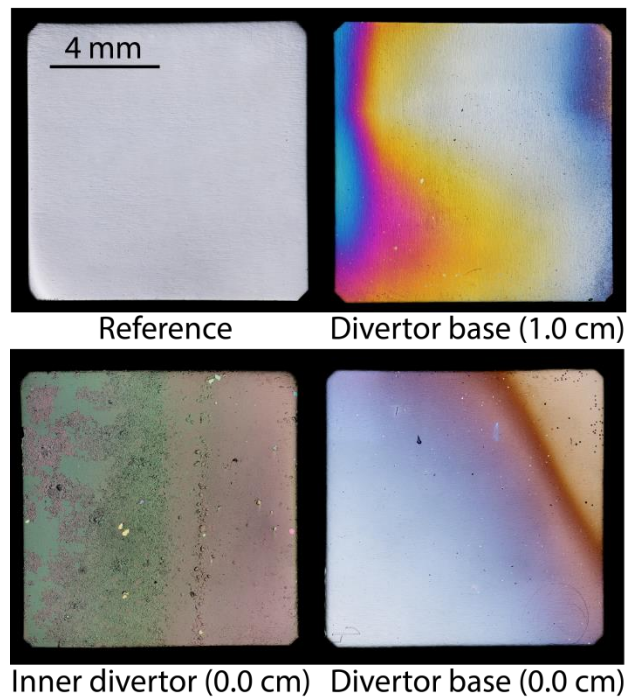
Visual inspection revealed that all divertor mirrors were covered with smooth-looking layers displaying a variety of colourful patterns thus indicating inhomogeneous material deposition. The appearance of several surfaces is presented in Figure 2. The total reflectivity was degraded by 50 – 80 % regardless of the substrate material or the location in the carrier. Plots in Figure 3 show the reflectivity for the outer divertor mirrors before and after the exposure to plasma. The distances in the legend refer to the depth of the mirror in the channel of the

Figure 2: Visual inspection of divertor mirrors after exposure to plasma.

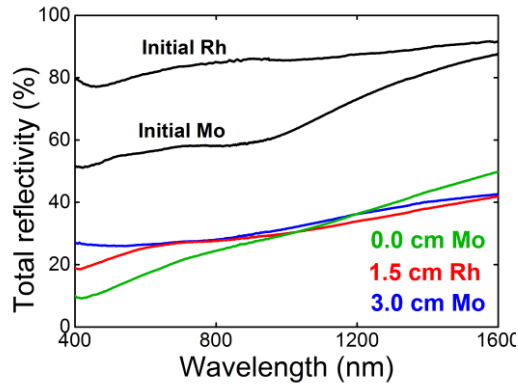
carrier. Diffuse reflectivity is below 5 % over the measured spectral range. It confirms that surface has remained fairly smooth despite the presence of co-deposits.

Figure 3: Reflectivity of outer divertor mirrors before and after exposure to plasma. The distances 0.0, 1.5, 3.0 cm refer to the depth of the mirror in the channel of the carrier.

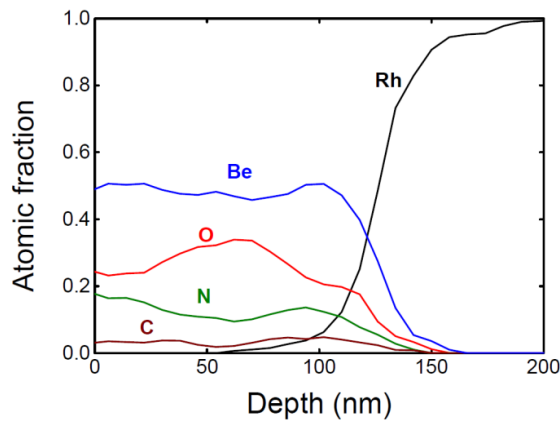
Surface composition of divertor mirrors is presented in Table 1. The main impurity is beryllium, followed by oxygen, nitrogen, deuterium, carbon, tungsten and traces of Inconel constituents (Ni, Cr, Fe); the latter is not shown in the table. The total thickness of deposits is in the range from 50 to 500 nm. Such layer thickness completely blocks the light from reaching the mirror substrate. This explains why reflectivity of all mirrors is degraded to a similar level regardless of the position and the substrate (Mo or Rh), because the reflected signal originates from the deposit itself.

Figure 4: Concentration depth profile of rhodium mirror located in the inner divertor, 1.5 cm deep into the channel of the carrier.

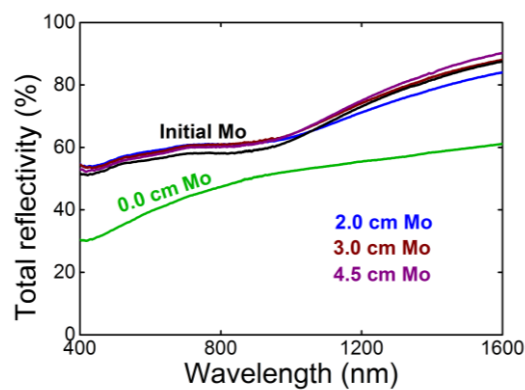
The total reflectivity plots for the mirrors from the main chamber wall are shown in Figure 5. There is a decrease in reflectivity by about 20% for the specimen located at the entrance of the carrier. However, reflectivity of all other mirrors is maintained or even slightly increased in the visible range as a result of erosion of Mo oxides by impinging neutral particles, as discussed in more detail in [12]. Diffuse reflectivity has not changed significantly after plasma exposure: it is below 5% over the measured spectral range.

Figure 5: Reflectivity of main chamber wall mirrors before and after exposure to plasma. The distances 0.0, 2.0, 3.0, 4.5 cm refer to the depth of the mirror in the channel of the carrier.

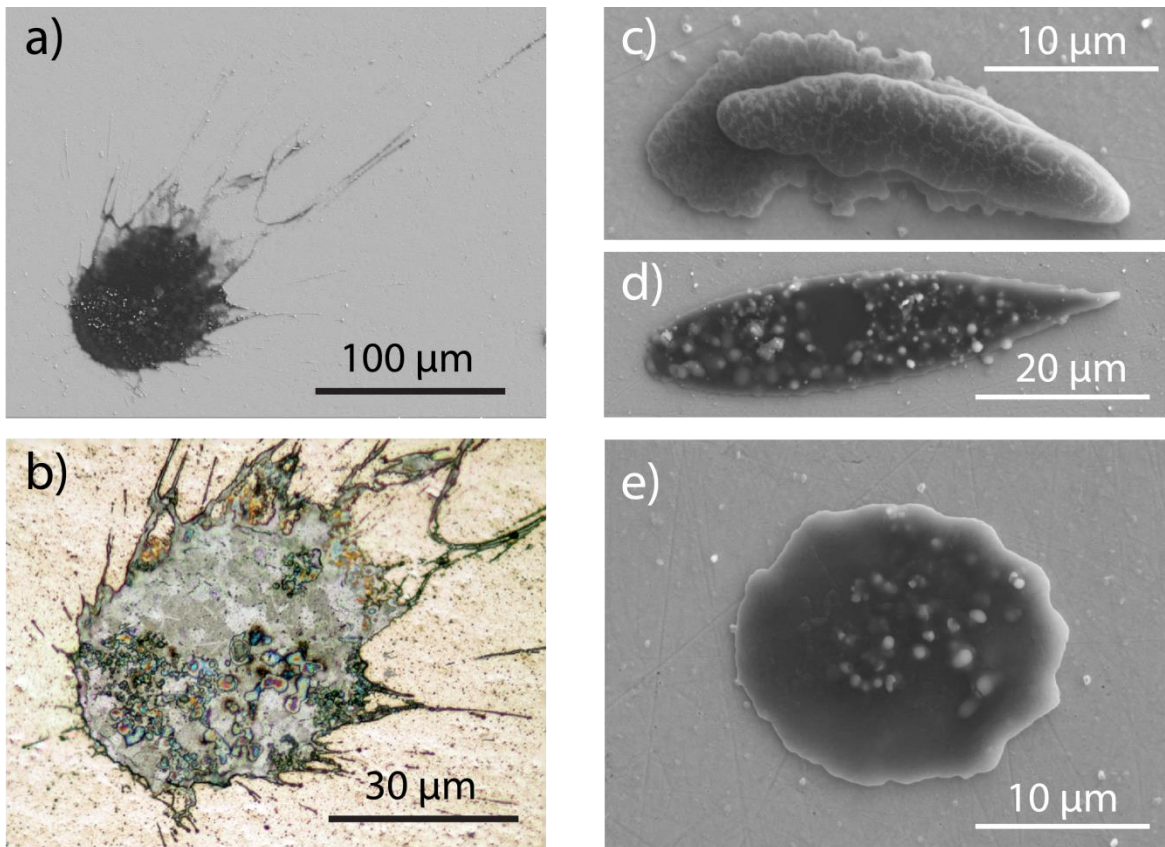
Results of detailed topographical studies performed with SEM and EDS on the mirror at position 0 cm are shown in Figure 6 and 7. On top of the fairly uniform co-deposits there are numerous macroscopic particles of various shape and size: from 3  $\mu\text{m}$  to over 100  $\mu\text{m}$ . These are elongated splashes (Fig. 6 (a-d)), flat splashes (Fig. 6 (e)) and spherical droplets (Fig. 7(a)). The variety of objects gives strong indication that they were deposited at different events. The elongation proves that splashing occurred under strong magnetic field. The splashes cannot be associated with a single disruption because they have different orientations. A common feature of all these objects is the presence of beryllium as the main component. The other detected elements in all particles are: C, N, O and traces of steel and Inconel alloy constituents. The spherical droplet shown in Fig. 7(a) is not splashed and its composition is complex (see EDS spectrum in Fig. 7(b)). Besides light elements there are also heavy species: W, Mo, Ni, Cu and Fe. It gives a fairly strong indication that the origin of such particle(s) is not associated with melting and splashing of the limiter material. One may suggest that it is most probably a W-Mo or W-Ni particle formed earlier in another region of the machine and then transported, for instance, during a disruption. The deposition of other species (Be, C, N) occurred when the droplet was already residing on the mirror surface. This statement regarding the droplet composition and the sequence of events is justified by the detection of beryllium on the surface. The energy of Be( $K\alpha$ ) radiation is only 108 eV and would not have been detected if it was a Be droplet coated with high-Z species.

Figure 6: Images of beryllium splashes on the surface of the mirror at position 0 cm. The splashes have elongated (a-d) or flat (e) shapes. Images (a) and (b) show the same particle under electron and optical microscopy respectively.

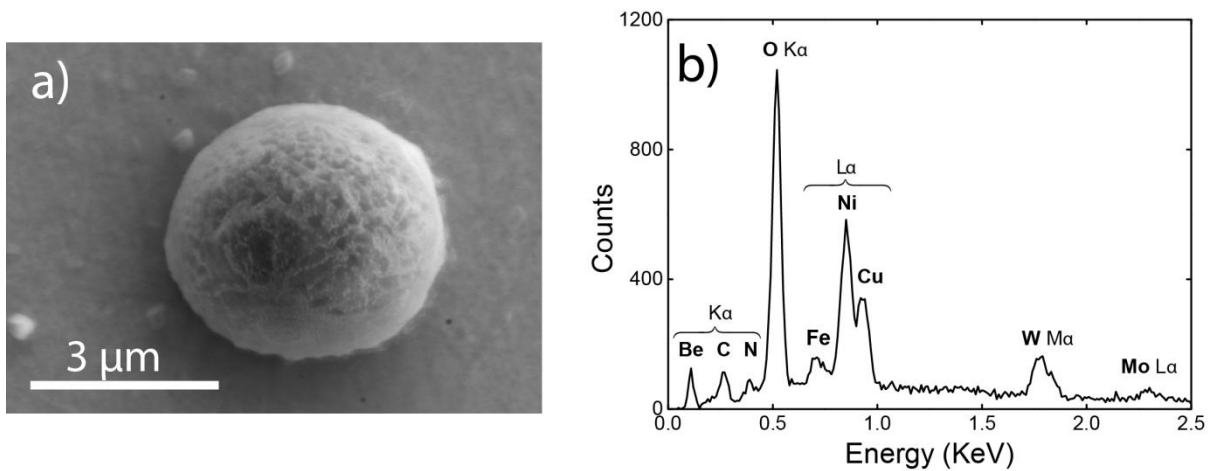
Figure 7: (a) spherical droplet on the surface of the mirror at position 0 cm, (b) EDS spectrum of the spherical droplet.

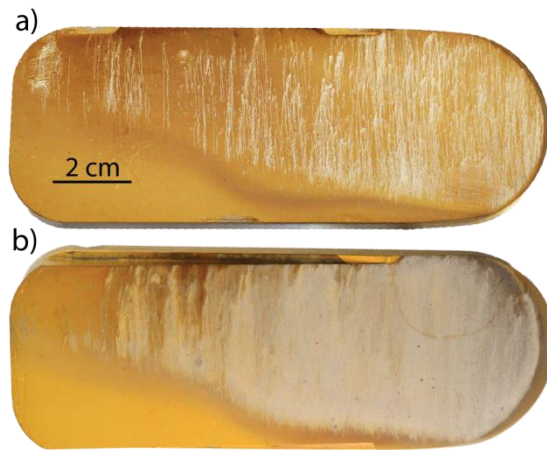
Li-beam diagnostic mirrors were retrieved after the 2011-2012 and 2013-2014 campaigns. Images in Figure 8 show the appearance of those mirrors. In both cases, significant areas of their surfaces were damaged. The topography of the damaged area, as recorded by optical microscopy in Figure 9, clearly proves melting of the surface layer (Au coating and the

Figure 8: Li-beam diagnostic mirrors after exposure in JET in a) 2011-2012 experimental campaign, b) 2013-2014 experimental campaign.

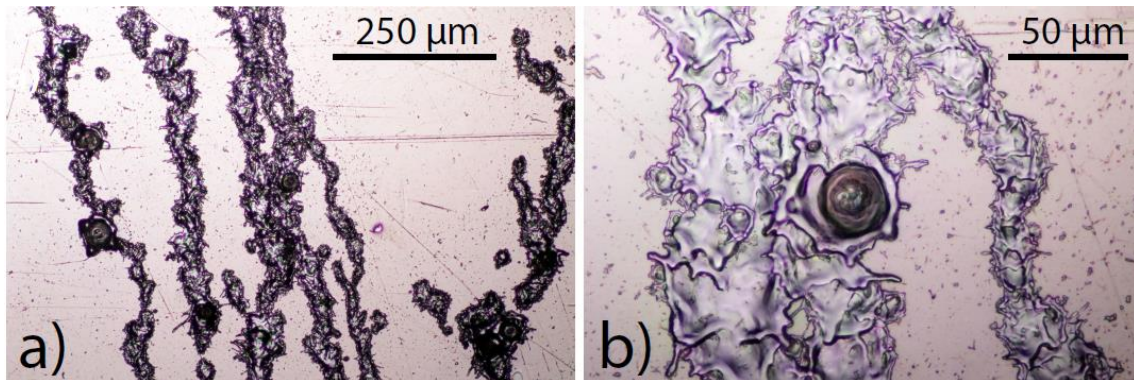
stainless steel substrate) by arcing. Arcing is a well-known erosion process in fusion devices [18-21]. The main conditions to form electric arcs are a sufficiently high potential and an electron-emission spot such as a small surface protrusion (for instance, a beryllium droplet). In the presence of magnetic fields, the cathode spot moves across the material in the direction perpendicular to the magnetic field. This effect is known as retrograde motion and it produces characteristic dendrite-like tracks, as those observed in the mirror [22].

Figure 9: Optical microscopy pictures of the surface of the Li-beam diagnostic mirror: a) arc traces along the mirror surface, b) detail of material melting produced by arcing.

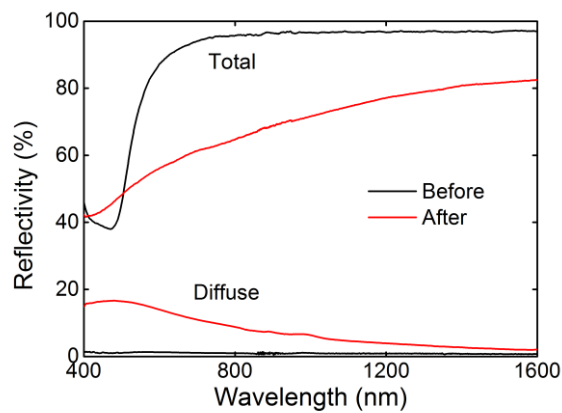
Total and diffuse reflectivity in the visible and NIR range are presented in Figure 10. Total reflectivity decreased after plasma exposure from over 90% to about 60%. The values after plasma exposure resemble those characteristics for stainless steel. This suggests erosion of the gold layer and consequent mixing with stainless steel in the surface region. In the visible range, diffuse reflectivity increased from 2% to more than 15% as a result of surface roughening by arcing. In conclusion, optical properties of the mirror were significantly degraded.

Figure 10: Total and diffuse reflectivity of the Li-beam diagnostic mirror before and after exposure to plasma during the 2013–2014 campaign.

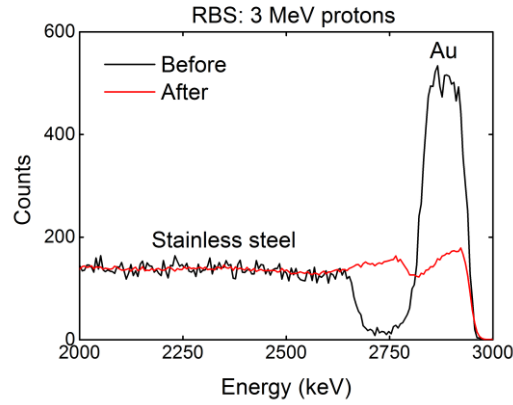
The result of analysis with RBS for the mirror exposed during 2013-2014 is presented in Figure 11. Initially, there was a well-defined gold layer of 0.6  $\mu\text{m}$  on top of a stainless steel substrate, while after exposure, the gold signal is reduced and overlaps with the stainless steel background. This indicates a reduction in the gold concentration by a factor of 2 (from  $3.7$  to  $1.8 \times 10^{18} \text{ cm}^{-2}$ ) and strong material mixing being a result of melting. In the damaged area, the concentrations of D and Be were up to  $5 \times 10^{17} \text{ cm}^{-2}$  and  $10 \times 10^{17} \text{ cm}^{-2}$ , respectively. Deposition of impurities most probably formed hot spots for the initiation of electric arcs. In the non-damaged area, the concentrations of D and Be were much lower (about  $1 \times 10^{16} \text{ cm}^{-2}$ ) because of the protection given by the crane rail placed in front of the periscope head (see Figure 1). Traces of C, N and O were also detected but they could not be quantified because of the surface roughness.

Figure 11: RBS spectrum of the Li-beam diagnostic mirror before and after exposure to plasma during the 2013–2014 campaign.
