EUROFUSION CP(15)10/09

Post Mortem Analysis of a Tungsten Coated Tile from the Outer Divertor Strike Point Region of ASDEX Upgrade

17th International Conference on Fusion Reactor Materials (ICFRM), Aachen, Germany (11th October 2015 – 16th October 2015)

POST MORTEM ANALYSIS OF A TUNGSTEN COATED TILE FROM THE OUTER DIVERTOR STRIKE POINT REGION OF ASDEX UPGRADE

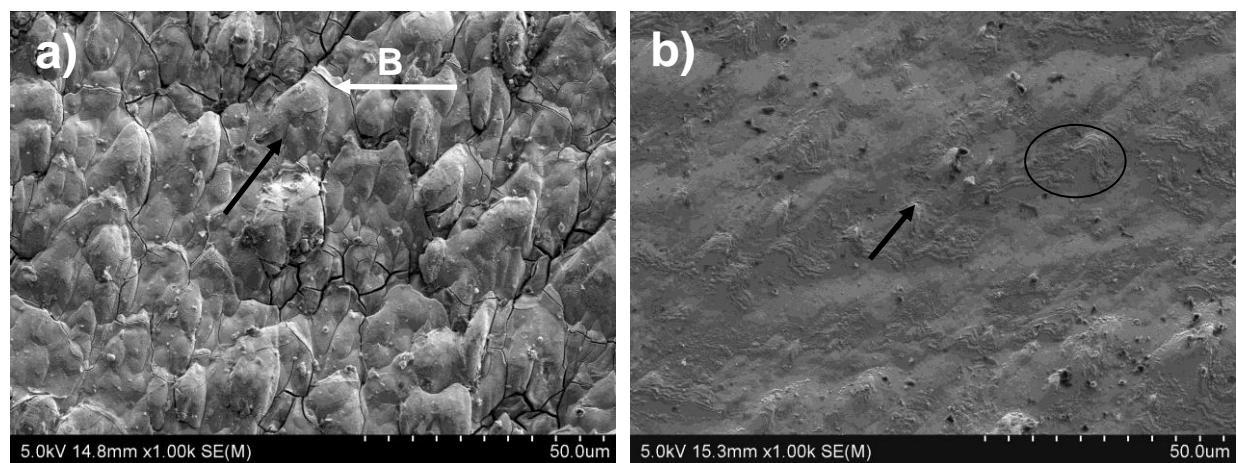
Fig. 2. SEM images of the coating morphology of sample 1-1A, (a), and 1-3A, (b). Black arrows indicate the direction of the erosion, whereas the white arrow in (a) indicates the direction of the lines of the toroidal magnetic field. Deposit is encircled in the oval in (b).

The highest roughness has been measure for the sample 1-1A shown in Fig. 2a. The surface is covered by a thick, cracked, stratified deposit of good adhesion to the coating. Small fragments of deposit are chipped off, very likely contributing to the dust production.

The surface morphology of the three other samples is different. They exhibit a more pronounced surface smoothening, as evidenced by the SEM images in Figure 2b and 3a. Their surface is also covered by deposit, however, of a different character, with a tungsten-based, sponge like structure shown in Figure 3b. Glass-like layers, rich in boron were also found. The thickness of the deposit is inhomogeneous and higher in the shadowed areas, as indicated in Figures 2b and 3a. Particles rich in boron were also found and elongated artefacts as observed already before by M. Balden [8] – see Figure 3a.

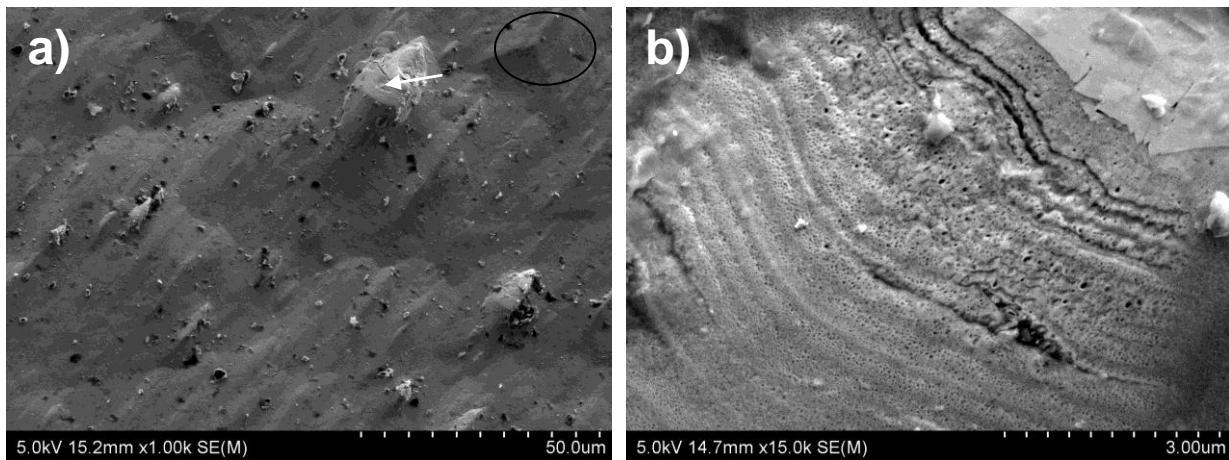
Fig. 3. SEM images of the coating and deposit morphology: a) sample 1-4A, b) sample 1-10A. Deposit is encircled in the oval.

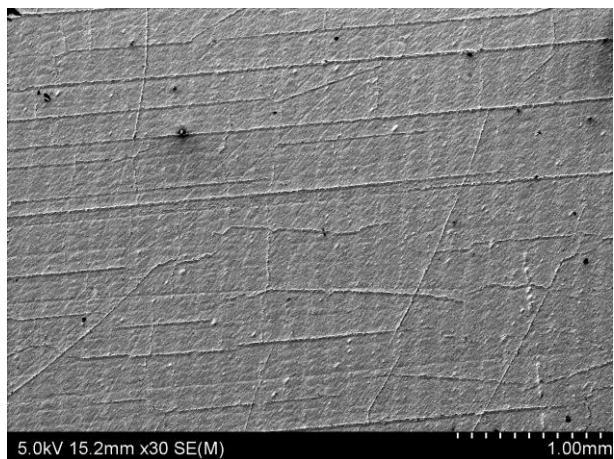
It should be noted that the surfaces of samples 1-3A and 1-4A, which were from the strike point and the highest plasma fluence region respectively, revealed a network of cracks shown in Figure 4. The examinations of coating cross-sections revealed that these cracks go through the entire CMSII-W and Mo (inter)-layers down to the graphite substrate. It is worth noting that cracks and other defects have also been revealed underneath the surface of the tungsten layers (see Fig 5). Thus, it can be concluded that the cracks observed are very likely to initiate at the graphite/molybdenum interface.

Fig. 4. SEM image of cracks on the surface of 1-4A sample.

It should be noted that the CMSII-W layer preserved its thickness of approximately 10 μ m after three campaigns of AUG operation at high flux/heat-load region, i.e. the net erosion was comparatively small. The observations on cross-sections of the coatings revealed, however, micro-cracks around the strike point region. These cracks are caused by thermal stresses due to periodic heating and cooling of the layer during ELMs. The observed cracks extend through the entire CMSII-W layer and the Mo interlayer down to the graphite substrate.

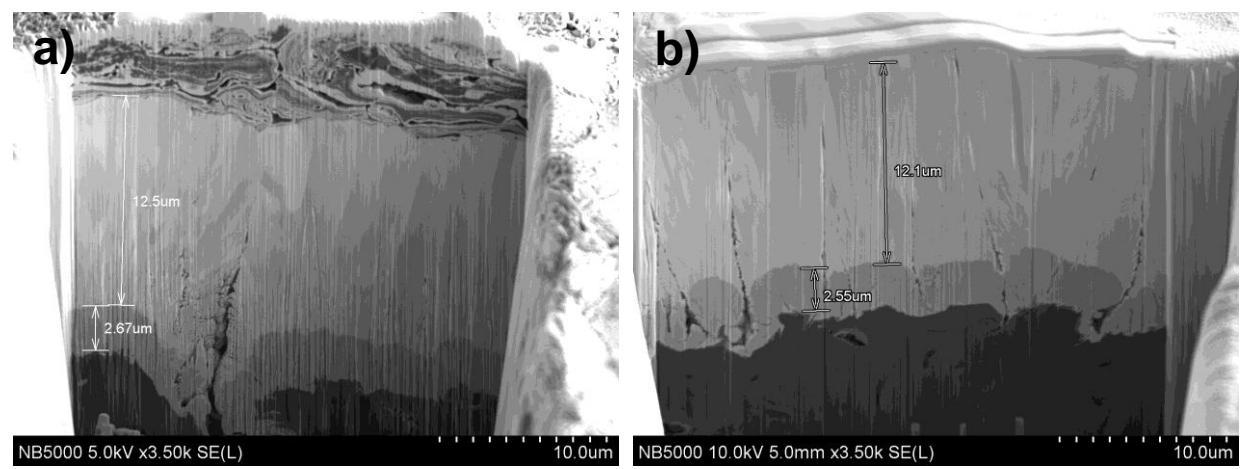
The observations on cross-sections of the coatings, prepared by FIB – see Figure 5 - showed the same thickness of the tungsten and molybdenum layers, ~12.5 and ~2.5 μ m, respectively. The thickest deposit, up to 6.5 μ m, was found in sample 1-1A. The deposit on sample 1-10A was the thinnest and not covering the entire surface. In sample 1-1A crystals rich in boron and pores up to several microns long were found.

Fig. 5. SEM images of the coating cross-sections: a) sample 1-1A and b) sample 1-10A.

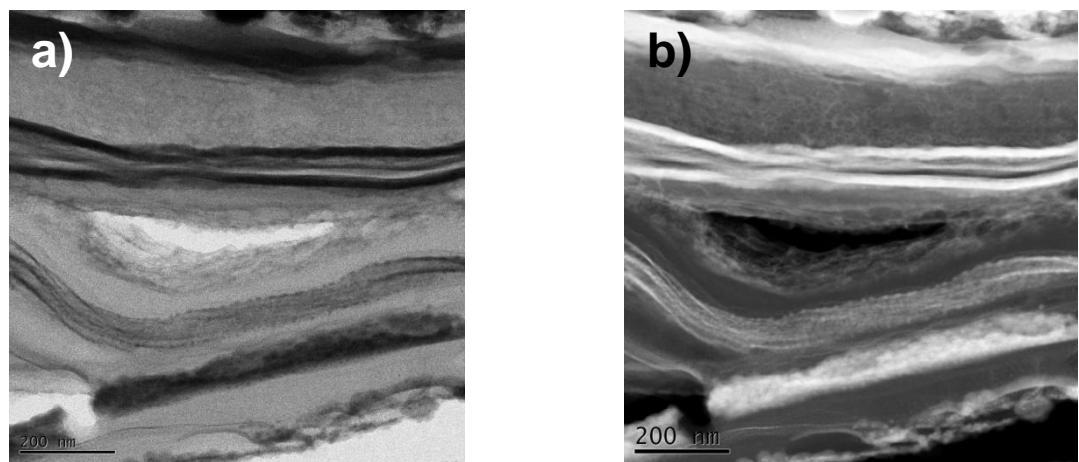
The structure of the deposit was investigated by STEM observations of thin lamellas cut by FIB. In the case of sample 1-1A in the lamella cut from the "flat" region, a stratified structure of deposited material has been revealed with sub-layers having thicknesses up to 200 nm – see Figure 6. Observations using a high angle annular dark field (HAADF) mode, also called Z-contrast, proved differences in their chemical composition. Diffraction patterns obtained from the deposit area show the presence of both crystalline and amorphous matter.

Fig. 6. STEM images of the deposit on sample 1-1A: a) bright field (BF) mode and b) HAADF mode.

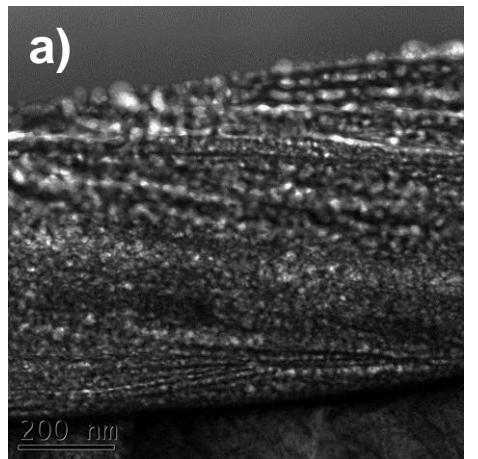
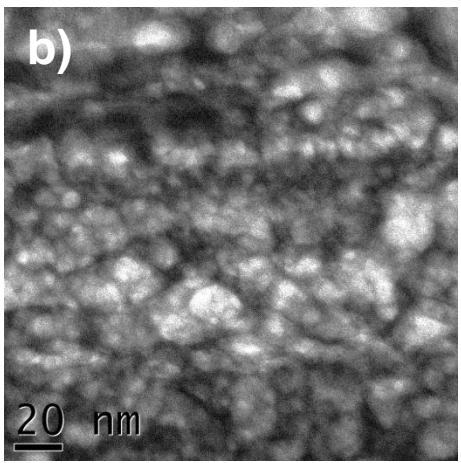
The deposit on the samples designated as 1-3A, 1-4A and 1-10A is similar and reveals redeposited tungsten in the form of a three dimensional sponge-like structure illustrated in Figure 7. The structure is inhomogeneous with pore sizes varying from a few to several tens of nm. Diffraction patterns from the deposit area proved the presence of both amorphous and crystalline matter, as shown in Figure 8.

Fig. 7. STEM BF images of deposit present at sample 1-3A, BF mode

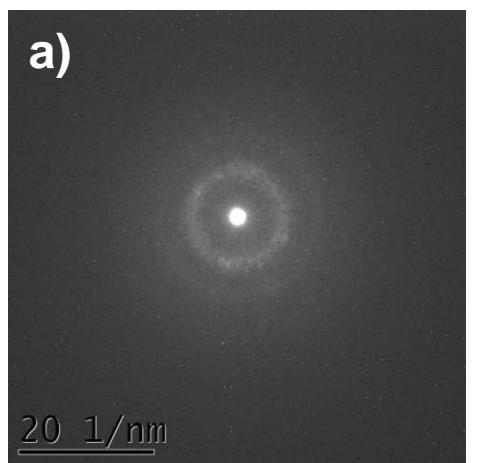
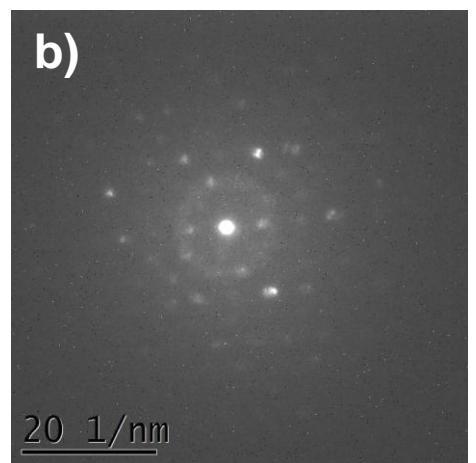
Fig. 8. Diffraction patterns from deposit present in Fig. 7a
