EFDA–JET–CP(00)01/02

# Operational Experience with a Variety of Plasma Facing Tile Assemblies at JET

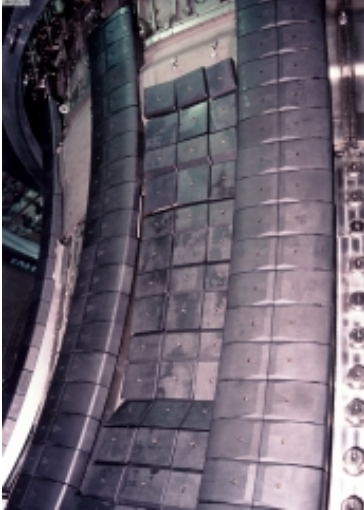
*Fig.1: Inner Wall Guard Limiter (IWGL)*

During the mid-1990's deterioration in the integrity of the Inner Wall Guard Limiter (IWGL, see Fig.1) tiles was observed. Significant cracks began to appear in the plane of the fibres in a high proportion of the tiles. For IWGL tiles, one of the principal fibre directions is perpendicular

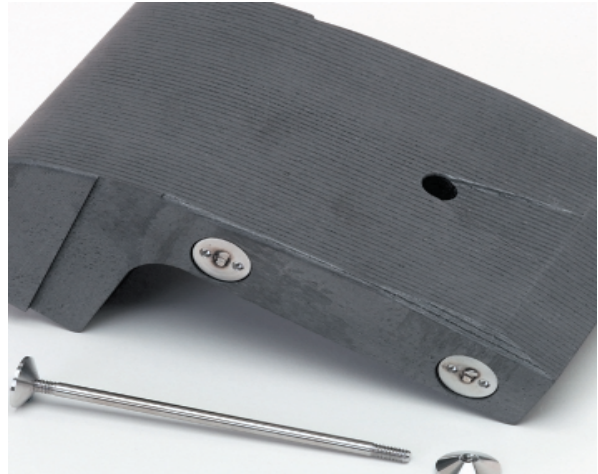
*Fig.2: Modified IWGL Tile and tie rods*

to the contacting plasma to maximise thermal conductivity and reduce the tile surface temperature. However mechanical stresses caused by halo currents reacting with the poloidal and toroidal magnetic fields caused cracking in the plane of the fibres (delamination). Remedial action was therefore taken during the 1996 shutdown. The full inventory of IWGL, approximately 600 were removed from the Torus to an appropriate contamination controlled area, and holes drilled through the tile width to enable  $\text{\O}4\text{mm}$  alloy 718 tie rods to be fitted. A compression load was applied across the tile by torqueing opposing conical nuts threaded onto the tie bar ends to 3.5Nm. (See fig.2). This remedial action has been successful in preventing further cracks, and has been applied to other tiles subsequently installed in JET, notably the divertor tiles. Amending of the tie rods limits the tile bulk temperature to  $800^{\circ}\text{C}$ .

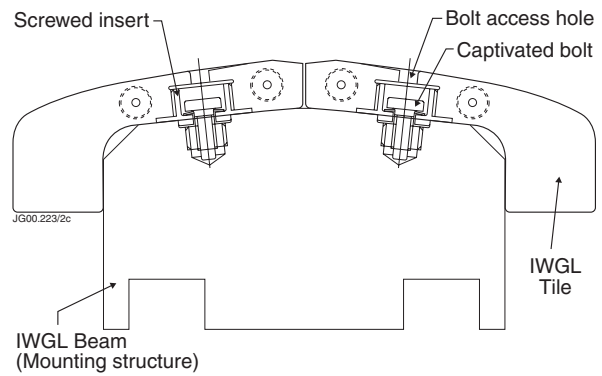
Fig.3: Cross-section through IWGL Tile showing typical single point fixing

Various methods for Tile fixing have been used over the years varying from the complex arrangements of the Poloidal Limiter keyed spigot to a single bolt fixing that has been adopted as the standard. Generally captivated bolts and combinations of Alloy 718 disc springs are secured to the tile assembly with a threaded top hat insert (see fig.3). The alloy 600 or stainless steel 304/316 insert is screwed into a tapped counter-bore of typically M24 within the tile with the thread axis perpendicular to the fibre plane. The tapping of threads within CFC is feasible but the fibrous, anisotropic nature of the material leads to chipping of the threads. The insert is pinned against rotation by a pressed dowel that is tack welded to the insert during assembly. The single bolt fixing generally engages in an aluminium-bronze nut to avoid seizures. The nut is held captive by a number of different methods including open ‘c’-shaped cups with a tack welded locking strip or an integral clamping housing. In either case the aluminium bronze nut can be replaced if defective threads are experienced during installation.

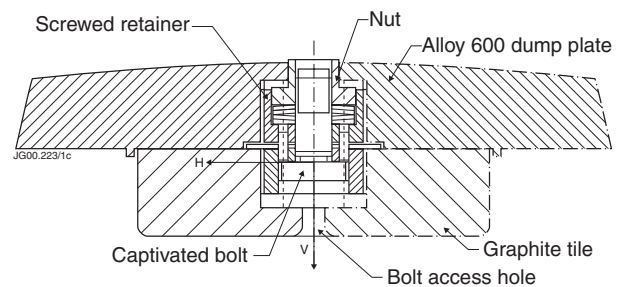
Fig.4: Cross-section through Dump Plate Tile showing alloy 600 to graphite bolted interface.

The vast majority of Tile assembly fixations have a metal to metal bolted interface and there has been no observation of loosening of the fixation in operation. In contrast, the Dump Plate tiles on the ceiling of the machine include a graphite interface in the bolted assembly (see fig.4). A reduction in torque on the retaining bolt from 15 to 3 Nm after 4 years of operation equates to a relaxation of 0.2mm. The clamping load is further reduced with a graphite interface due to differential expansion, as the torque is applied at ambient whilst the vessel normally operates at 320°C [3].
