EFDA-JET-CP(06)02-08

Main Chamber Power Load During Disruptions

Preprint of Paper to be submitted for publication in Proceedings of the
17th Plasma Surface Interactions in Fusion Devices,
(Hefei Anhui, China, 22nd May - 26th May 2006)

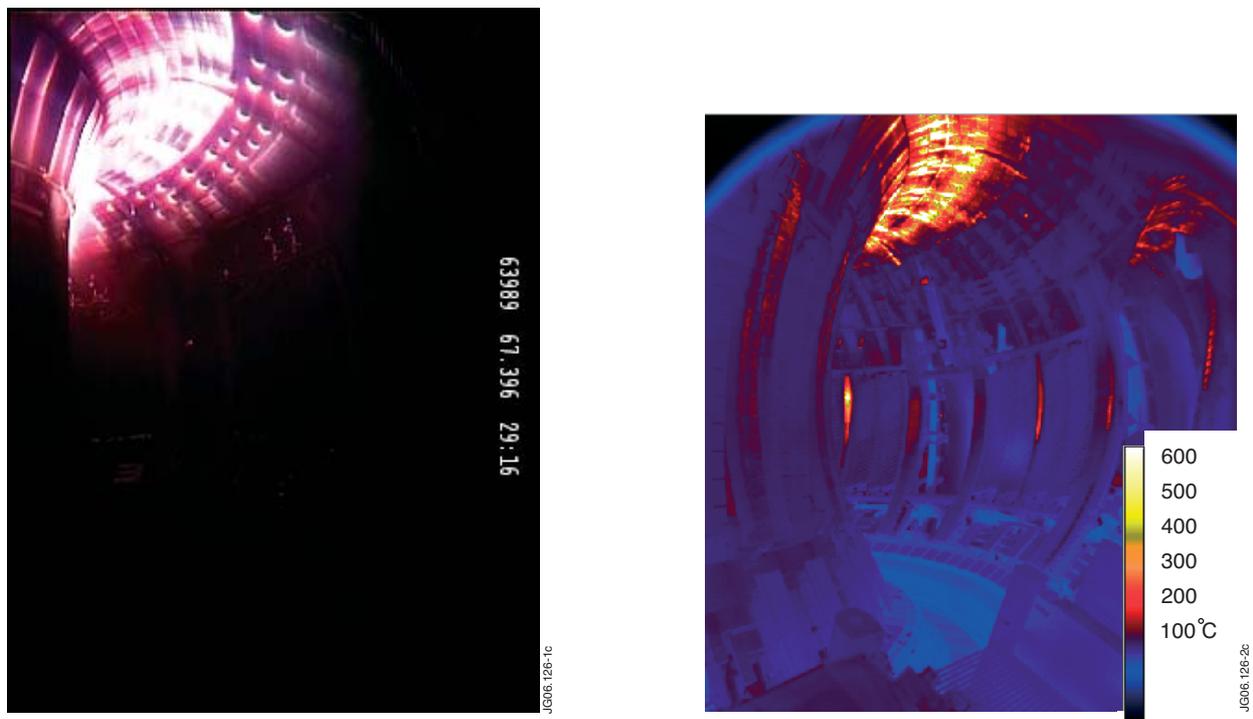
Figure 1: Visible (left) and Infrared images during the disruption of a vertically displace plasma.

From the infrared image it can be seen that there has been heating of the protection tiles at the on of the torus up to about 600°C. The maximum temperature may be higher depending how soon the first IR camera exposure occurred after the disruption. Some of the midplane limiters are also significantly above the 200°C starting temperature which is not a result of the disruption; these surfaces are still cooling after the start up limiter phase.

from the temperature cool down after the disruption. This was done by applying the equation for a 1-dimensional analytical formula [4] for the response to a rectangular heat pulse to the surface averaged temperature. For the ~ 3 sec period over which the fit is applied lateral diffusion may be neglected, and the fit only depends on a single parameter: the energy density deposited. Assuming toroidal symmetry and applying the result to the whole of the upper protection tiles, of which we only see a 60° toroidal section, gives 1.4MJ energy deposited on these tiles.

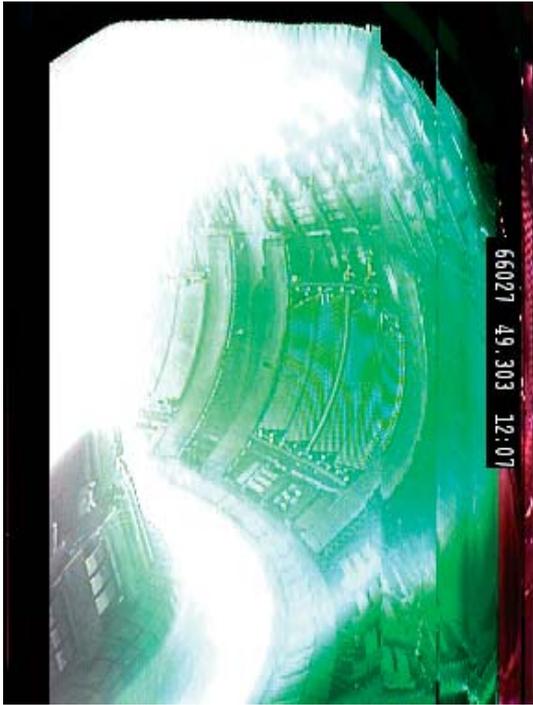
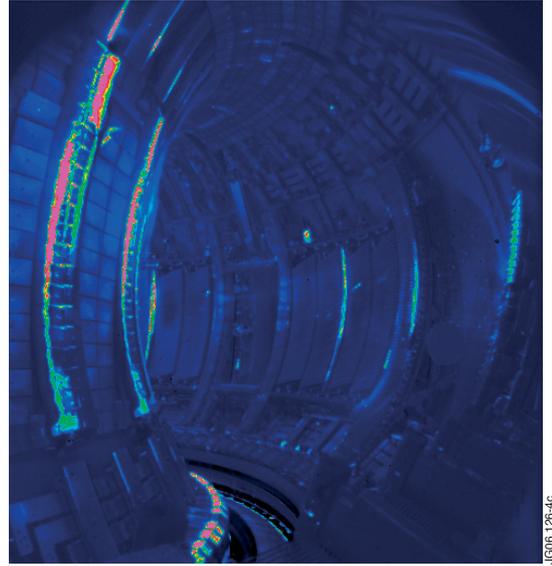
Figure 2: Visible (left) and infrared images during the disruption of a plasma contacting the inner limiters.

Figure 2 shows visible and IR images during the disruption of an ITB diverted plasma, having 2.5MJ thermal energy prior to disruption. The IR image is actually the difference image between the frame before and after the loss of thermal energy. As with previous observation of ITB disruptions, the thermal energy loss cannot be accounted as deposited heat in the divertor. The present plasma, however, is distinctly different in the evolution of the stored energy and plasma current. The stored energy is released slowly, over 40 msec, and the plasma current decays 60 msec later. This delayed current decay is helpful in making a clear distinction between the release of thermal and magnetic energy since, again, we are using the camera in its slow, wide-angle mode.

The temperature footprint of this disruption is characteristic of most JET disruptions observed with the wide angle IR system. The hottest surfaces are on the sides, of the inner limiter tiles, and on the inner divertor shoulder tiles. Both these regions are known to be areas of deposited surface layers, which experience much higher surface temperature rise per unit power compared to layer-free regions [5, 6, 7].

The effect of the layer on the inner divertor shoulder is clear. Firstly, one of the tiles in the view is relatively cold compared to all the others, which is also the case during steady state divertor plasmas. This is a tile which was replaced during the last major shutdown, and therefore has not had time to build up a significant layer like the neighboring tiles. Furthermore, thermocouples in these tiles reveal the bulk temperature of the tile is inconsistent with the surface temperature unless there is excess thermal resistance at the surface.

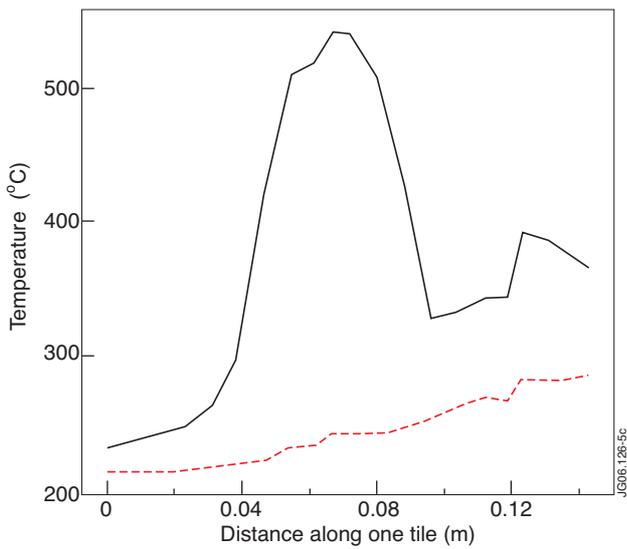
Figure 3: Temperature profile across a single limiter tile during (red) and after (blue) contact with an auxiliary heated limiter plasma. The tile is inclined so that the plasma is closest at the right hand side of the figure.

As for the inner limiter tiles, the regions of surface layers can also be seen during limiter discharges. Fig.3 shows the temperature profile across a single limiter tile during and a few seconds after plasma contact. The profile after the heating is as expected given the tile geometry, but the profile during heating has an extra peak on top of this, corresponding to the brightest regions in fig.2. The time between the profiles is too small for the heat to have smoothed out by lateral diffusion.

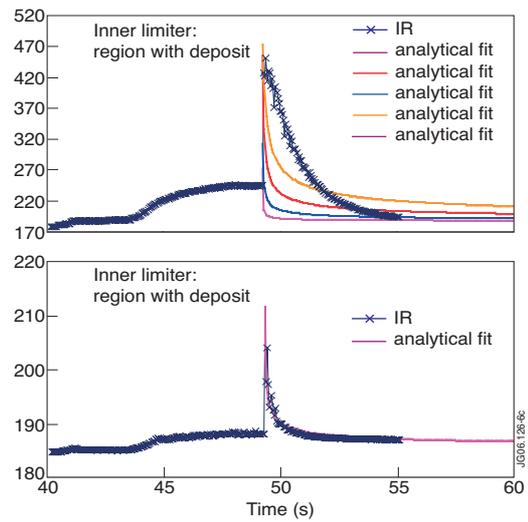
Figure 4: Temperature evolution of 2 positions on the limiter tile: with and without a deposited layer.

Figure 4 shows the time evolution of the temperature for the case of the disruption both on and off the region affected by a thermally resistive surface layer. Off the layer, it is possible to model the temperature with the simple model used for the upper protection tiles. On the layer, however, the time evolution of the temperature, characterized by several seconds of cool down time for a few msec heat pulse, cannot not be describe by the layer-free model. This temporal behavior was previously noted for JET inner divertor tiles [7] and was modelled as a layer of finite thermal mass which was in poor thermal contact with the bulk, therefore taking much longer (5ms) to cool down than to heat up(<1ms). The present layers on the limiter, however, are taking seconds to cool down, so they would have to be much more resistive and/or have a much higher heat capacity (e.g. thicker).
