Operational Impact on the JET ITER-Like Wall In-Vessel Components

Preprint of Paper to be submitted for publication in Proceedings of the
11th International Symposium on Fusion Nuclear Technology, Barcelona, Spain
16th September 2013 - 20th September 2013

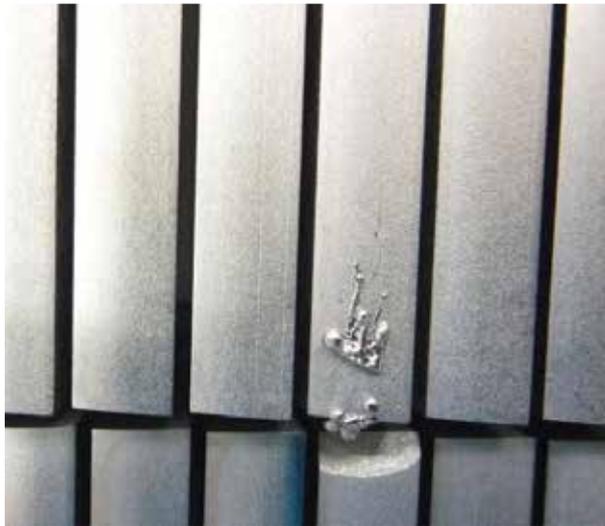
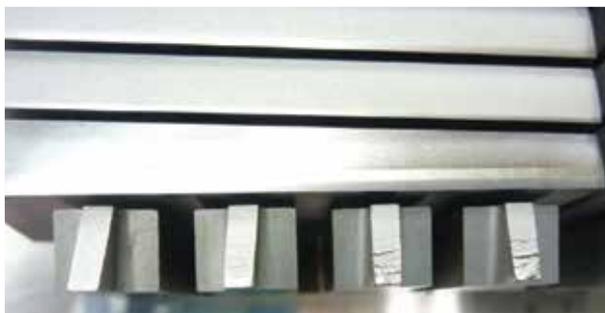
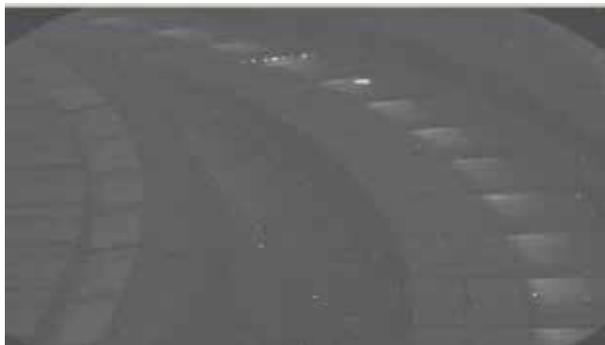
CPS13.1110-5c

Figure 5: Collection of tungsten melts: top - inboard edge of one lamella on the outermost stack; middle - Langmuir probe tips melted and cracked; filtered visible camera view showing one set of Langmuir probes (top chain of dots) and the lamella melt of the top picture (large isolated hot spot).

As far as we know only one location had melted tungsten, rather than beryllium. This was in the same module as one set of Langmuir probes and in view of one of the near infrared cameras, as shown in Figure 5. This camera recorded the presence of the hot spot the melted globule of tungsten generated since a filter was added till the end of plasma operation, that is >1000 pulses, including those with the strike point in the vicinity of the globule and the highest neutral beam power achieved in this operational period. This observation shows that operation with a limited amount of misshaped tungsten is compatible with operation, as it went unnoticed until it was found during ex-vessel inspection of the tile. The location of the lamella chip is rather fortunate, as the outboard edge of the lamella adjacent on the inner side (top in Figure 5) shadows it for most plasma configurations.

Figure 5 also shows the damage accumulated by the divertor Langmuir probes. There are signs

of melting on some of the Langmuir probe tips in all poloidal positions and in all three toroidal sets. However, those located where the strike-point used to reside the most during high power operation are the most damaged, and those in the toroidal position where electron collection was performed. Here two effects combine: the probe surface angle is steeper than that of the lamella and the power is enhanced by drawing electron current. Both these drivers for damage can be addressed, respectively by redesigning the probes and by limiting the voltage bias in operation.

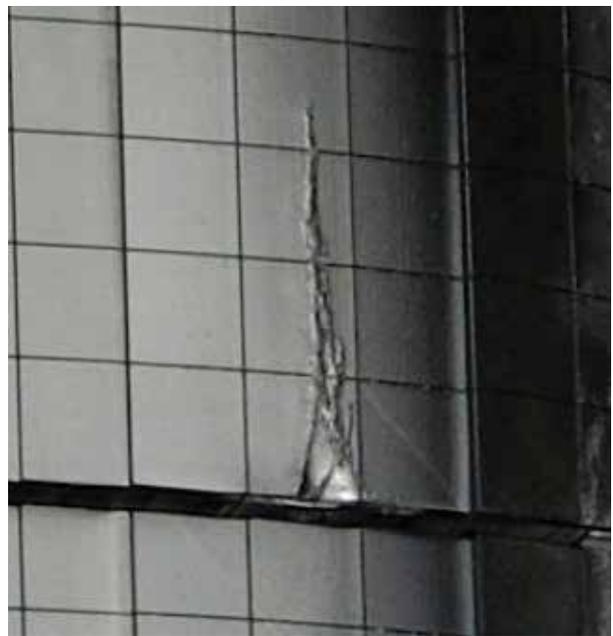
CPS13.1110-6c

Figure 6: Langmuir probe on the inner wall guard limiter and damage on the neighboring beryllium tile.

Also some of the main chamber Langmuir probes had power handling issues. Figure 6 shows the top probe on the inner wall. Here, while the probe seems to have survived, the neighboring tile has been damaged. Like in the apex melting caused by the power handling experiments, the molten material has moved against gravity, indicating that some charge collection must have been preset. However, the cause of the melting is unclear. Even if the probes came into contact with the beryllium, heat transfer is very poor. As the Langmuir probe is very thin, it should have the same temperature both sides excluding radiation as cause of damage.
