Migration and retention studies during the JET carbon divertor campaigns

Preprint of Paper to be submitted for publication in
Fusion Engineering and Design

MATERIAL MIGRATION AND FUEL RETENTION STUDIES DURING THE JET CARBON DIVERTOR CAMPAIGNS

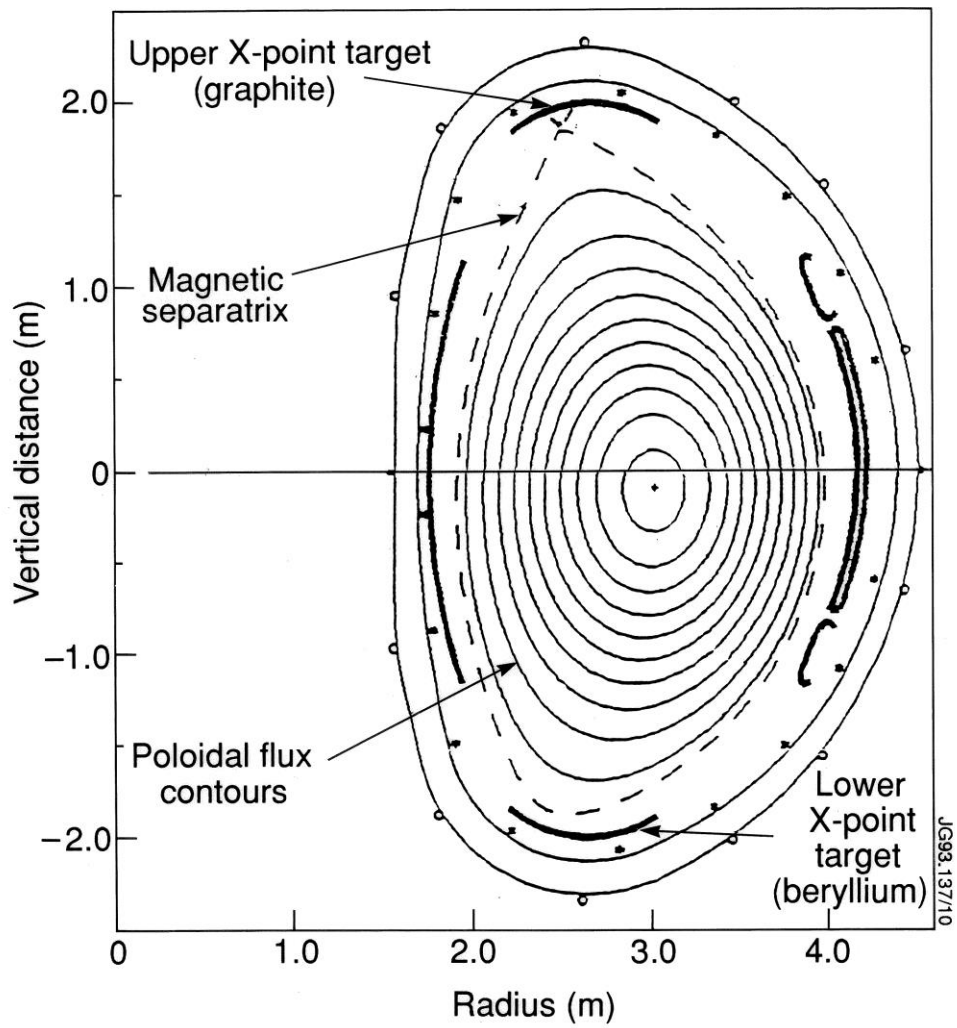
Figure 4: Cross-section of JET showing the plasma configuration for discharges with an X-point inside the top of the vessel, close to the upper dump plates.

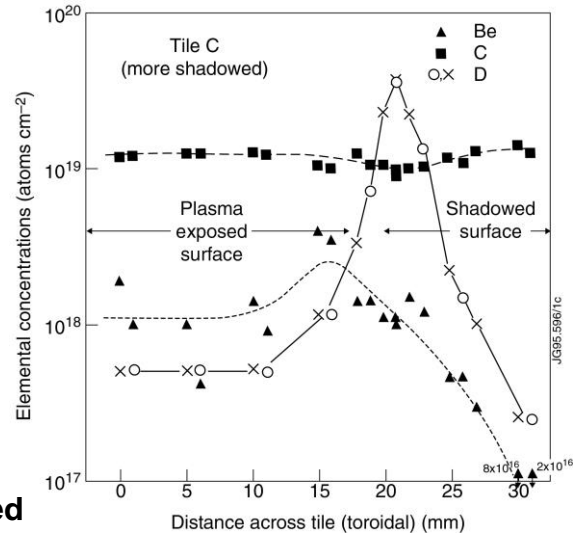
Divertor tiles are arranged in "roof-top" pattern to protect tile edges and prevent "blooms"

Heavy re-deposition of C in shadowed area of each tile adjacent to erosion zones

Figure 6: Deposition in the JET MkI divertor due to the "roof-top" design of the divertor elements (left, vertical scale exaggerated). The deposition is strongly peaked just inside the shadowed region (right).

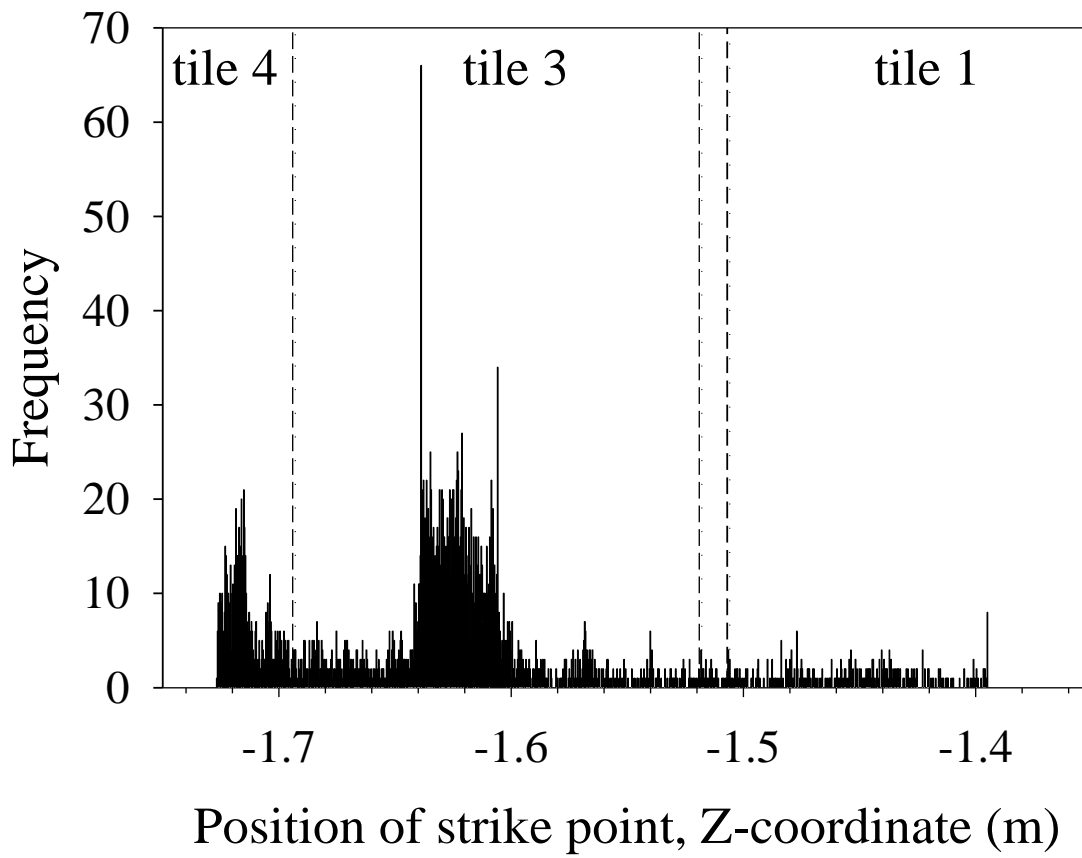
Figure 11: Histogram of the inner strike point positions (Z-coordinate) during the operational campaigns with the MkII-GB divertor. Position of inner divertor Tiles 1 and 3 is indicated with vertical dashed lines

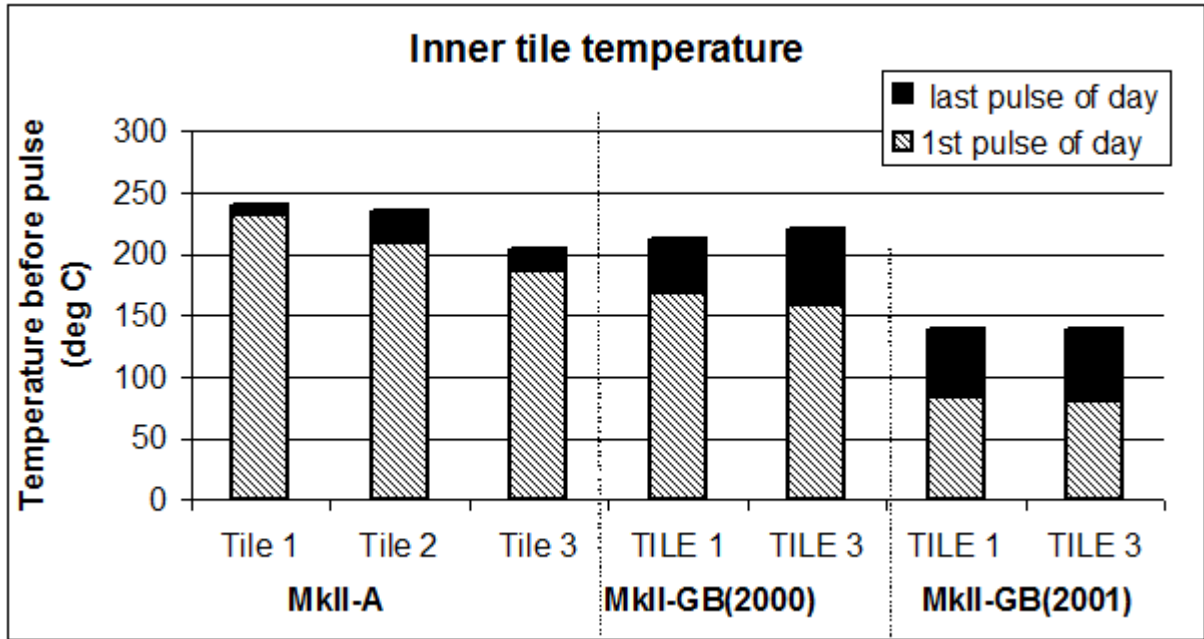
Figure 12: Histogram of tile temperature in the inner target during the operation with the MkII-A and Gas Box (in 2000 and 2001) divertors.

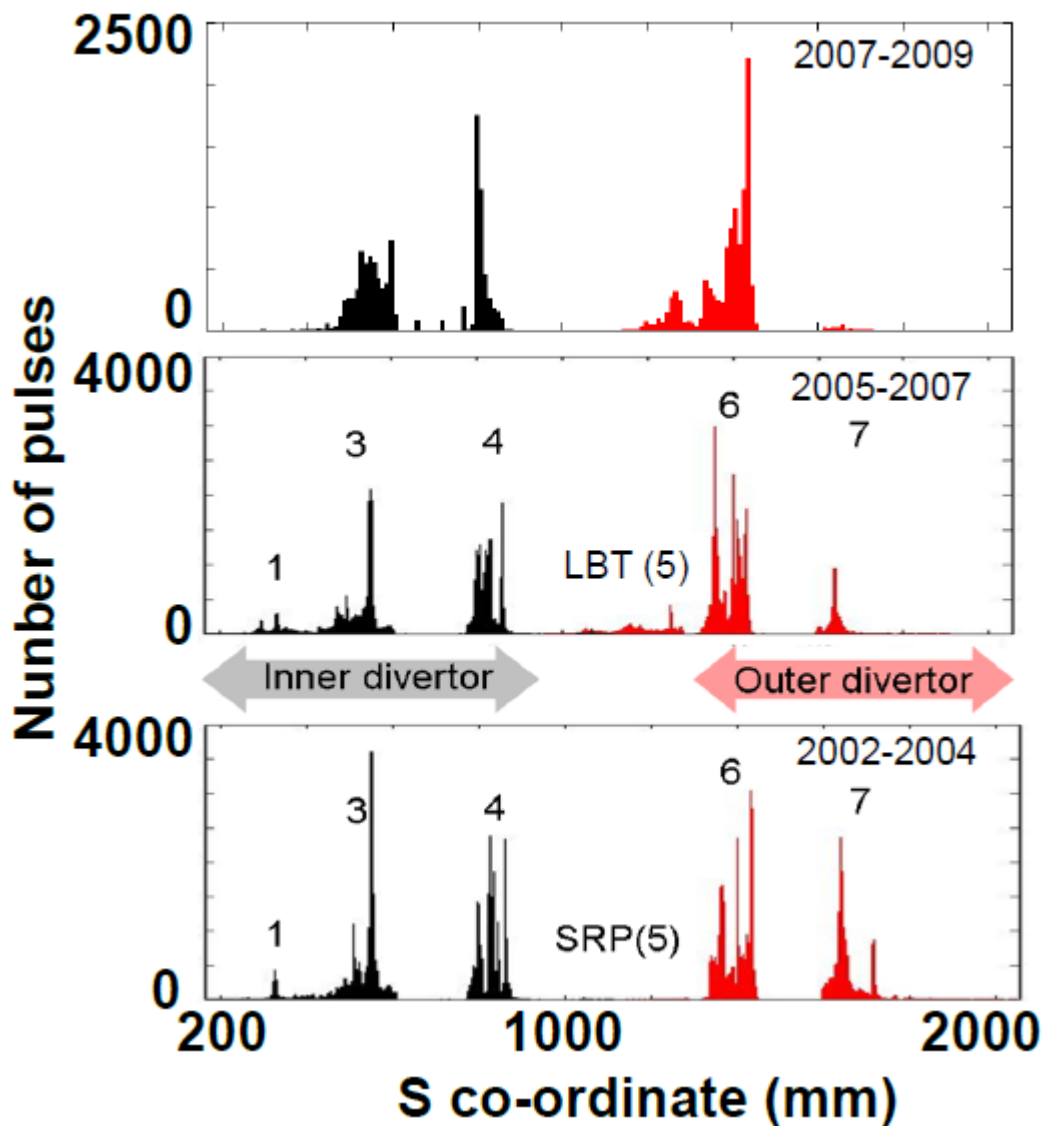
Figure 16: Histogram showing the distribution of strike point positions in the divertor during the MkII-HD operations 2005-7 and 2007-9, and comparison with the MkII-SRP operations 2001-4. The X-axis is the s co-ordinate: the changes from Tiles 1-3-4-5-6-7-8 occur at approximately 0.43, 0.7, 0.95, 1.32, 1.55 and 1.81 m

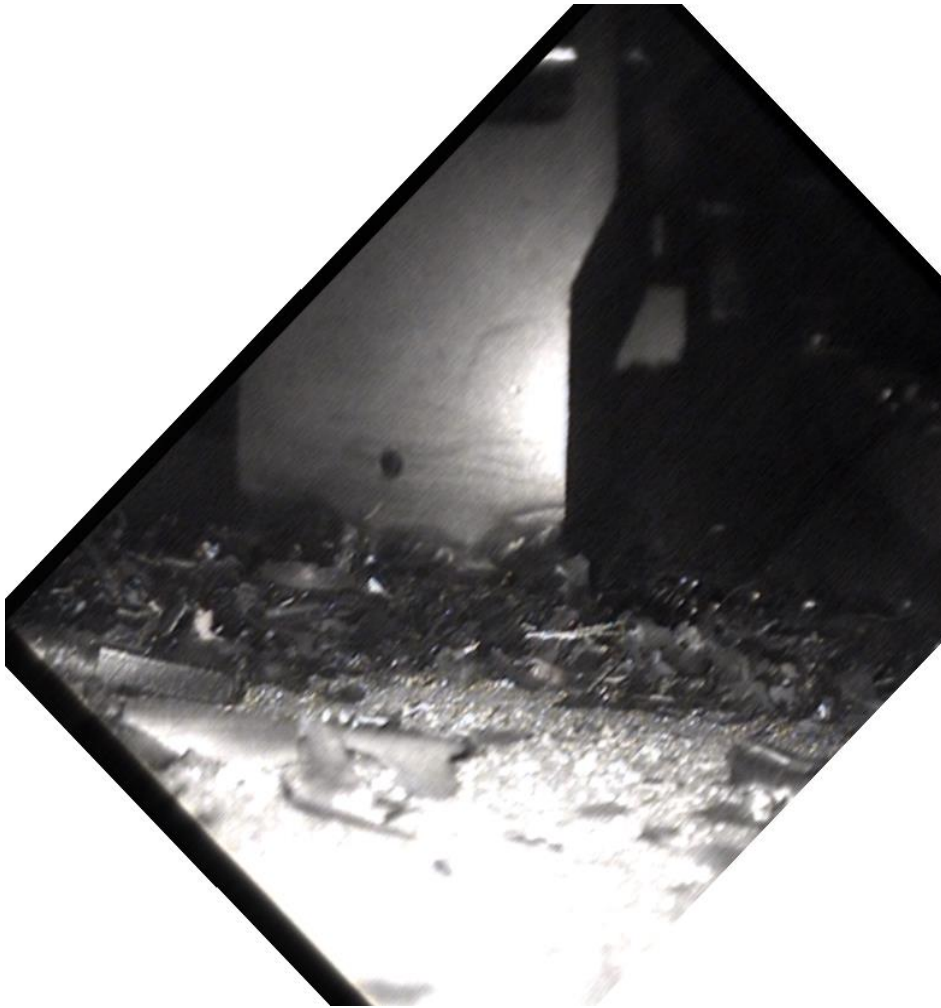
Figure 19: Flakes piled behind a divertor support leg, observed using an endoscope in 1999

There was a significant accumulation of flakes and dust on the divertor floor next to the inner louvres, much of which appeared to have resulted from spalling of deposits from the louvres themselves; there were no flakes observed on or near the outer louvres. All the flakes from the inner divertor corner were collected after the tile carriers were removed (all round the torus) using a vacuum cleaner, weighed and a sample analysed at AEA, Winfrith. The analysis showed that the flakes were carbon with a very high D and T content: based on the sample analysed, the 152 g collected contained 0.52 g tritium, giving a specific activity of 1.3 TBq g⁻¹ for the flakes [30]. This reduced the missing T to ~3 g. The way the louvres are angled, most material spalling from their blades would fall into the void under the divertor. If it is assumed that all the missing T is in flakes that have fallen below the divertor, there would need to be ~1 kg of flakes similar to those collected at the inner divertor corner [31]. In the next intervention (in 1999) an endoscope was fed through the louvres to see if there were indeed flakes in the sub-divertor volume. As the endoscope was being fed through the gap between the divertor structure and the inner divertor coil housing flakes could be seen balanced on each bolt head and ledge, and on the floor of the vessel (which under the inner divertor is sloping towards the lowest point which is approximately beneath the outer divertor) there were piles of flakes behind every obstacle, for example divertor support legs as seen in Figure 19. In the 2001 shutdown there was a plan to remove all the flakes from one sector of the sub-divertor in order to assess their T content and, by extrapolation of the mass of flakes recovered, the total T inventory. Some flakes were recovered by inserting a metal pipe attached as an extension to a vacuum cleaner

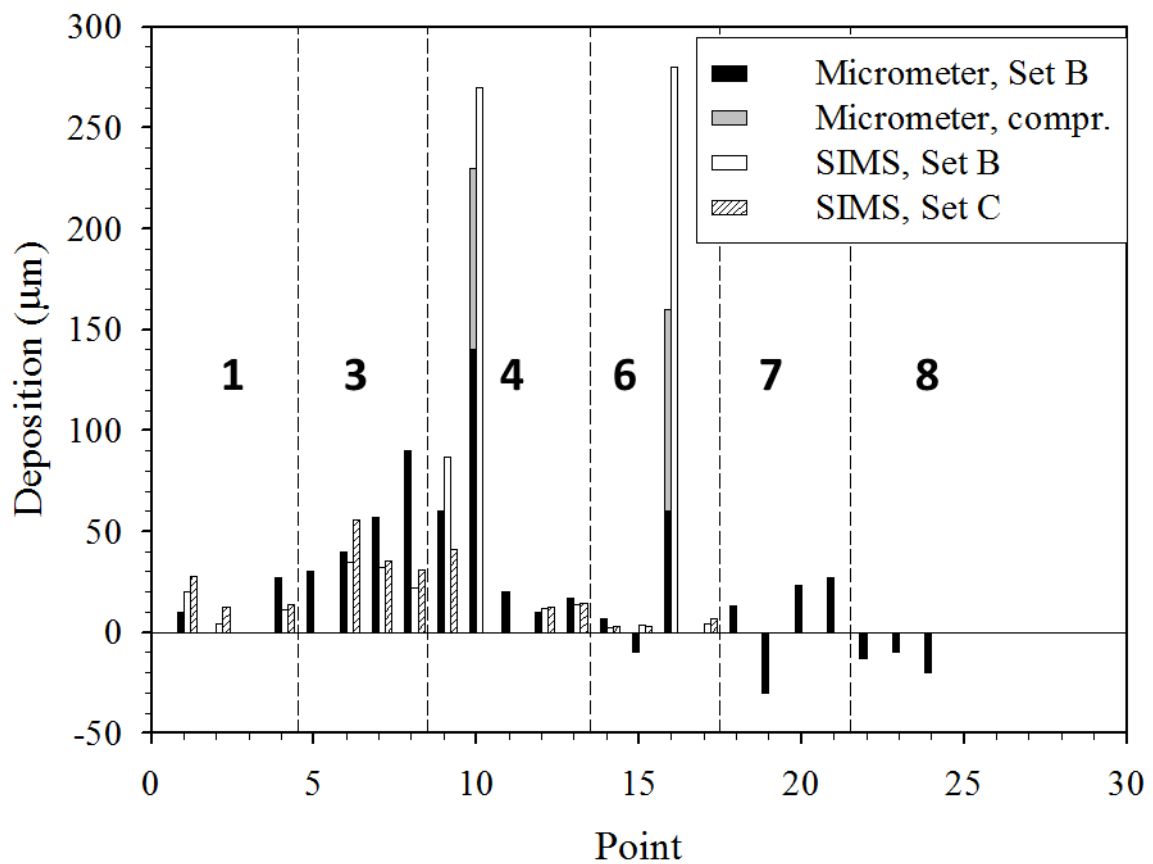
Figure 21: Erosion or deposition on a poloidal set of divertor tiles following exposure from 1999-2001, as derived from micrometer measurements (see also Figure 10): grey shading shows the amount of compression in the micrometer measurements (only occurred at two points). Also included are film thicknesses measured by SIMS. The tile numbers are shown on the figure.

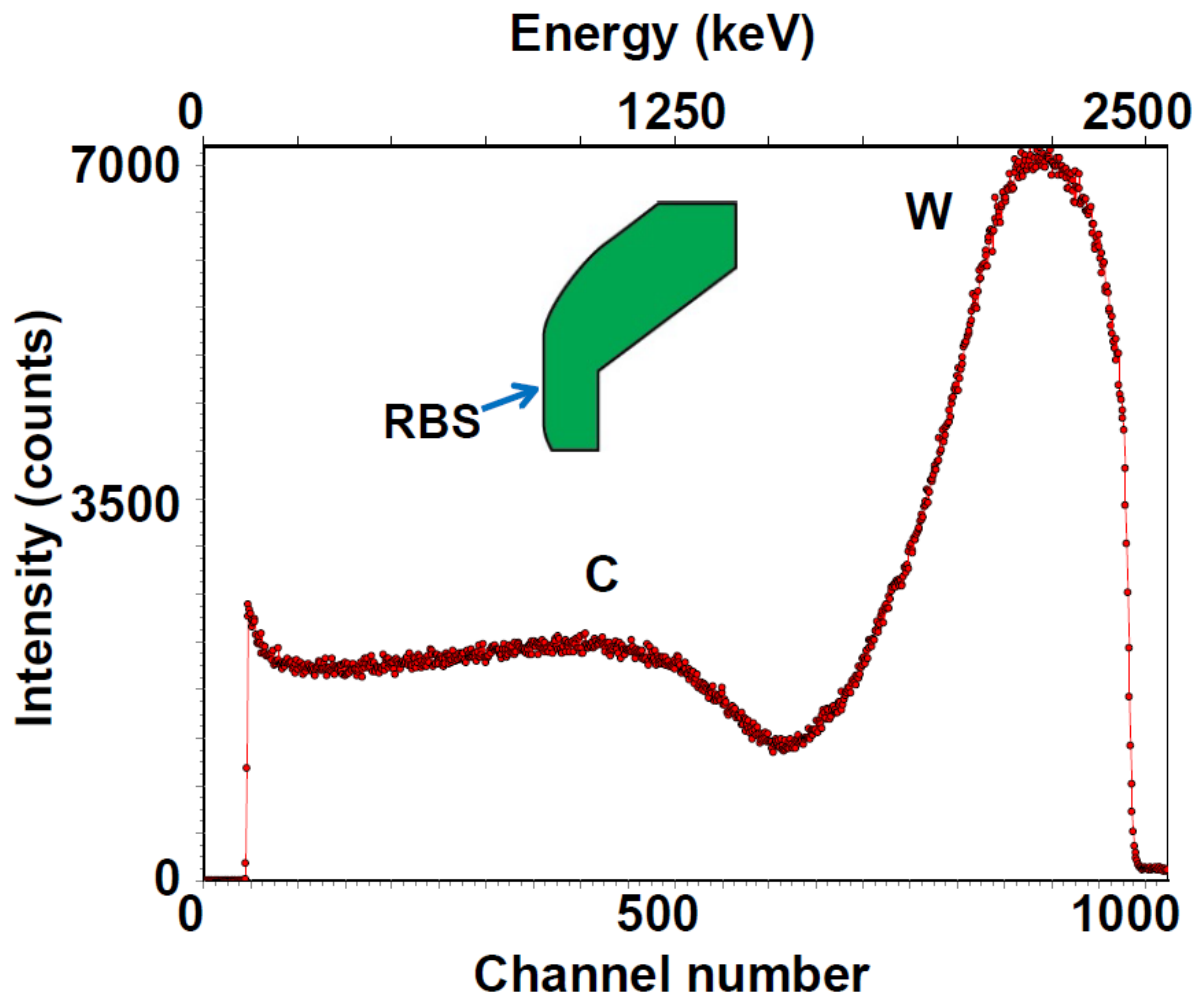
Figure 26: RBS spectrum from the W stripe near the bottom of the front face of Tile 8 exposed in JET 2001-4. The spectrum shows a continuous film of W at the surface, and is similar to the spectrum before exposure in JET.

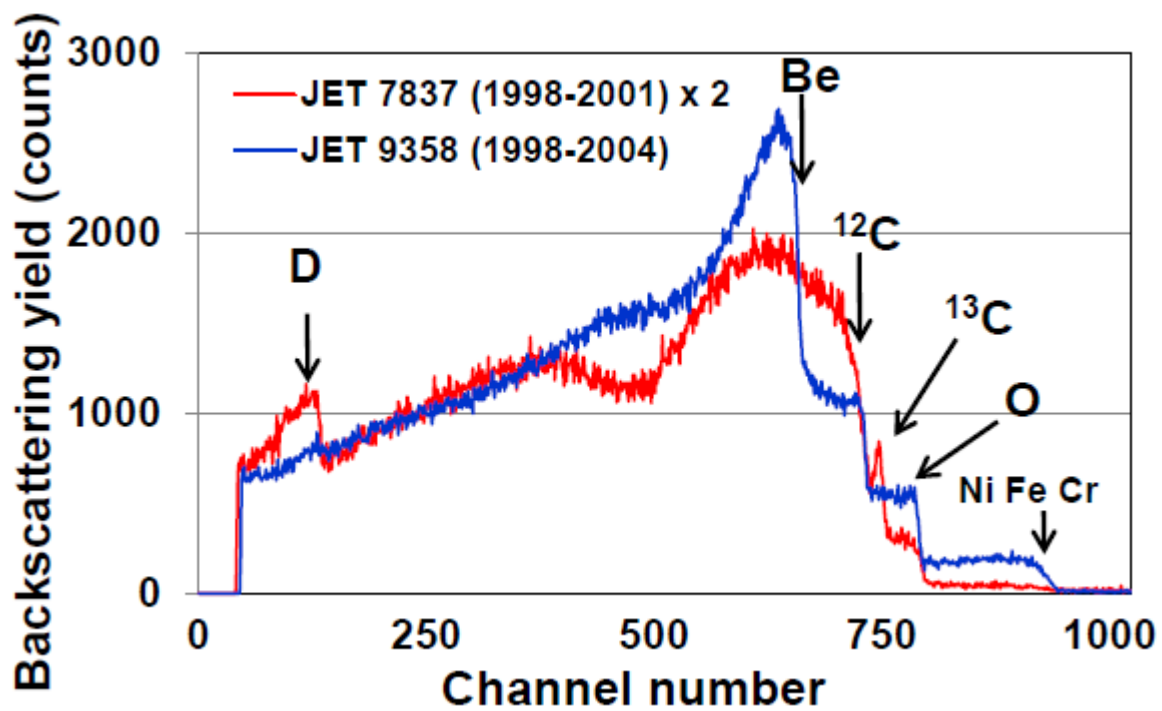
Figure 33: RBS spectra from the upper part of the front face of Tile 3 for tiles removed in 2001 and in 2004

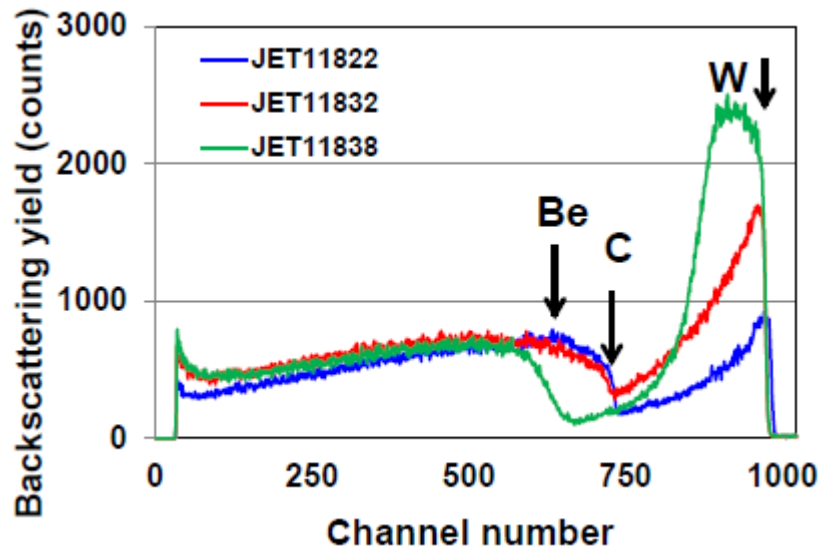
Figure 42: RBS spectra from the centre (poloidally) of the W-coated stripes on LBSRP Tile 14WR (a) on the thinner coating (JET11822), (b) on the plasma-exposed part of the thicker coating (JET11832), (c) on the shadowed part of the thicker coating JET11838).

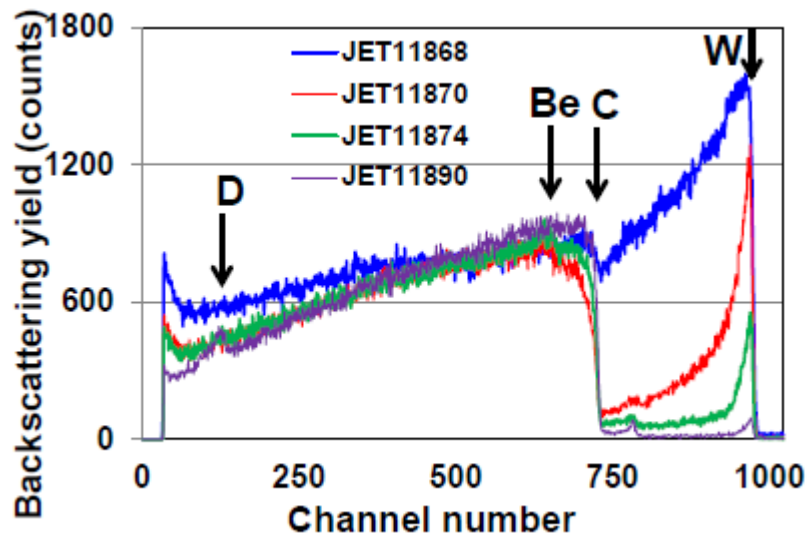
Figure 43: RBS spectra from the thicker W stripe (JET11868), in the gap between stripes (JET11870 and 11874), and downstream from both stripes (JET11890)

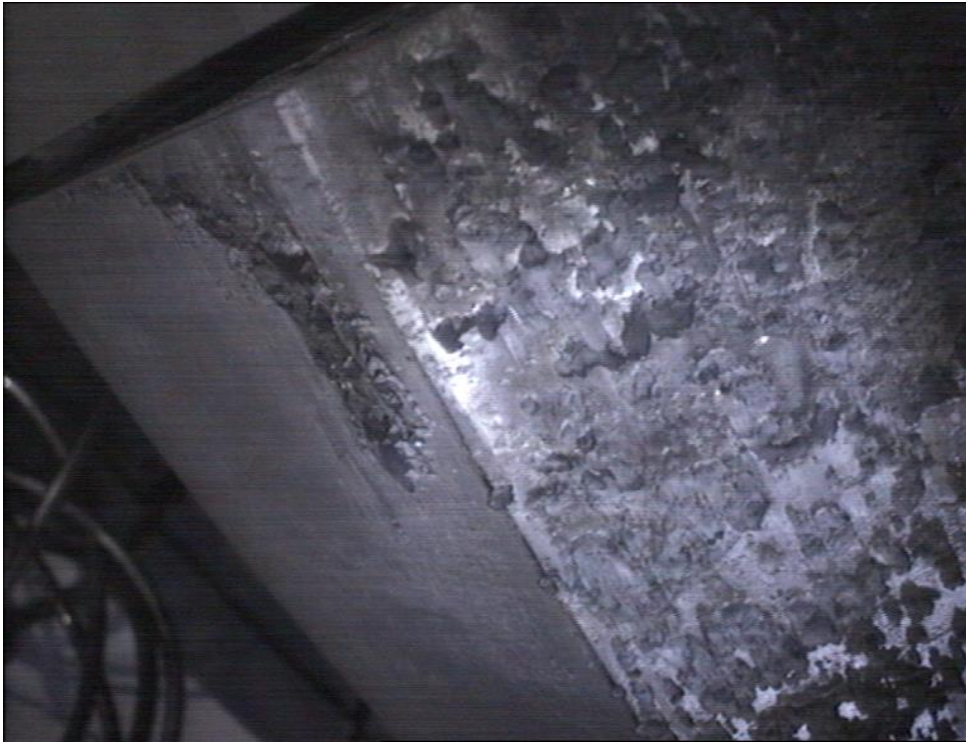
Figure 45: View of part of the apron of a Tile 1 (right-hand side) and the upper front face of the tile (towards the left-hand side) during the 2007 JET shutdown inspection, showing spalling deposits. The tile had been exposed 1998-2007.

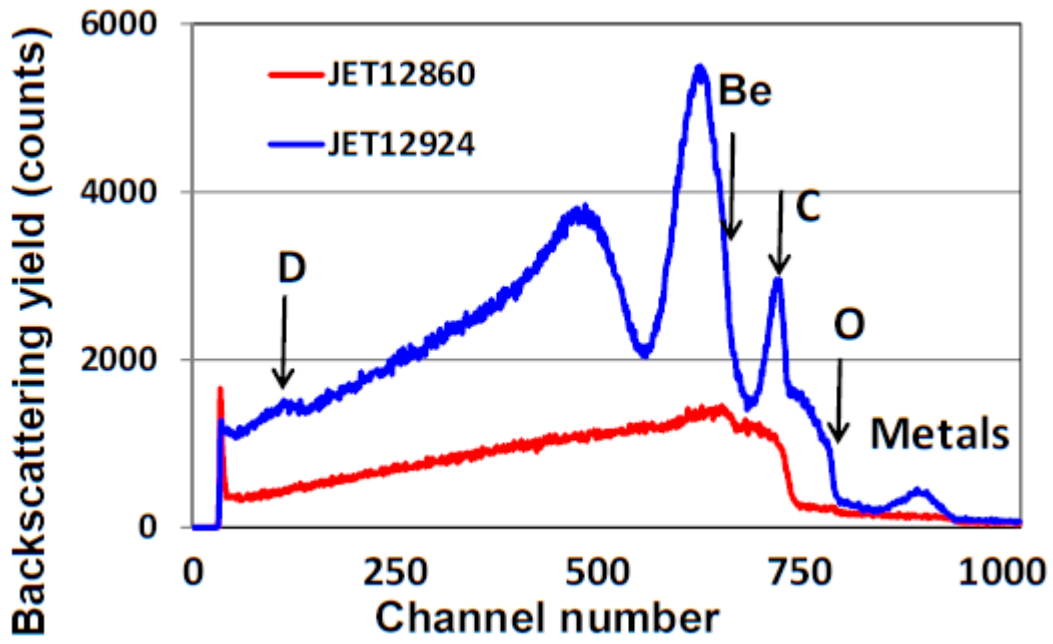
Figure 46: RBS spectra from the apron (JET12860) and the lower part of the front face (JET12924) of Tile 2IWG1A exposed 2005-7.

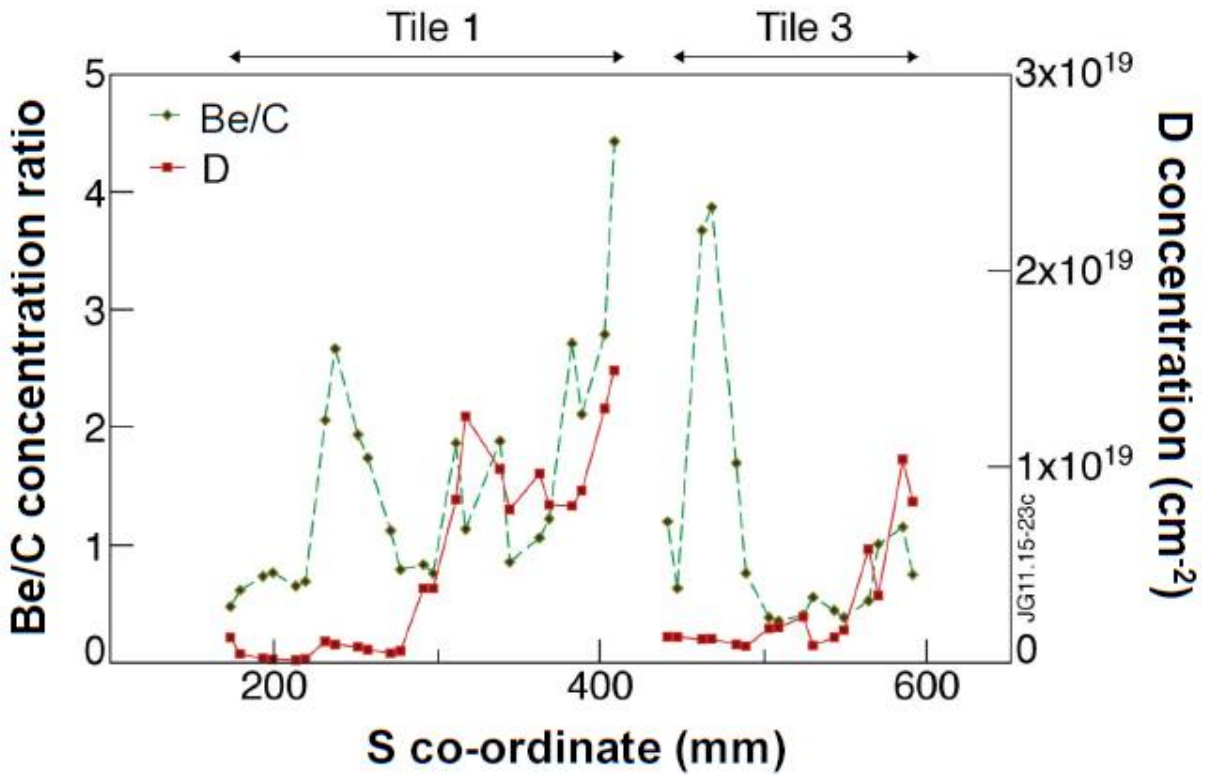
Figure 47: The ratio of Be/C and the D in the surface layer on Tiles 1 and 3 exposed 2007-9 from NRA data.

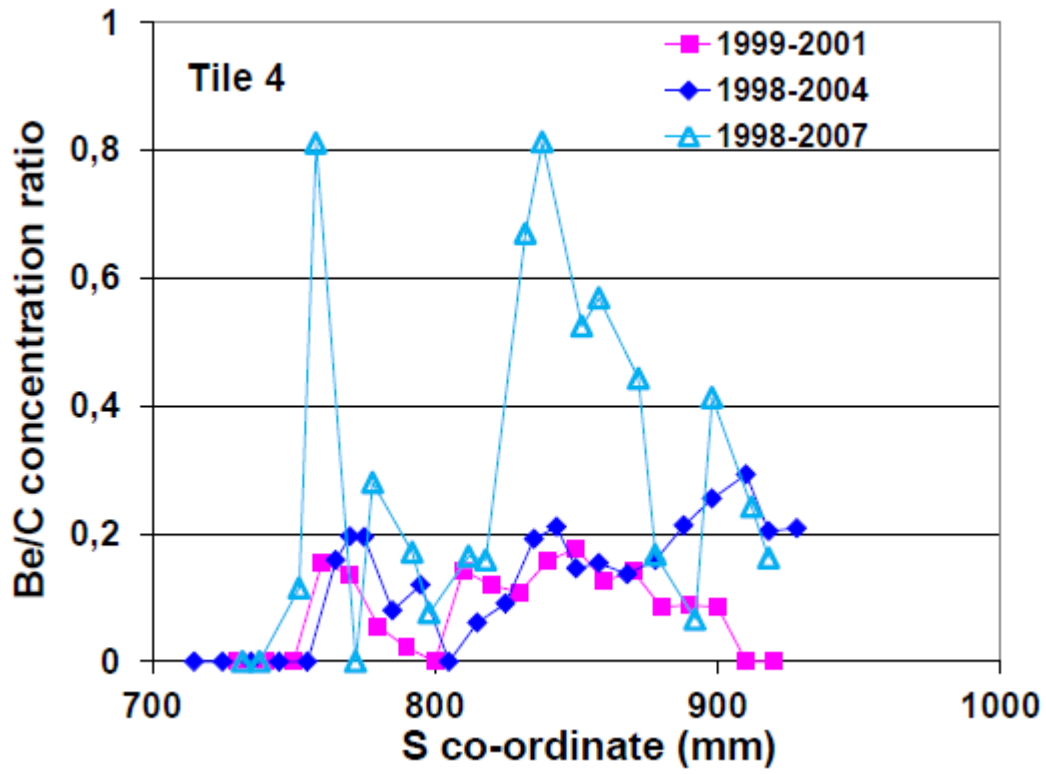
Figure 48: Comparison of Be/C ratios on Tile 4 for tiles removed after the last three JET campaigns (1999-2001 – Mk II Gas Box, 2001-4 – MkII SRP, 2005-7 – MkII HD divertors)

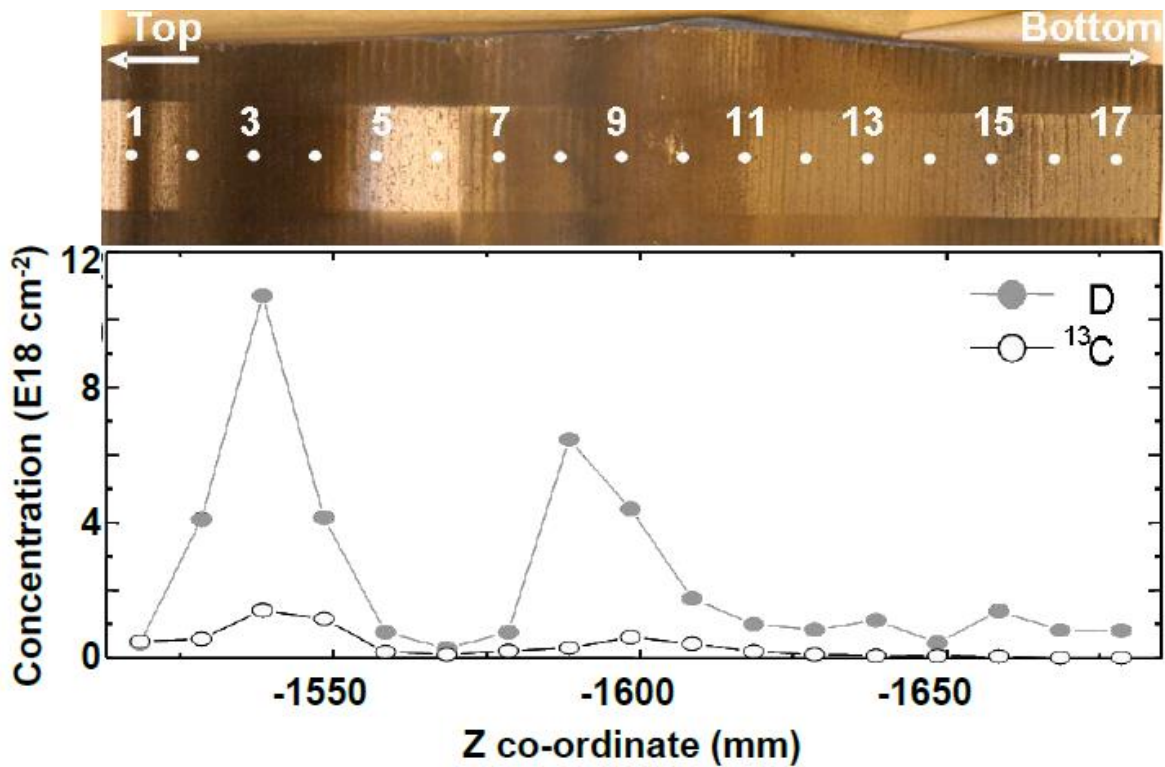
Figure 54: D and ¹³C concentrations plotted along the W-stripe seen in the panel above. The left-hand edge of the stripe in the picture is the top of Tile 7, the right-hand edge is the bottom

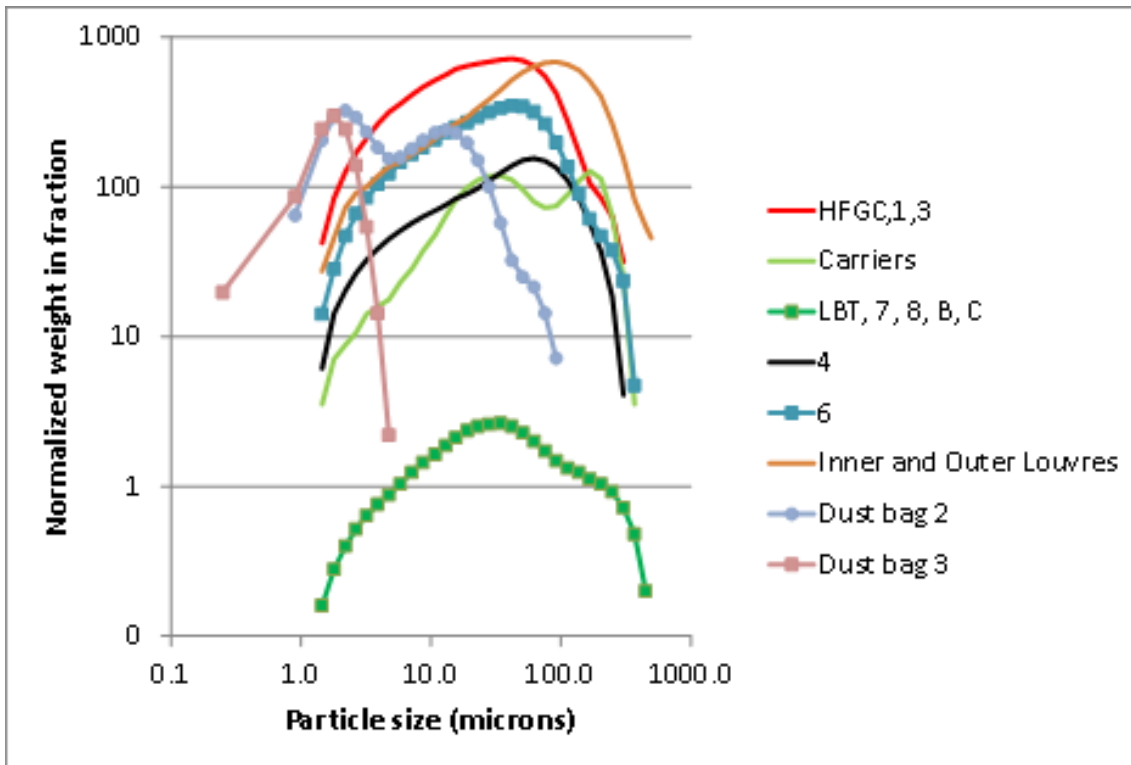
Figure 60: Particle Sizing Data - Results given as weight in the particular size fraction multiplied by the total weight of the dust sample collected versus the particular size fraction in microns.

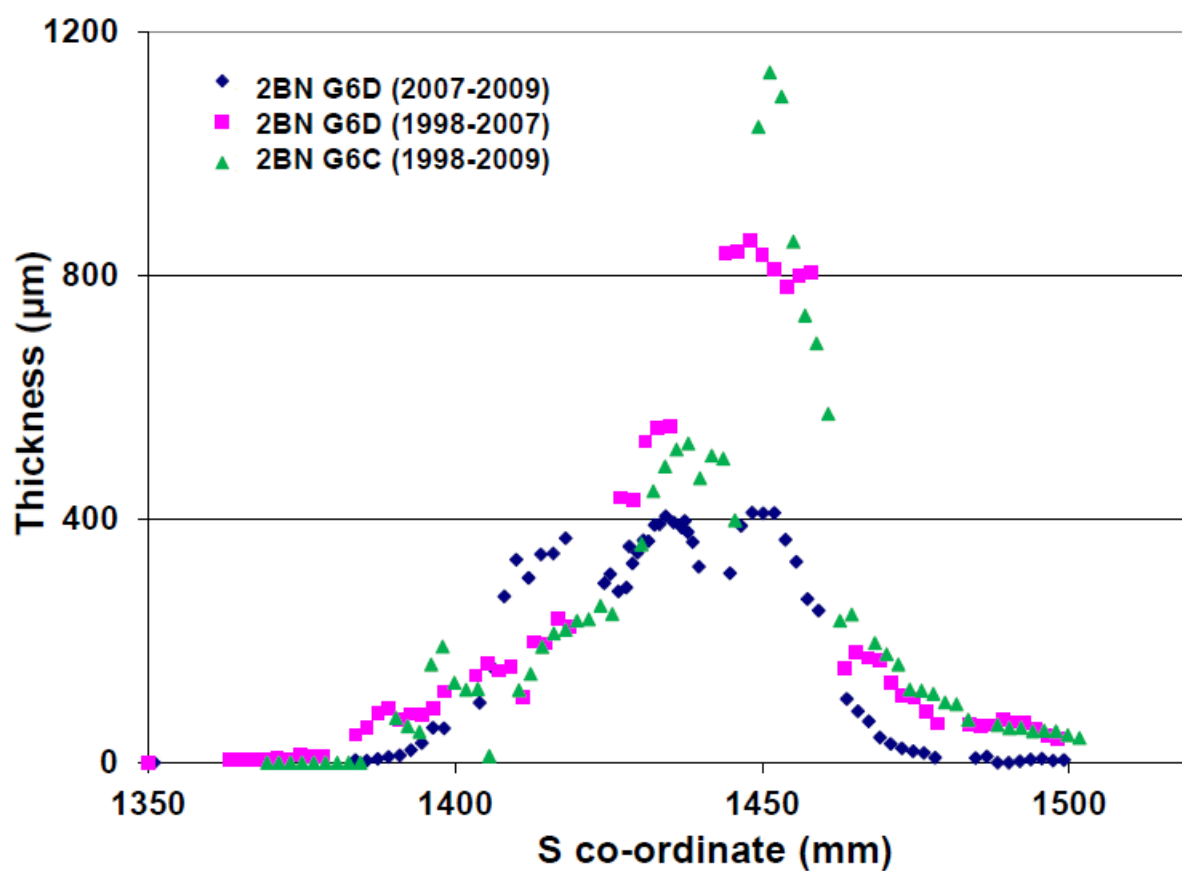
Figure 62: Film thicknesses from optical microscopy of sections for Tiles 6 removed from Module 2 after operational periods 1998-2007, 1998-2009 and 2007-9.
