Corrosion protective action of different coatings for the helium cooled pebble bed breeder concept

T. Hernandez* and F.J. Sánchez

National Laboratory for Magnetic Fusion. Materials CIEMAT Avda. Complutense 40

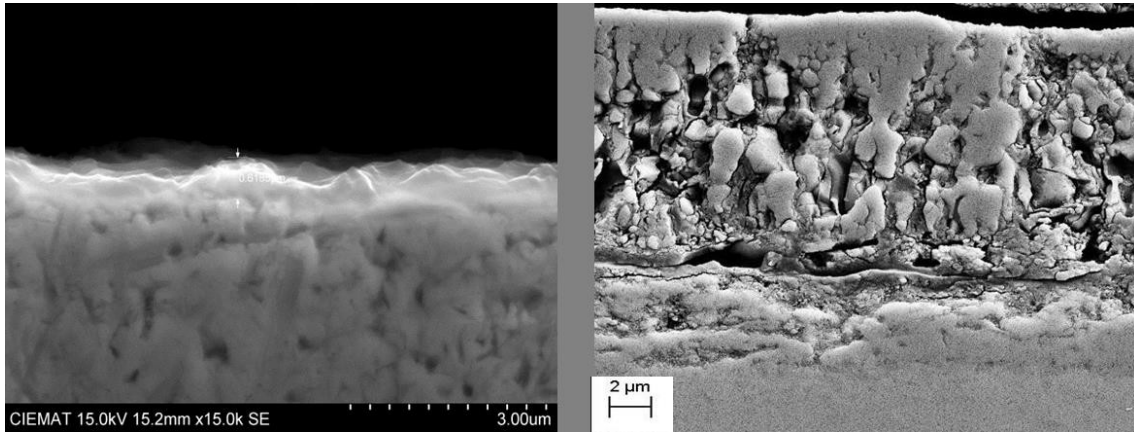
Figure 1 shows the corrosion layer that has been produced after a 3700 h test at 550 ° C with the pebbles K-S and J-T respectively in He/H_2O flow gas. At the usual working temperature for the pebbles the corrosion layer produced by the K-S pebbles is practically negligible while it is important for the J-T. The reason seems to be the distinct nature of the corrosion layer. While in the case of the K-S corresponds to a vitreous layer composed of silicon, lithium and other

metals that adheres and protects the steel, the J-T is oxidicoxide-like and porous, so it does not provide Eurofer with any protection. The exhaustive study of these layers can be found in [8 and [9]]. At higher temperature (800ºC for 730 h), the vitreous silica layer that protects the surface of the Eurofer has disappeared and the corrosion is favored by the small proportion of water contained in the helium purge stream, as can be seen in figure 2.

Figure 1: Corrosion layer produced on Eurofer after 3700 hours of exposure to the He/H2O mixture at 550ºC. Left: K-S pebbles. Right: J-T pebbles.

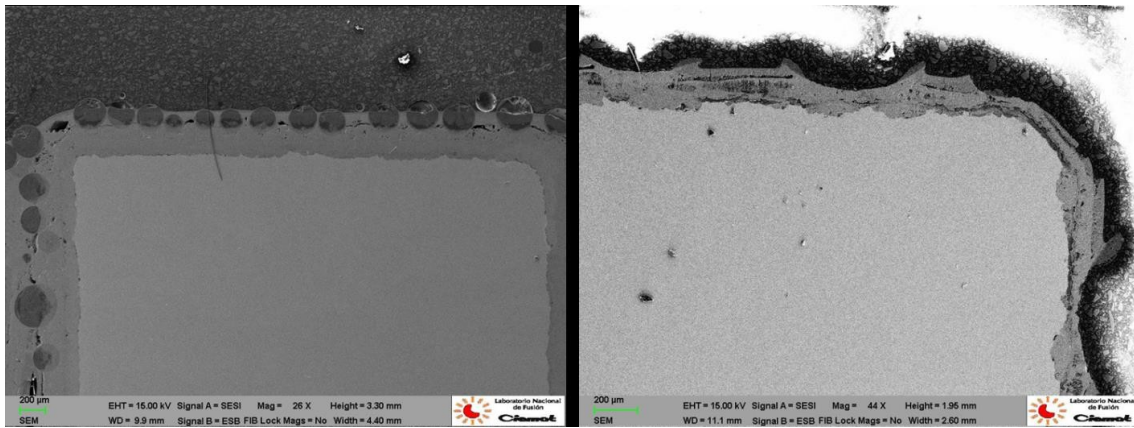
The first result to discuss is the effect of temperature. As seen in Figures 3 and 4, the corrosion layer formed solely by the action of the purge gas at 800 C is very important. The protective layer that the silicon-containing pebbles form on the Eurofer (an amorphous lithium silicate) that has been discussed in previous papers [8], is not stable at high temperature, so it does not form, or if it forms in a first stage, decomposes and leaves the material completely unprotected to external actions (Figure 2).

Figure 2: Corrosion layer produced on Eurofer after 730 hours of exposure to the He/H_2O mixture at 800ºC. Left K-S pebbles. Right: J-T pebbles.

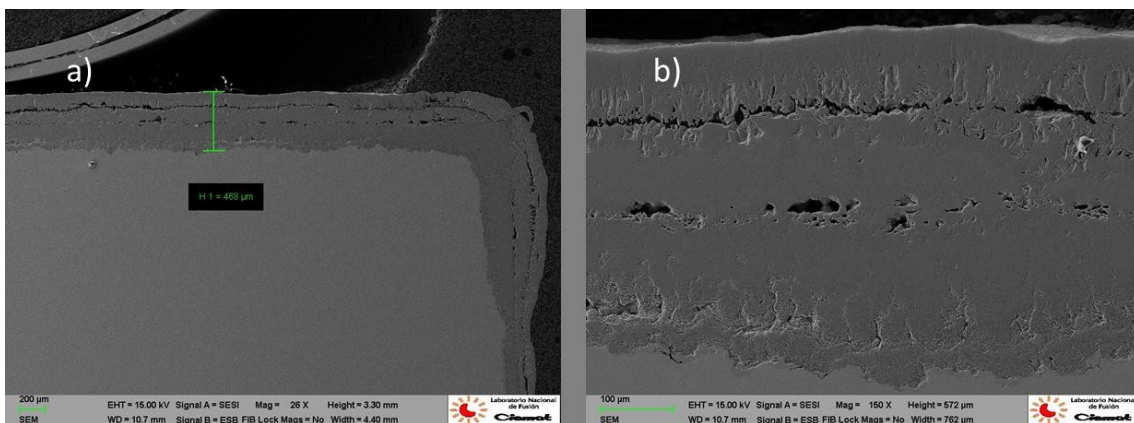
To separate the effect of the temperature itself from that produced in combination with the pebbles, an experiment was carried out in which the temperature was maintained at 800 °C and the time, 730 hours, but the pebbles were removed. The results can be seen in Figure 3.

Generalized corrosion around all material that reaches almost 500 microns depth can be found after the test. The mapping of the elements in the corrosion layer can be seen in Figure 4. As a consequence of the temperature in a He/H_2O mixture, the corrosion layer is formed by sublayers corresponding to different compositions. Next to the Eurofer is enriched in chromium and slightly in manganese, elements that disappear gradually as the surface approaches. The layer is porous and fragile so it exfoliates easily. Under these conditions, it can be ensured that the adhesion of the layer to the substrate is low and can be detached easily, which means a new exposure of the steel to the medium that will continue to act on it.

Figure 3: a) Corrosion layer formed at 800ºC and 730 hours without pebbles by the action of a He / H_2O gaseous flow. b) Expanded detail of the layer in which the existence of sublayers is appreciated.

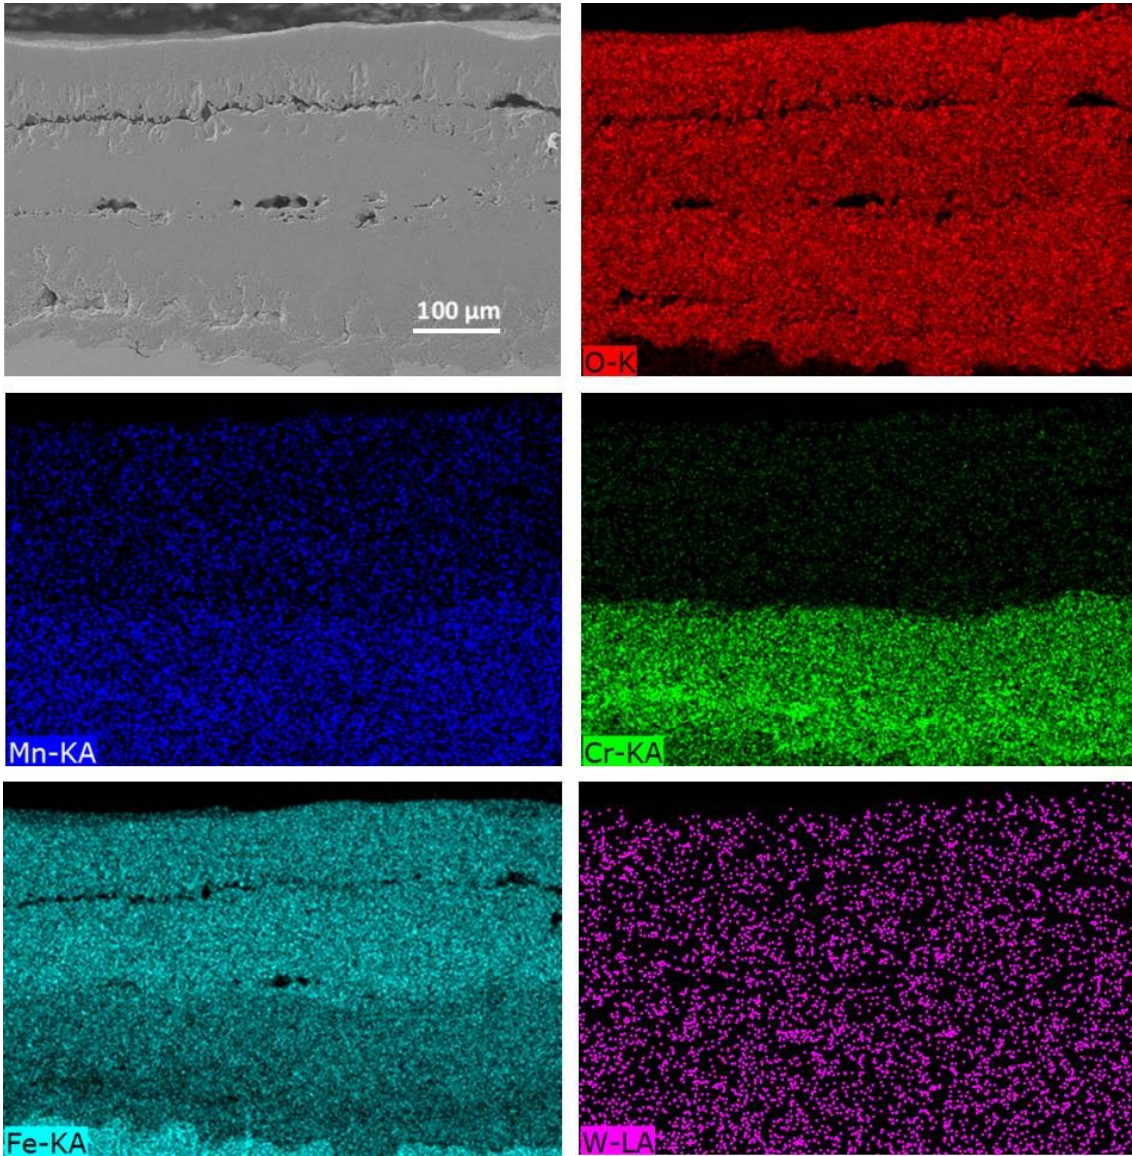
Figure 4: EDX mapping of the corrosion layer formed at 800ºC and 730 hours by the action of a He / H2O gaseous flow showing the composition of the different oxidized sublayers (outer Fe rich and inner Cr rich).

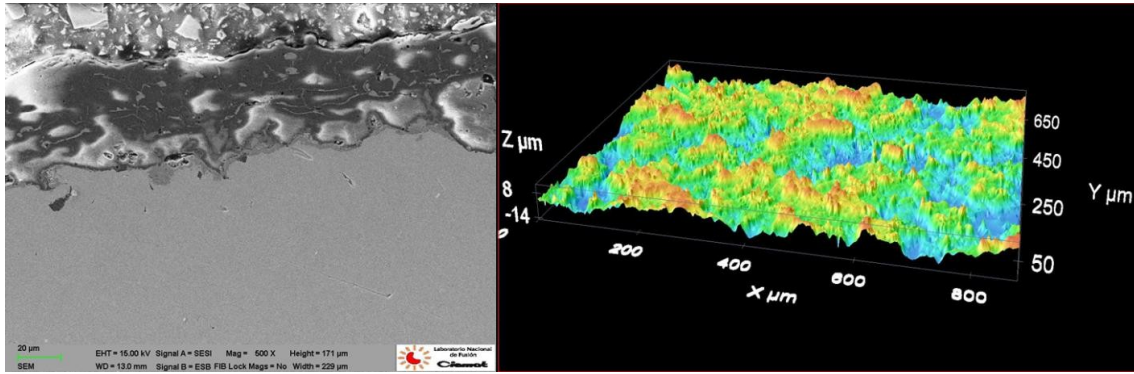
Figure 5 shows the appearance of the alumina coating prepared by thermal projection before (a) and after (b) the accelerated corrosion test at 800 °C for 730 hours.

As can be seen in the photographs, the coating remains after an experiment in such severe conditions. The adhesion of this coating is demonstrated in the same way the roughness does not seem to be altered to a great extent. Something to highlight is the "filling" with material from the Eurofer of the pores and cracks characteristic of the thermal projection process. It is most likely that the excessively high temperature has facilitated the diffusion of the alloying elements towards the surface. Beyond that part of the steel, the material appears protected.

Figure 5b: Appearance of the TP-coating after the accelerated corrosion test with K-S pebbles and He / H2O mixture as purge gas. Left: cross section of the coating. Right: appearance of roughness after the test.

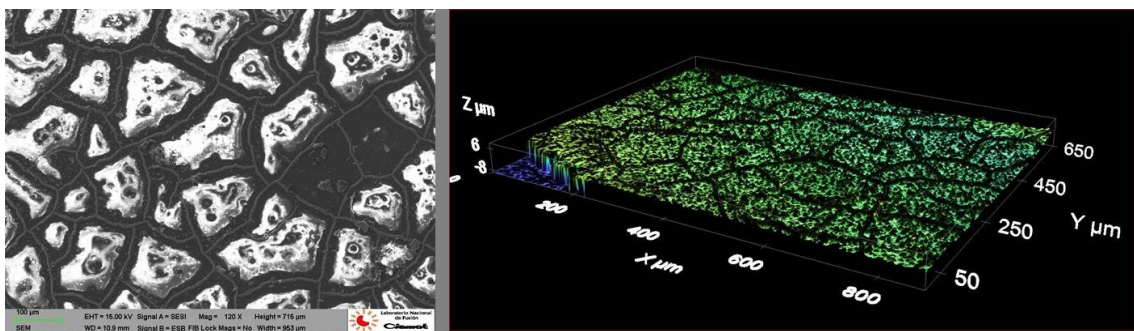
Figure 6a shows the appearance of the coating produced by the PLD technique. As can be seen, it is a homogeneous aluminium oxide layer, well adhered to the substrate and with very low roughness. Figure 6b shows the confocal image of the coating surface after the corrosion test at 800 °C. As can be seen in the image on the left, the coating is fragmented but remains attached to the substrate. This effect is more perceptible in the 3D image.

Figure 6b: cross section; Right aspect of the roughness obtained by confocal microscopy.

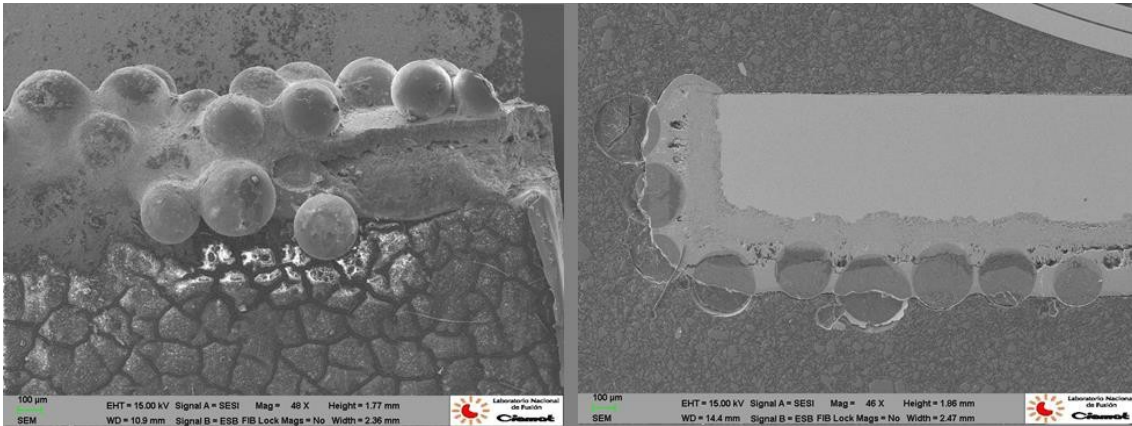
The specimen had a prismatic shape in which only one of its faces was covered with aluminium oxide. That face is the one shown in Figure 7 (left) that appears fragmented after the test. It is the huge layer of corrosion that has occurred in another of the faces that had not been protected and in which the K-S pebbles have been immersed. Figure 7 (right) represents a cross section of the probe in which it is possible to distinguish in the upper part the thin layer of alumina that has protected the Eurofer. On the left side and below is the thick layer of corrosion formed as a consequence of the temperature, the pebbles and the atmosphere used in the test.

Figure 7: Coating prepared by PLD after corrosion test at 800ºC. Left: front view of the coating after the test; Right: cross section by SEM.

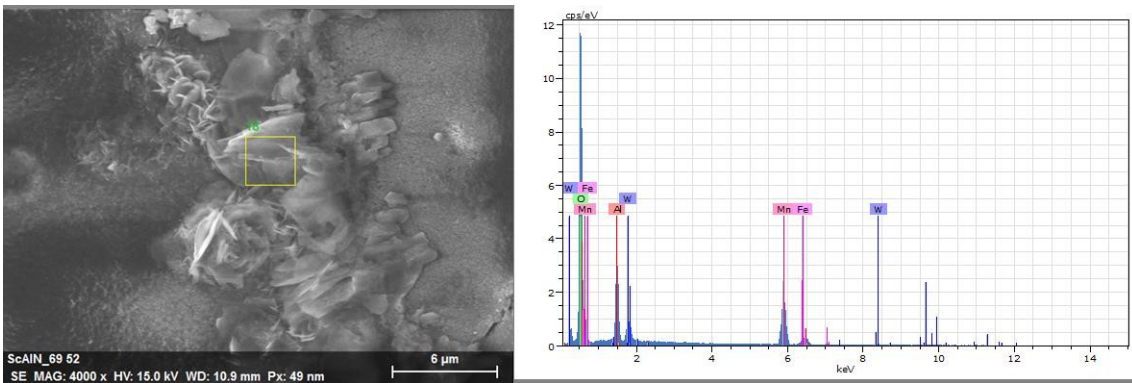
Facts of special interest are the precipitations observed in the cracks of the coating. The observation by SEM shows the precipitation of a phase that forms crystalline sheets. The EDX analysis performed on such structures shows they are formed mostly by Mn and W, as can be seen in Figure 8. To complete the analysis, an EDX was made across one of the excrescences that arise between the fractures of the coating. The analysis does not give rise to doubts of the manganese being involved in its composition.

Figure 8: Left: precipitated crystals found in the cracks of the PLD-coating after the corrosion tests. Right: chemical analysis of them carried out by EDX.

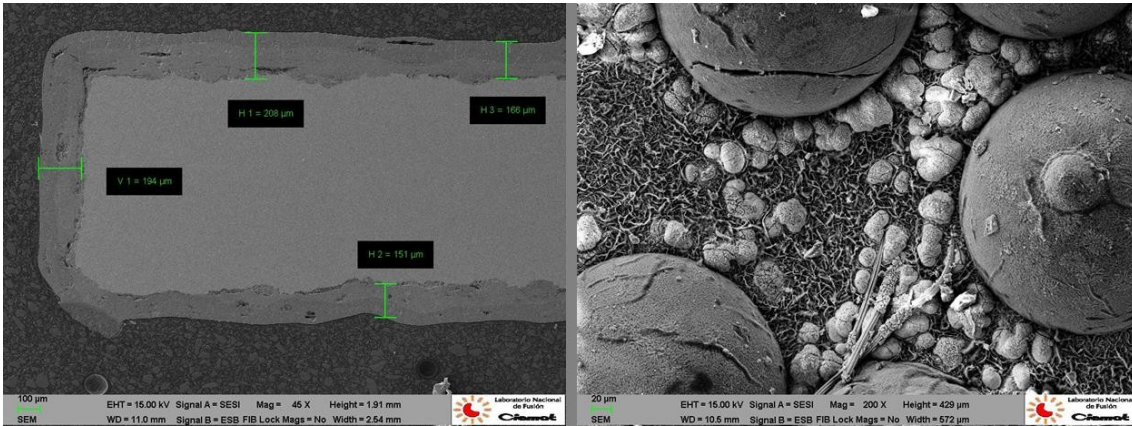
Figures 10 shows the great deterioration suffered by the coating after the corrosion test. At the corrosion test temperature the tungsten layer is not stable and comes off leaving the Eurofer unprotected. Figure 10left) presents the final state of the specimen showing it has

suffered corrosion on all its faces. The layer formed oscillates between 150 and 200 microns in thickness and, as usual, consists of two sub-layers of different composition. In some areas it is possible to visualize remnants of the original nanostructured W layer between the lithium silicate pebbles (figure 10 right). These remains appear as spherical shapes between frames of acicular crystals. The analysis of the crystals appeared on the surface carried out by EDX shows they are mostly composed of manganese oxide (Figure 11). As in the case of the PLD-alumina coating, manganese seems to diffuse easily to the surface and form crystalline structures with the silica from the lithium silicate pebbles.

On the other hand, the layer thickness found in the nanostructured tungsten coated material seems to indicate that it was maintained at the beginning of the test and was able to partially protect the surface of the steel, however, after some time that has not been determined; its decomposition began, as demonstrated by the remains found by scanning microscopy. Thus, the thickness of the corrosion layer found for the coating of W is half that corresponding to the bare material.

Figure 10: a) Corrosion layer produced in the nanostructured coating after the test at 800ºC. b) Remains of the original nanostructured W coating.

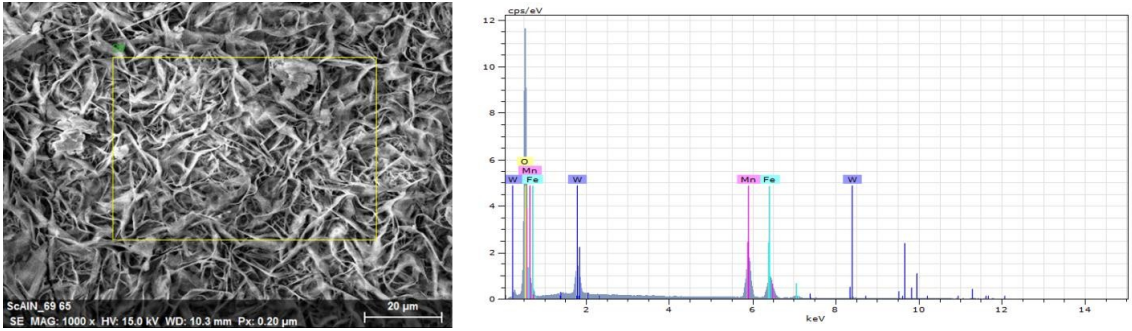
Figure 11: Surface SEM image (left) and EDX analysis of the crystals found on the surface for the nanostructured W coating (right).

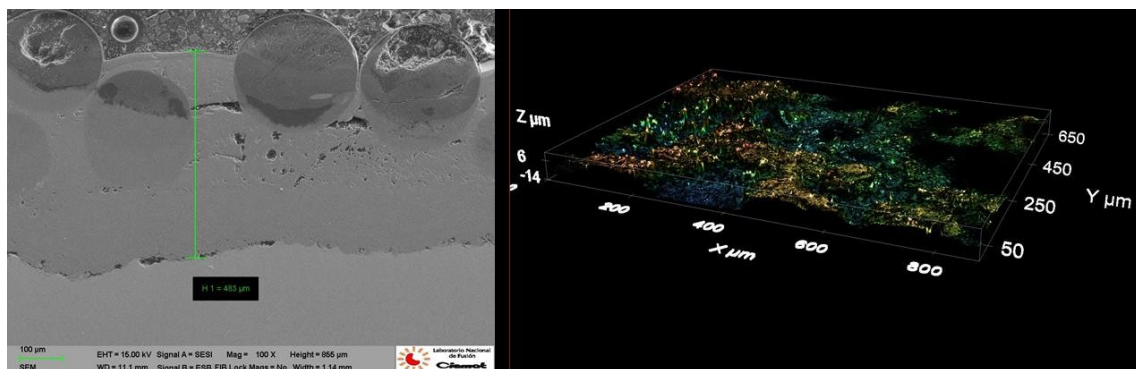
The situation that arises after the corrosion test at 800ºC is complex. Figure 14 shows the thick layer of corrosion produced when the Eurofer specimen has been in contact with the K-S pebbles, which approximates 500 microns thick. This result seems to indicate that the ALCRONA layer left the steel uncovered in the first hours of the experiment and did not protect the steel surface at all.

The same happens with some of the commercial coatings tested in this study. The data obtained with respect to ALCRONA commercial coating indicate that it is not stable under the conditions considered and disappeared in the early stages of the test, giving rise to layers of corrosion similar to those of the uncoated material.

Figure 14: Corrosion layer produced by the K-S pebbles at 800ºC in the Eurofer covered by ALCRONA.

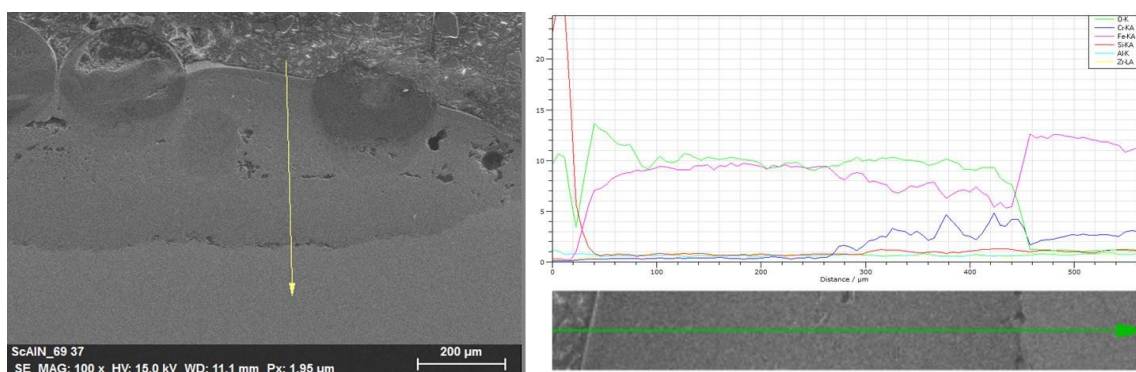
In the EDX analysis of the corrosion layer, traces of the coating are not detected. The layer of oxides formed is what is usually found in these cases, formed by two sublayers of different composition, the closest to the steel being enriched in chromium. Figure 15 shows the analysis.

Figure 15: EDX analysis of the corrosion layer produced on the ALCRONA coating by the K-S pebbles at 800ºC.
