An Overview of Comprehensive First Mirror Test for ITER at JET

Preprint of Paper to be submitted for publication in Proceedings of the
18th Plasma Surface Interactions in Controlled Fusion Devices, Toledo, Spain
(26th May 2008 - 30th May 2008)

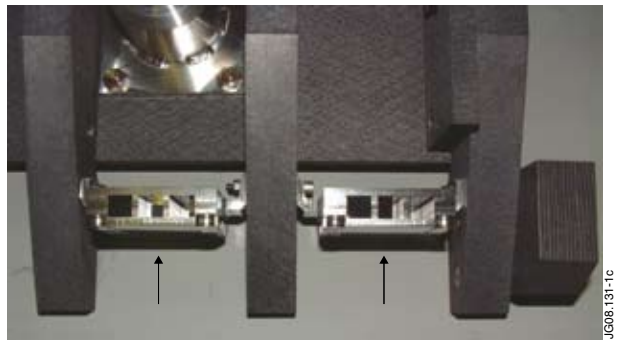
Six units were installed in three locations in the divertor: inner leg, outer leg and under the load bearing tile on the base. Fig. 1 shows cassettes installed on the outer divertor carrier; for clarity of view the Tile 4 blocks have been removed. In all locations the cassettes were mounted in the vicinity of deposition-erosion monitors [7]. Two units with 5 – channel cassettes, one with Mo and another with steel mirrors, were placed vertically (poloidal direction) on the outer wall in Octants 3 and 4, respectively. The unit installed in Octant 3 near the beryllium evaporator was equipped with a magnetic shutter protecting three mirrors placed near the channel mouth. Mirrors sitting deeper in the channel (3.0 and 4.5cm) were not protected. This arrangement allowed for a check of possible impact of wall conditioning on reflectivity. The distance of mirrors in wall units to plasma was from 42cm (mouth of the channel) to 46.5cm, whereas in the divertor it was 10 to 14.5cm. The range of solid angles for particle bombardment (Ω_{PB}) was $6.3 \times 10^{-3} - 5.5 \times 10^{-2}$ sr. These solid angles and aspect ratio for mirrors in cassettes (depth in channel to aperture width: 1.5-4.5) simulated the experimental situation of many mirrors planned in ITER.

Figure 1: Cassettes with mirrors installed between the ribs on the outer divertor module.
