C. Ruset, H. Maier, E. Grigore, G.F. Matthews, G. De Temmerman,
A. Widdowson and JET EFDA contributors

W Coatings Under High Thermal Loads in JET and Magnum-PSI

Preprint of Paper to be submitted for publication in Proceedings of the
14th International Conference on Plasma-Facing Materials and Components for Fusion Applications,
Jülich, Germany.
13th May 2013 - 17th May 2013

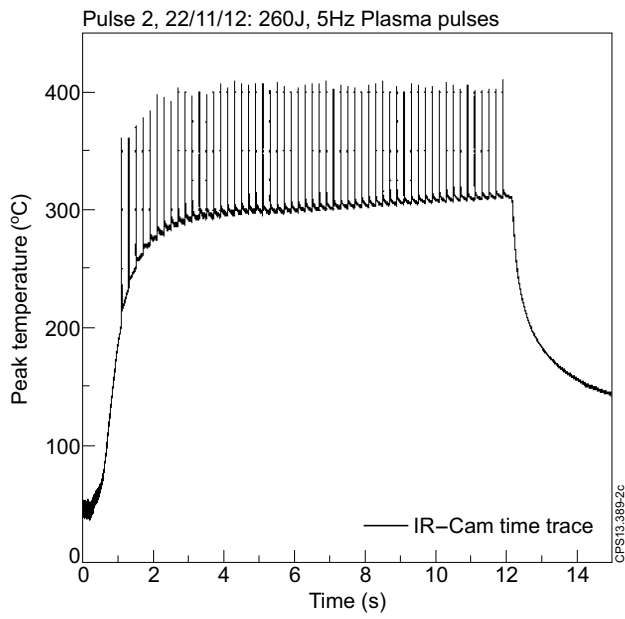
The temperature was measured with an IR camera at a frequency of 4kHz on the wavelength of 4 μ m. Under these conditions the temperature due to the steady state plasma was in the range of 200–400°C. The increase of surface temperature due to short pulses was about 100–120°C. The time dependence of the W coating temperature is shown in Fig.2.

Figure 2: Typical temperature time trace for 5Hz.
