EFDA–JET–CP(02)04-04

# Refurbishment of the JET Halo Current Diagnostics

Preprint of Paper to be submitted for publication in Proceedings of the  
19th IEEE/NPSS Symposium on Fusion Engineering  
(Atlantic City, New Jersey, USA 22-25 January 2002)

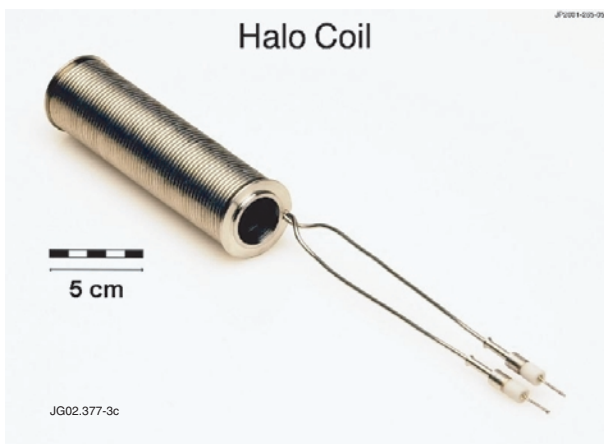
Figure 3: IUIWP toroidal field pick-up coil.

During the 2001 shutdown three Rogowski coils (Fig.2) and three toroidal field pick-up coils (Fig.3) have been installed together with the Improved Upper Inner Wall Protection (IUIWP); two toroidal field pick-up coils (Fig.4) in the divertor region, together with the Septum Replacement Plate (SRP).

The IUIWP toroidal field pick-up coil (Fig.3) is made of about 110 turns of inconel sheath MIC (outer diameter 1.5 mm) wound on a stainless steel cylinder 94mm long, with an external diameter of 18 mm and a wall thickness of 1.5mm. The coil is encased in a stainless steel tube 126 mm long, with an external diameter of 30mm and a wall thickness of 2mm. The MIC of the IUIWP coils has a vacuum sealed termination that is connected to a more flexible fibreglass braid insulated copper cable, which runs to the RH plug located in the same octant station. From there, another fibreglass braid insulated copper cable goes to the vessel feedthrough.

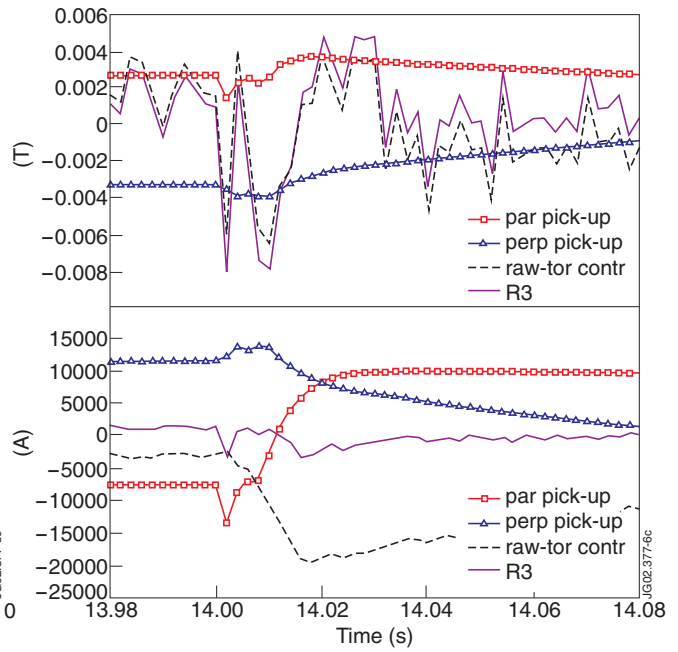
Figure 6: Poloidal field pick-up in the top probes during the (downwards) disruption of Pulse No: 55221. Top: toroidal field pick-up coil, bottom: Rogowski coil.
