EFDA–JET–CP(02)05/04

Refurbishment of the JET Halo Current Diagnostics

Preprint of Paper to be submitted for publication in
Proceedings of SOFT 2002 (Helsinki, Finland, 9–13 September 2002)

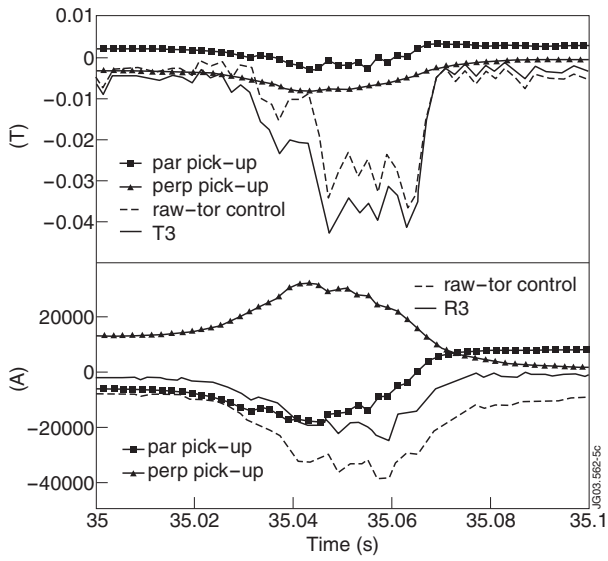
Figure 5: Poloidal field pick-up in the top probes during the (upwards) disruption of Pulse No: 55676. Top: toroidal field pick-up coil, bottom: Rogowski coil.

Best fit coefficients to approximate the field pick-up have been computed using the full duration of plasma and dry pulses and requiring that, in absence of a disruption, the halo current was zero. In Fig.5, for Pulse No: 55676 (a 1.8MA deliberate upwards VDE), and in Fig.6, for pulse 55221 (a 2.5MA downwards density limit disruption), the contribution to the local toroidal field due to poloidal halo current (“T3”, top) and the current collected by the IUIWP tile (“R3”, bottom) in Octant 3 are plotted together with the poloidal field components seen by the probes (parallel, “par pick-up”, and perpendicular, “perp pick-up”, to the vessel wall) and the raw signals with only the external toroidal field removed (“raw-tor contr”). In both cases the effect of the poloidal field on the toroidal field pick-up coil is very small, while it is larger on the Rogowski coil signal. The downward event also provides an estimate of the error due to disruption fields for the Rogowski current: $\sim 1.2\text{kA/MA}$, i.e. 3kA in a 2.5MA disruption; the typical current for a 2MA disruption is 30kA.
