EFDA–JET–CP(07)03/19

J.A. Alonso, P. Andrew, A. Neto, J. L. de Pablos, E. de la Cal, H. Fernandes,
J. Gafert, P. Heesterman, C. Hidalgo, G. Kocsis, A. Manzanares, A. Murari,
G. Petravich, L. Rios, C. Silva, P.D. Thomas and JET EFDA contributors

Fast Visible Camera Installation and Operation in JET

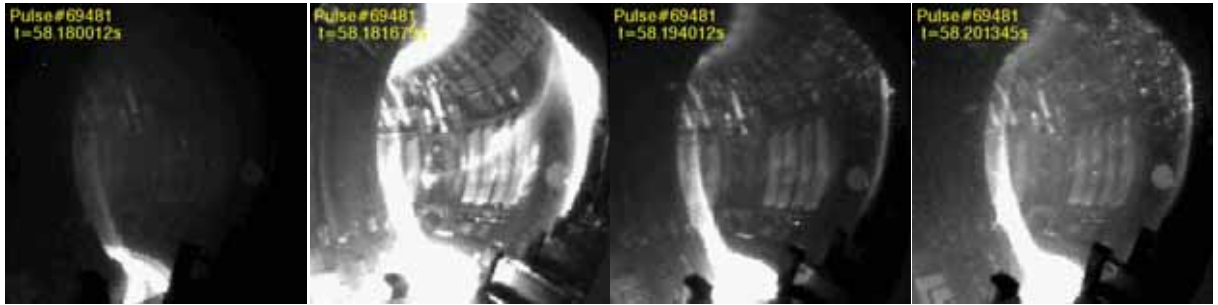
Figure 1. Particle expulsion from a poloidal limiter. Images are taken at 3 kfps with 166 μ s exposure time.

The fast camera has proven to provide useful information to study different fusion plasma relevant issues including plasma wall interaction, ELMs and disruption physics. Figure 1 shows the expulsion of macroscopic particles from the wall after the occurrence of an ELM.

Some 6ms after the sudden radiation increase caused by an ELM, a shower of solid fragments is seen to come out of an outer wall poloidal limiter and seem to be accelerated in the toroidal co-current direction (that is also the direction of the parallel plasma flows for this configuration). These particles can be seen for 50ms.

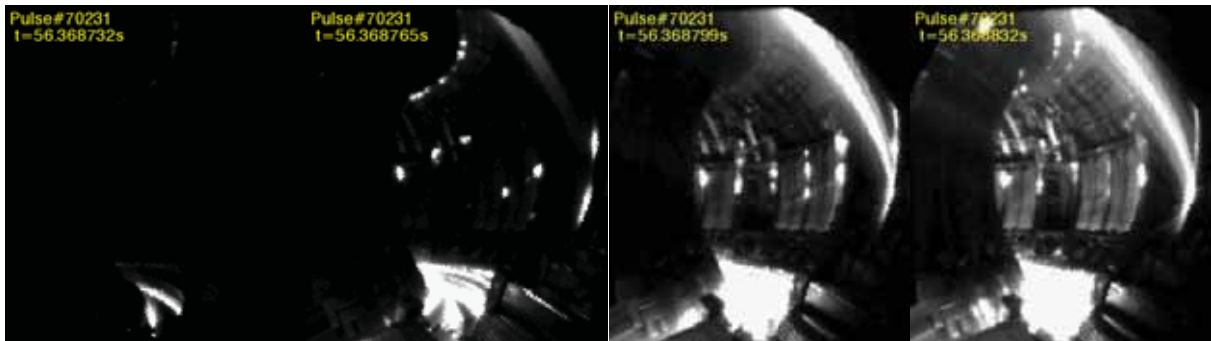
Figure 4. ELM onset and interaction with the wall (@ 30 kfps 25 μ s exposure). A helical wall-interaction pattern can be seen less than 40 μ s after the start of the D_{α} rise.

ELMs are commonly seen in the images as a sudden increase of radiation. For high power type-I ELMs like the one in figure 2, an associated filamentary structure can be observed as in other machines [2], [3]. In the high frequency recording of an ELM in figure 4, a helical interaction pattern can be seen on the wall within 40 μ s following the onset of the ELM (the associated D_α rise). This kind of interaction pattern has also been seen with infrared cameras in JET [4]. It should be noted that an ELM impact can produce localized particle desorption from the wall elements. These particles are transported parallel to the magnetic field and can also be seen as filamentary structures (figure 4, third and fourth frames) which are thus different from the ELM own structure.
