EFDA-JET-CP(14)01/32

Global Erosion and Deposition Patterns in JET with the ITER-Like Wall

A. Baron-Wiechec¹, A. Widdowson¹, E. Alves², C.F. Ayres¹, N.P. Barradas³, S. Brezinsek⁴, J.P. Coad¹, N. Catarino², K. Heinola⁶, J. Likonen⁵, G.F. Matthews¹, M. Mayer⁷, P. Petersson⁸, M. Rubel⁸, W. van Renterghem⁹, I. Uytdenhouwen⁹ and JET EFDA contributors*

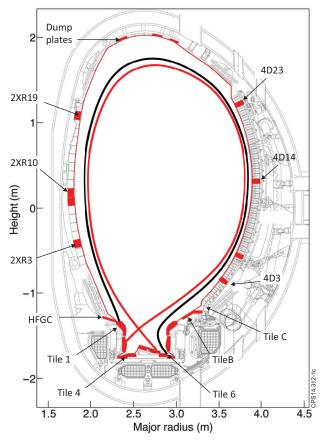
Figure 1: Poloidal cross-section of the JET vessel with investigated tiles location indicated.

Be marker tiles at poloidal locations in the main JET chamber and W coated CFC marker tiles in the divertor have been installed as shown in Figure 1: the tiles have an interlayer of Ni or Mo respectively as described in [3, 9]. The tiles were analysed prior to installation and after removal from the vessel by a set of ion beam analytical methods to determine the extent of erosion/deposition. Ion beam analyses were carried out using a Van de Graaff accelerator at the IST/ITN in Lisbon. Three complementary techniques were used: nuclear reaction analysis (NRA), Rutherford Backscattering Spectrometry (RBS) and Particle Induced X-ray Emission (PIXE). NRA employed the ${}^9\text{Be}({}^3\text{He,p}){}^{11}\text{Be}, {}^{12}\text{C}({}^3\text{He,p}){}^{14}\text{N}$ and ${}^2\text{H}({}^3\text{He,p}){}^4\text{He}$ reactions for detection of Be, C and ${}^2\text{H}$ (or D, deuterium) respectively using a 2.3 MeV He 3 beam at normal incidence, with the detector positioned at 135° to the direction of the incident beam. The chemical composition and thicknesses of the deposited layers were also analysed by RBS and PIXE using a 2.3 MeV protons at a scattering angle

The erosion/deposition at the outer poloidal limiters (OPL) tiles is illustrated by the analyses of tiles from rows 3 (4D3), 14 (4D14) and 23 (4D23) located as indicated (Fig. 1). Visual inspection of the OPL has been reported in [3, 6]. Representative RBS spectra from a tile near the midplane (4D14) are presented in Fig.2. It shows that at the centre of this tile 4D14 the marker has been eroded and only bulk Be remains (Fig.2, region a), profilometry indicate erosion of up to 30µm. IBA shows re-deposition of Be and Ni coating onto both left and right sides (eg RBS in Fig.2, region b). However, the right side of the tile is also characterised by some spalling of the coating, which limits the accuracy of the IBA analysis. Nevertheless based on IBA it can be concluded that where the coating remains it is a mixture of mainly Be with Ni and W. Between the eroded area and the ends of the tile are transition regions where the surface is virtually as the original marker layer (Fig. 2, region c). Secondly, there is no indication of erosion or local erosion and deposition on the 4D3, the marker coating is still intact. The tile is relatively clean, with some signs of deposition on the outer layer of the Be/Ni marker coating; mainly W and clear surface signals from Ni, Mo, Cr, Fe. Finally, there has been no visible interaction of the plasma with the tile 4D23, and certainly any profile changes were below the technique limit (±5µm).

Tiles B and C placed between outer divertor tiles and the main chamber (Fig 1) were also analysed by means of IBA. These CFC tiles were originally coated with approximately 10µm thick W prior

Visual inspection of the IWGL from rows: 3 (2XR3), 10 (2XR10) and 19 (2XR19) located as indicated (Fig. 1) has been reported in [3, 6]. Surface profiler and IBA analysis of Be/Ni marker tiles 2XR3, 2XR10 and 2XR19 has been completed recently. At the centre of tile 2XR10 the marker has vanished and only bulk Be remains, and profilometry indicate erosion of up to 60 µm. Towards the sides of the tile there is deposition of some Be and plasma impurities such as W and Ni, Mo, Cr, Fe (identified by PIXE) typical for Inconel composition, and at the very edges the composition reverts to the original marker composition (similar to Fig.2, region c). The marker tracer at the centre part of the top limiter 2XR19 is intact/conserved so no erosion has occurred, whilst at the centre of 2XR3 there is some thinning of the Be marker. These observations confirm the preliminary estimated erosion rate from the mid-plane of IWGL, of approximately 2.3 x 10e19 atoms s⁻¹ [3] which were based on a single tile. Analysis of 2XR3 indicates erosion with simultaneous deposition within the area of the central part of the tile and also a thick deposit (mainly Be with no more than 0.05% of W and 0.08% Ni) of thickness around 7-10·10¹⁸ at/cm² mostly on left side of the middle part and wing, Fig.4. IBA findings are in good agreement and are complementary to surface profilometry. Neither erosion nor significant deposition on the top of the inner limiter 2XR19 is observed, just traces of W and Ni.

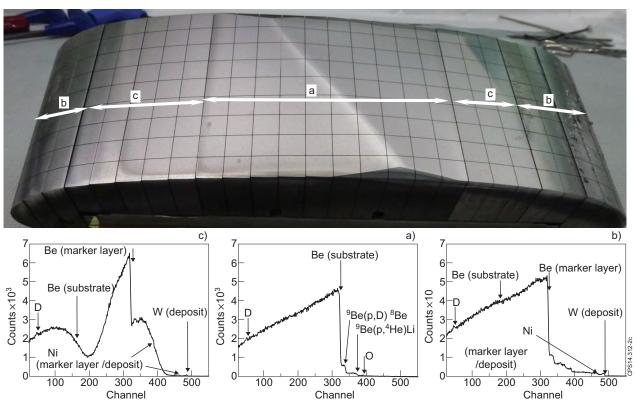
Figure 2: Photo of OPL (4D14) after ILW campaigns 2011-2 and the marker coating evaluation. RBS spectra of a central erosion zone (indicated by a), a left and right wing, deposition zone (indicated by b), and a middle part where the marker starts appearing (indicated by c).

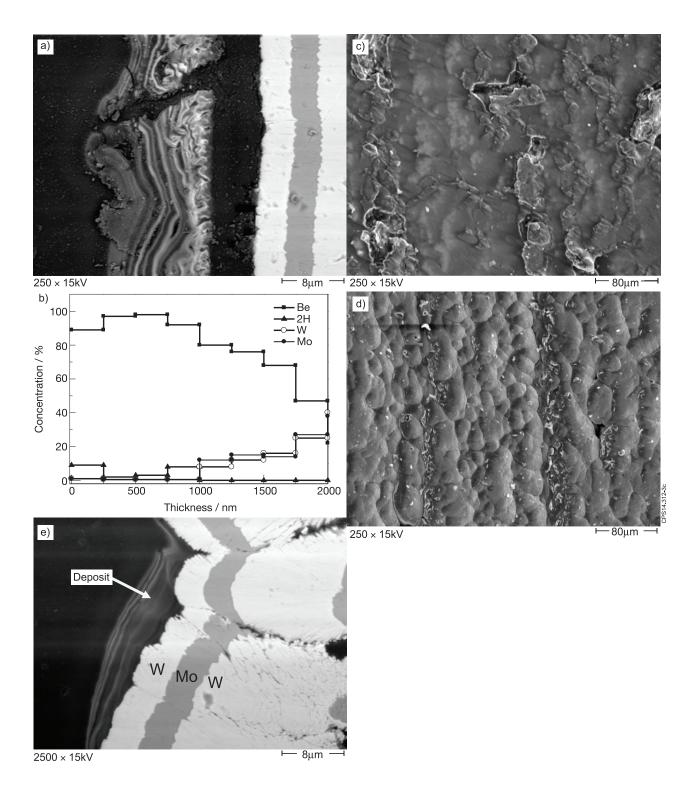
Figure 3: BSE image of a cross-section of the top part (apron) of tile 1, there is an open space marked by (1) between the marker coating and flake filled with resin during an embedding of the samples (a), corresponding elements distribution within 15-20µm calculatyed by WinDF software based on RBS/NRA/PIXIE data (b), BSE image of a top view of the upron of the tile 1 surface (c), characteristic cauliflower morphology BSE image of a top view of the tile 4 surface, characteristic cauliflower morphology (d), BSE image of a cross-section of the sloped part of tile 4 near the strike point, deposit in the valleys (e).

The summary of the deposition and erosion zones in the divertor, including Be concentration and also C and O concentration where it was possible to calculate have been reported [3, 5, 7]. The composition of the deposit is mainly Be with traces of W, Ni, Mo, Cr and Fe. Only small amounts of Be have been found on Tile 3, 4, 6 and 7 (less that $1 \cdot 10^{18}$ at/cm²), indeed SEM analysis suggest there may be some signs of erosion of lower part of Tile 1 and upper part of Tile 3. The thickest deposit has been found on top of Tile 1 (\sim 15 μ m, two points where it might be more than 17 μ m – the maximum accessible for IBA) and on the High Field Gap Closure (HFGC) tile (in the range from 3 to 8µm); there is no data from surface profilometry from these areas. RBS spectra of all the Be deposition, but particularly the thick deposit on tile 1 have proved difficult to fit with the WinDF or SIMNRA software. The surfaces are known to be rough, but it was not possible to say to what extent the problems were related to the surface roughness and/or chemical composition variability of the deposit. A fitting of the spectra by using sets of Be-W layers of slightly different Be to W ratio (ratio decreases towards the substrate) could give relatively good agreement with the measured spectra. However, it should be kept in mind that the data analysis assumes a flat surface. For the derived depth profiles roughness effects are interpreted as depth profiles of elements. Nevertheless, it has been already shown that in case of ambiguities between depth profiles and surface roughness the total amounts of elements are still correct even if the depth profiles may not reflect the sample structure correctly [12]. Recent scanning microscopy of a sample cross-section has brought some clarification for interpreting RBS spectra and confirmed a multi-layered structure of the thickest deposited material, which is clearly observed on tile 1, as shown in Fig.3a. Combining the information of the BSE microscopy, the EDS analysis and IBA, it can be concluded that the deposited material has a multi-layered structure consisting of an outer layer of pure Be and inner layer of mixed Be and W layers with W/Be ratio: 0.05-0.08 (Fig.3b). The oxygen concentration was not possible to evaluate in this work by IBA but it might be likely that the inner layer contains also a significant amount of oxygen (up to 10 %). The darker layers have a higher Be/W ratio, while the brighter layers contain more W. Due to the thinness of the layers, the EDS analysis could not be limited to a single layer and, therefore, it is not excluded that pure Be and W layers are deposited alternately, without mixing. The upper part of Tile 1, revealed areas of non-uniformity of the deposit (small cracks), Fig.3c; by contrast the vertical part of Tile 1, and Tiles 4 and 6 are characterised by a cauliflower-like morphology, as in Fig. 3d. The amount of material deposited on Tiles 4 and 6 was below $\sim 2.5 \cdot 10^{18}$ at/cm², but some deposition was found, mainly in the sloped part of tiles ($\sim 6 \cdot 10^{18}$ at/cm² of Be). The thickness of the deposition is of the order of a hundred nanometres to 1µm, but in the valleys between the fibres, the deposition thickness can increase up to 5 μ m,. In the thickest part of the deposit it was again found that it is built up by a multi-layer structure of different intensity in the BSE image, indicating a different composition of the layers (Fig. 3e).

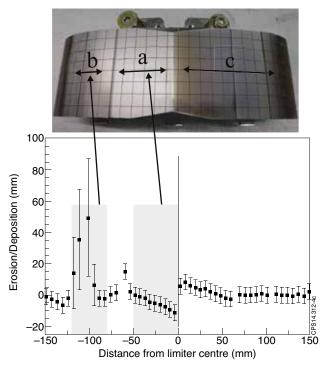
Figure 4: Surface profiling results for the IWGL beryllium tile (2XR3), the main deposition is observer on the left side of the wing tile and erosion on the left part of central tile, disappearance of Be marker confirmed by IBA: eroded Be marker (area a), deposition on top of the Be marker (area b), marker in tack/thinning of the marker (area c).
