WPJET2-CPR(17) 16984

M Rubel et al.

**Metallic mirrors for plasma diagnosis in  
current and future reactors: Tests for  
ITER and DEMO**

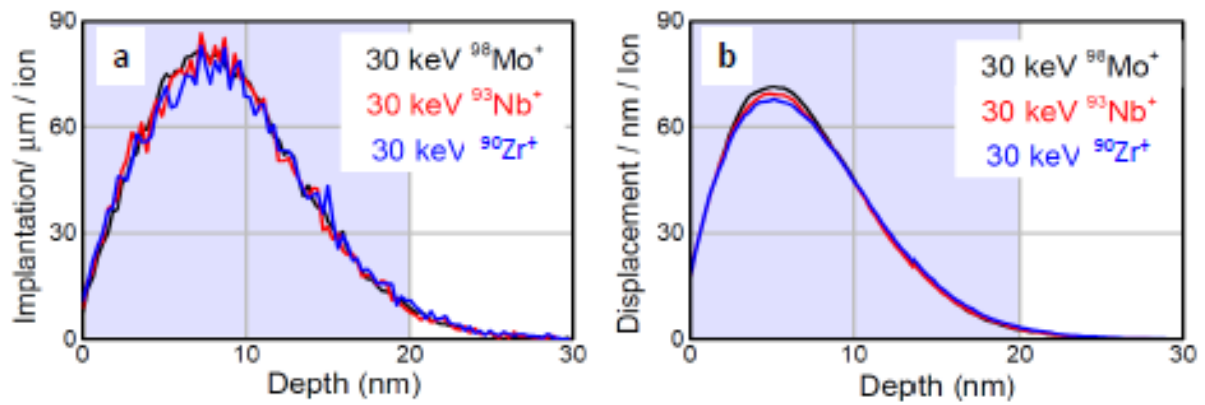
**Figure 1**

SRIM simulations of: a) implantation depth profile in a Mo mirror under Zr and Nb irradiation; b) damage depth profile of a Mo mirror under irradiation by Zr and Nb. The optically active layer is marked in blue.

Neutrons will interact with the surface and the bulk of components. For mirror it is the surface region which is important. Therefore, the irradiation programme has been based on SRIM [23] predictive modelling to define the irradiation conditions. This had to match the optically active layer in molybdenum mirrors, which extends to around 15-20 nm, as determined in [13]. To simulate neutron-induced effects the irradiation was done with 30 keV  $^{98}\text{Mo}^+$ ,  $^{93}\text{Zr}^+$ ,  $^{90}\text{Nb}^+$ , 2 keV  $\text{He}^+$  and 4 keV  $\text{H}_2^+$  ions. The irradiation with either zirconium or niobium was done, because both elements are formed as transmutation products in neutron-irradiated molybdenum. The damage of Mo in a reactor is foreseen to be 7 dpa and this would be accompanied by the presence of 45 appm of H, 479 appm of He [25,26]. The amount of Zr and Nb would be  $1 \times 10^{14} \text{ cm}^{-2}$  and  $1 \times 10^{13} \text{ cm}^{-2}$  in the surface layer of 15 nm. Graphs in Fig. 1 show the implantation and displacement range of the implanted heavy ions. The irradiations were performed at the Ion Technology Centre (ITC) of the Ångström Laboratory at the Uppsala University, Sweden. A 350 kV Danfysik 1090 implanter with a beam current of up to 1 mA was used.

SRIM simulations of: (a) implantation depth profile in a Mo mirror under Zr and Nb irradiation; (b) damage depth profile of a Mo mirror under irradiation by Zr and Nb. The optically active layer is marked in blue.

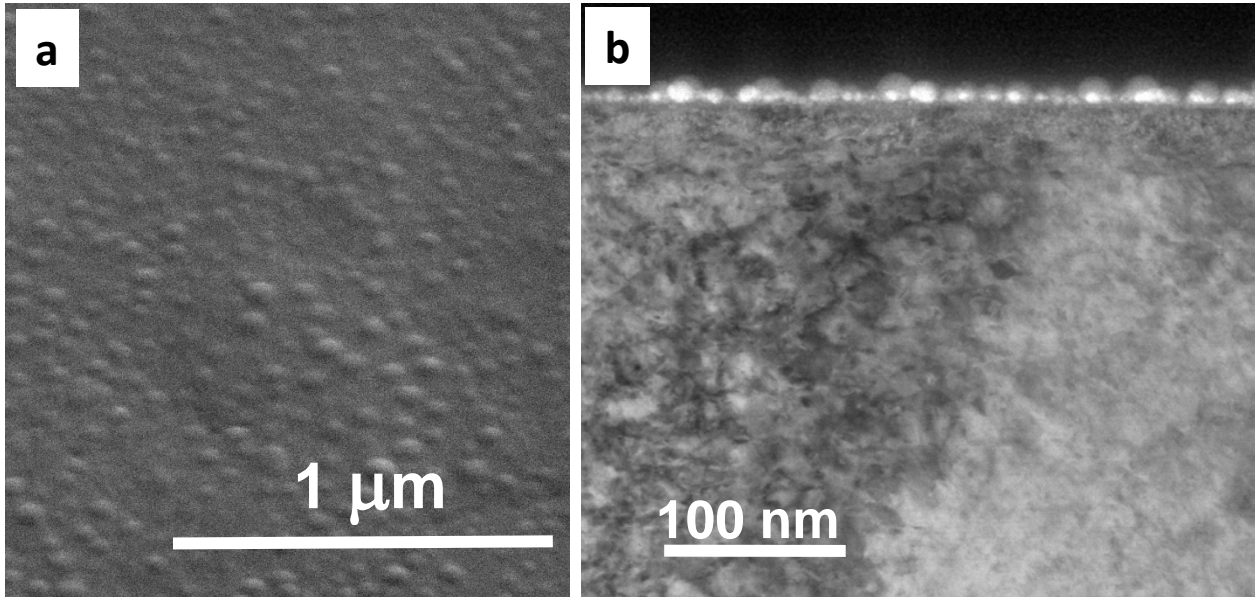
**Figure 9.**

Micrographs of the (a) surface and (b) sub-surface region of the Mo mirror irradiated first with  $^{90}\text{Nb}^+$  and then with helium and hydrogen ions.

Micrographs of the (a) surface and (b) sub-surface region of the Mo mirror irradiated first with  $^{90}\text{Nb}^+$  and then with helium and hydrogen ions.
